Titre Environmental Emergency Reports

Notes Document: Site Evaluation Report-Drinking Water pumping station Tasiujaq for Kativik Regional Government; 30 Novembre 2006

Potable Water Pumping Station
Tasiujaq, Quebec

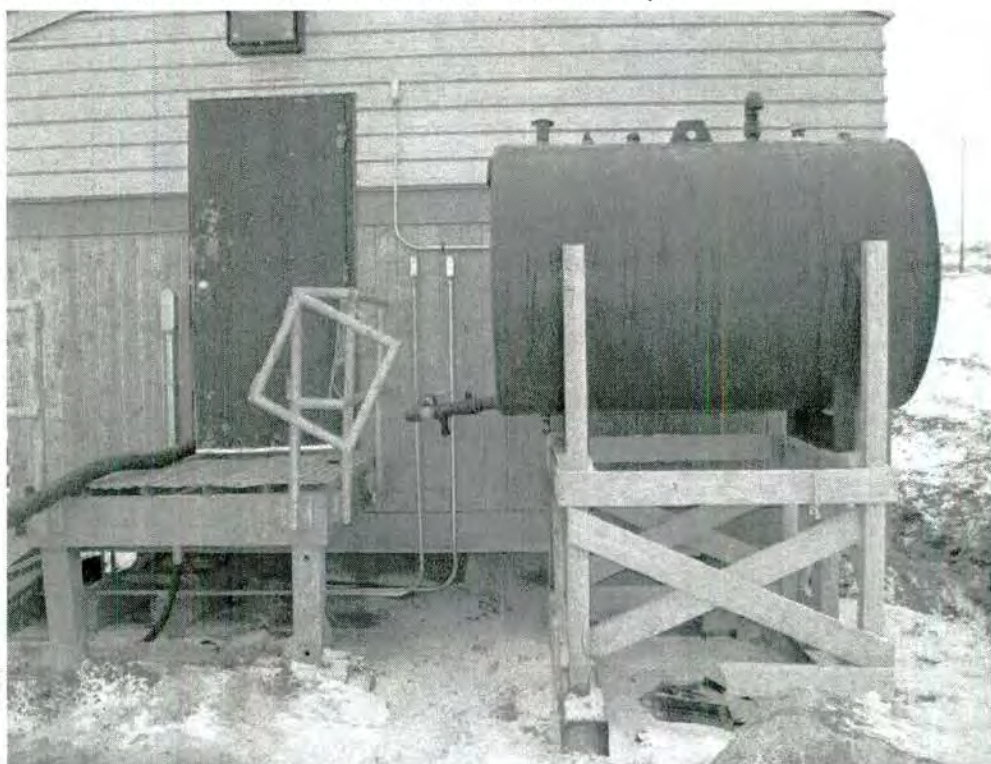
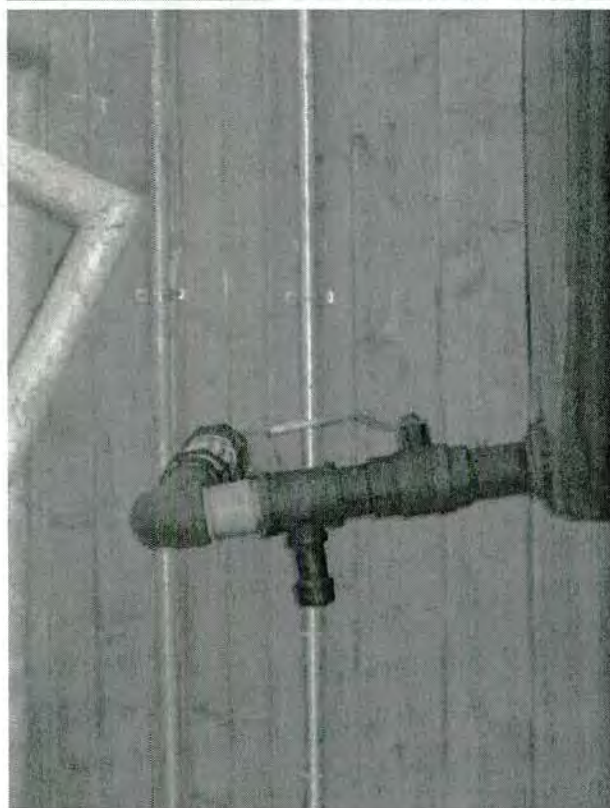
The fuel tank, located on the north side of the building, had released all of its contents after the feed line between the tank and the building had been damaged or broken. Public Health was a concern because of the location and Stabilis was also asked to assess the risk that the water in the well of the pumping station might be affected and contaminated by hydrocarbons released from the spill.

Photos 3 and 4 – Fuel tank and identified source of spill

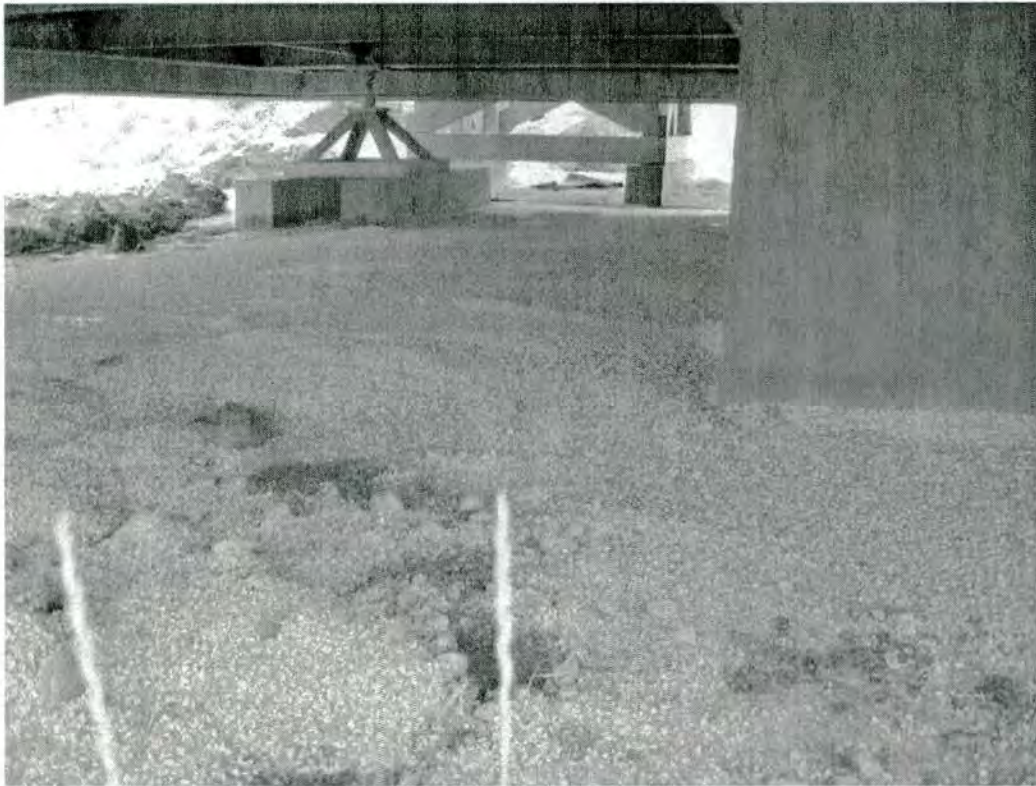
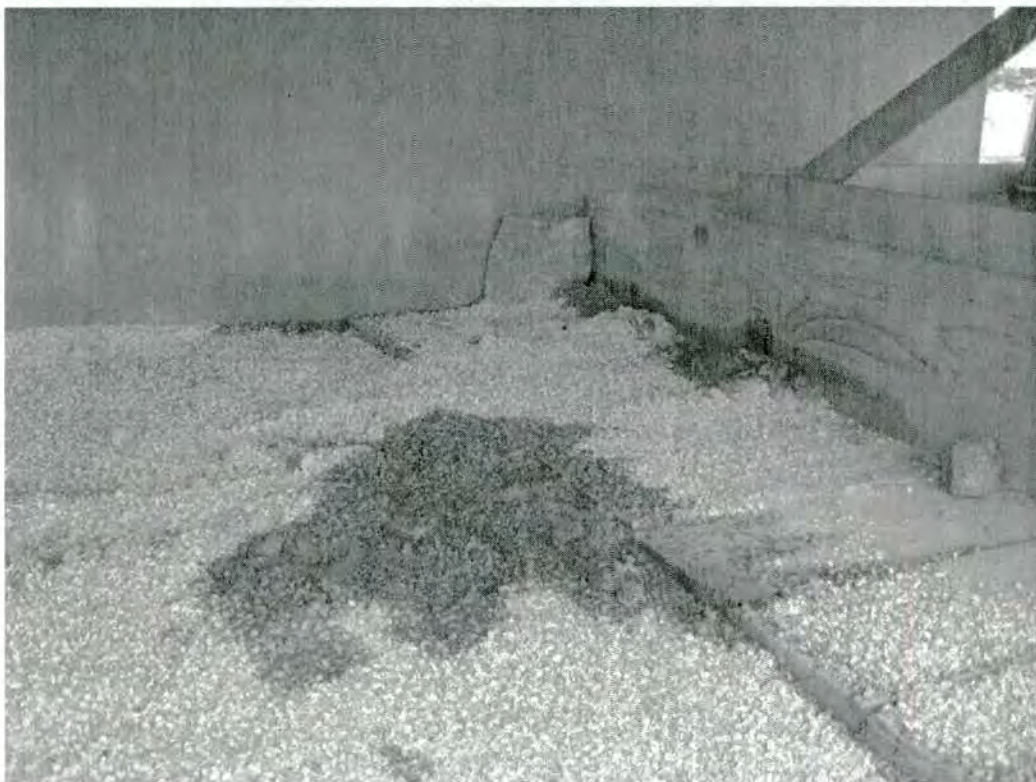
Photos 5 and 6 – Surface soils below building covered with sorbent materials

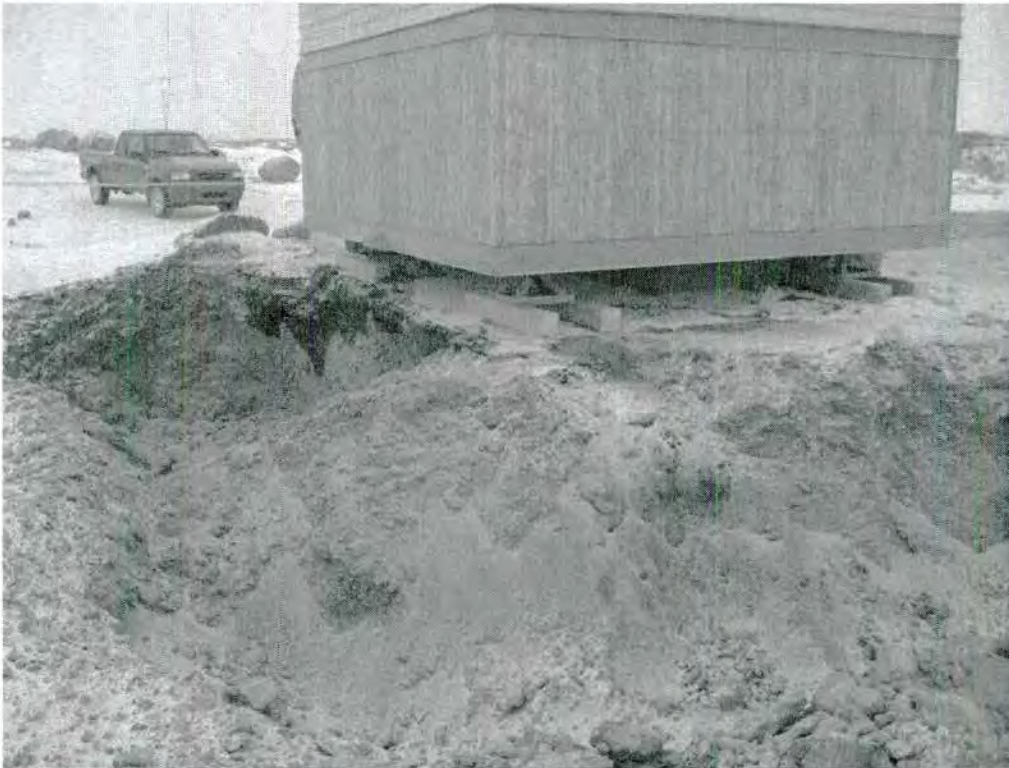
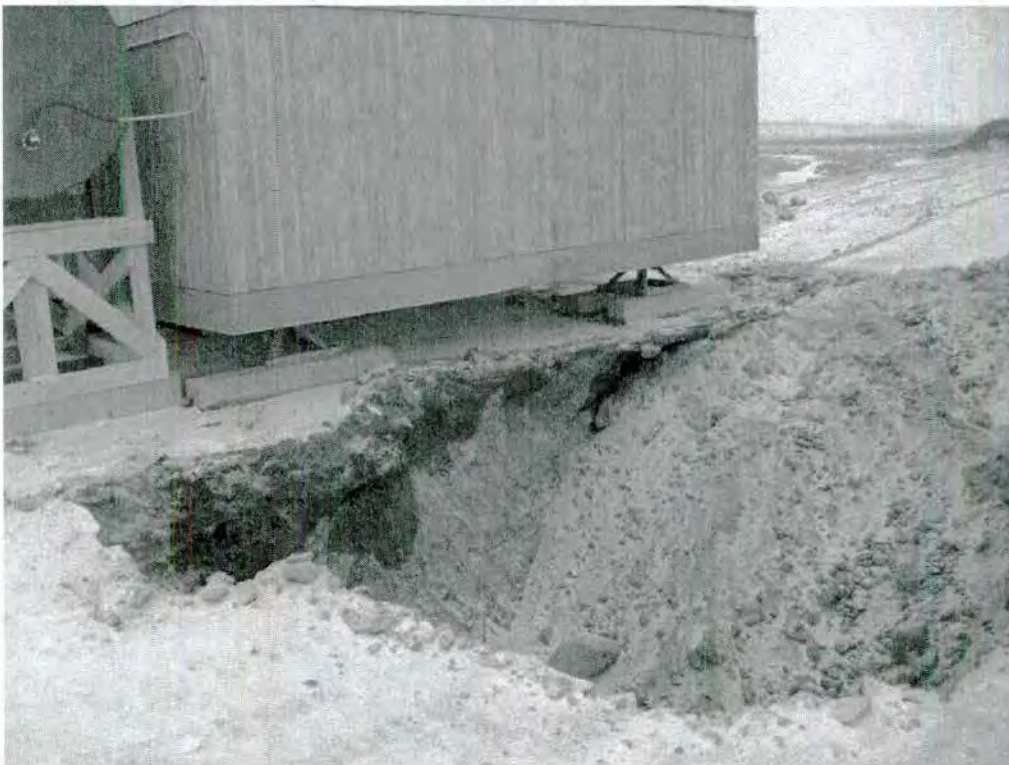
Photos 7 and 8 – Excavation work prior to Stabilis arrival on site

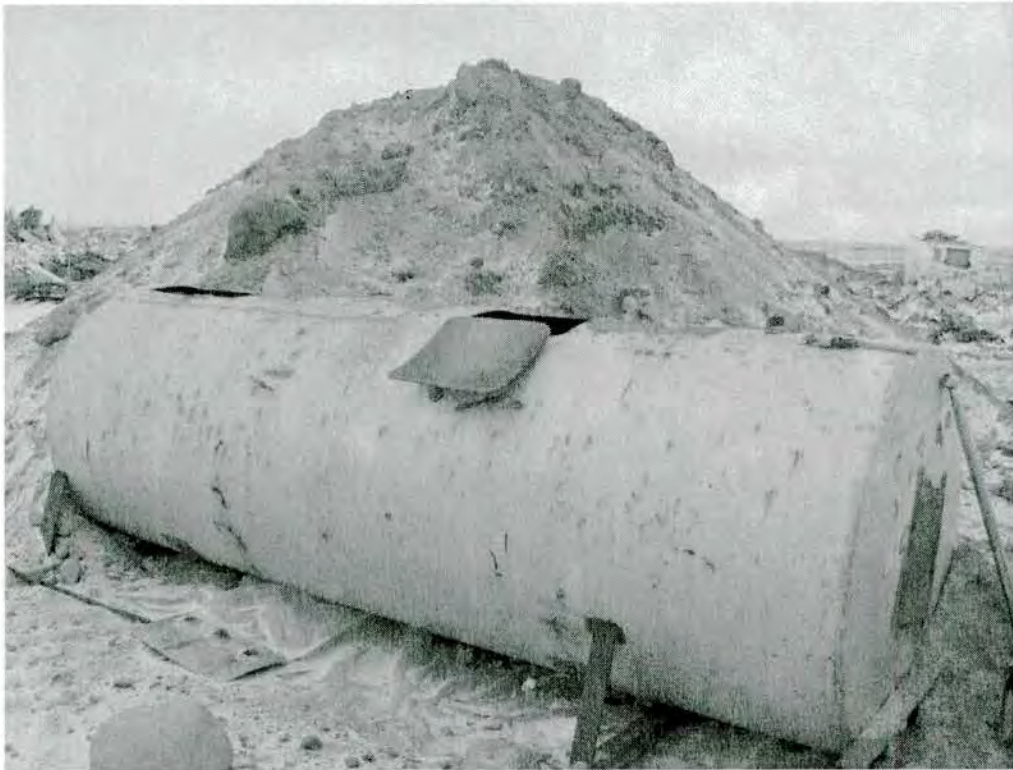
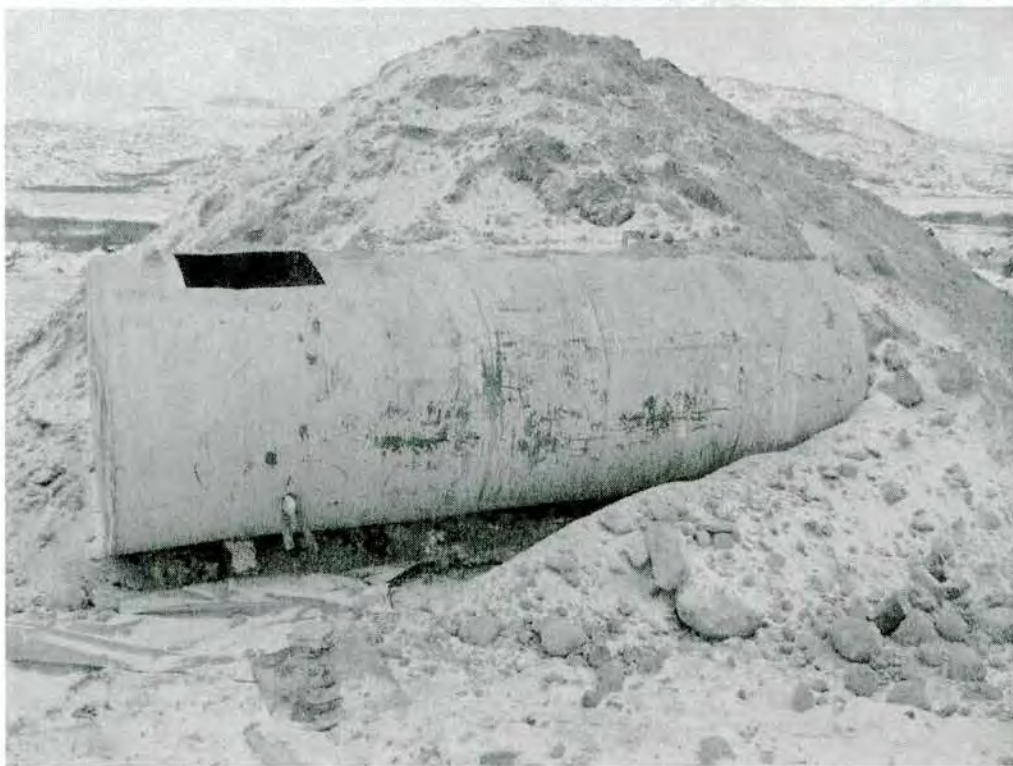
Photos 9 and 10 – Soils excavated and deposited at the community landfill site

recommended that municipal authorities order additional tarp as well as heavy duty polyethylene. These will be used to extend the area over which the soils were deposited at the landfill, lowering the height of the pile, and covering the whole with the polyethylene for the winter season.

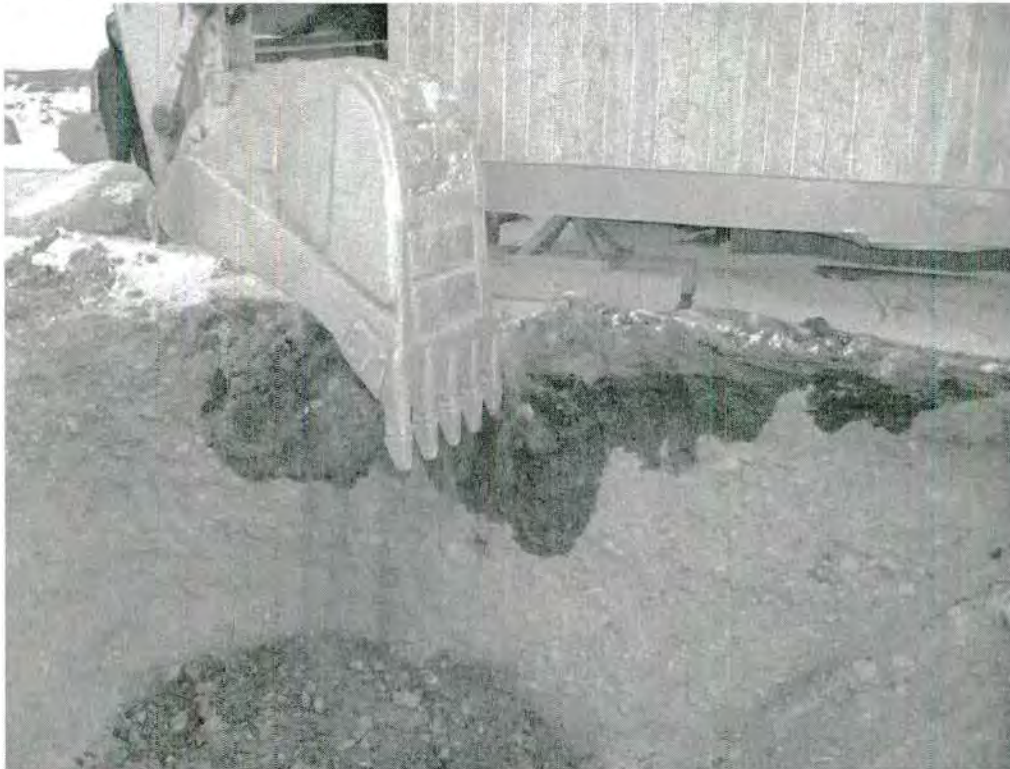
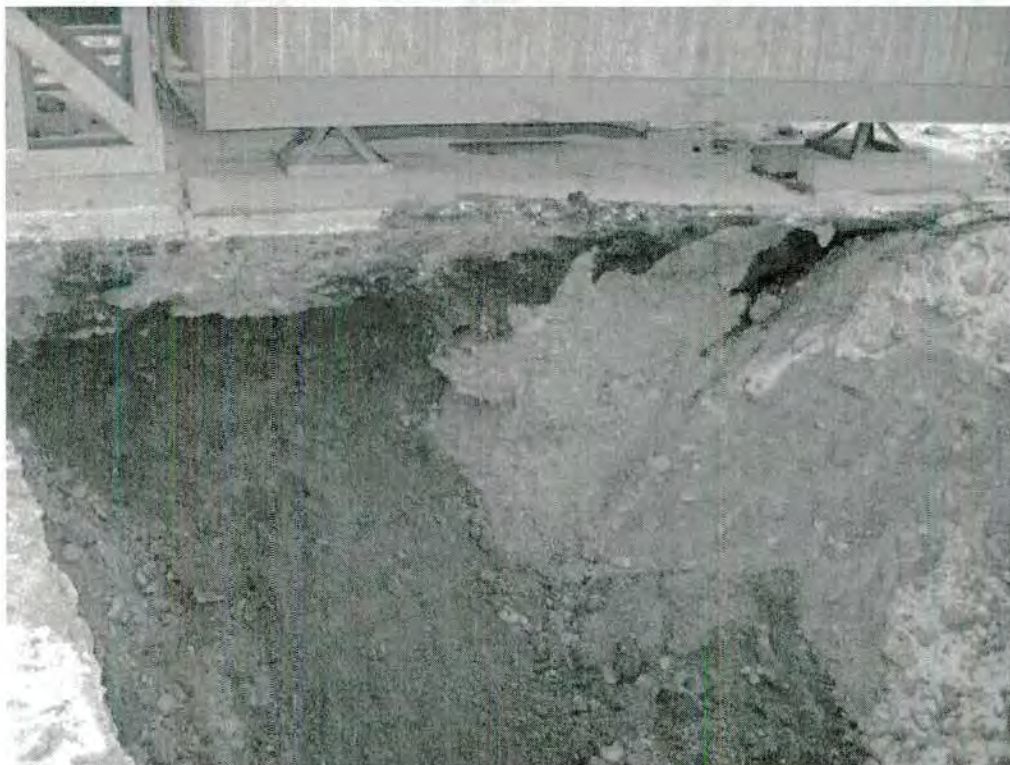
Extra excavation was performed on the west side of the station on November 19th, mostly to scarify soils still attached to the north-west pallet and accessible to the excavator (Photos 11 and 12, Appendix C). This additional work and cleaning up any soil that fell into the existing excavation resulted in approximately 15 cubic meters of contaminated soils to be removed. New depth of excavation was 3,4 m and new maximum depth of contaminated soils on that newly created wall of excavation was measured at 2,2 m on November 20th, 2006 (Photo 15, Appendix C). This deeper plume observed on the next day can be explained by being closer to the source or by removing the soils that restricted or slowed down the migration of the oil.

Photos 11 and 12 – Extra scarification work on the west side of the station

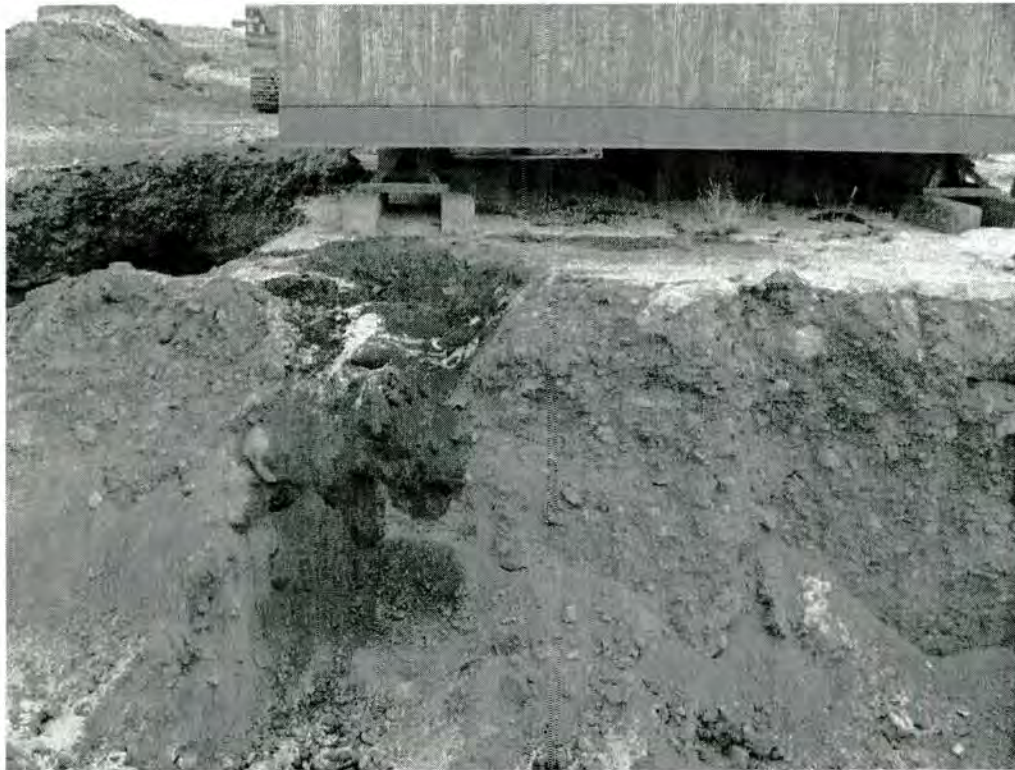
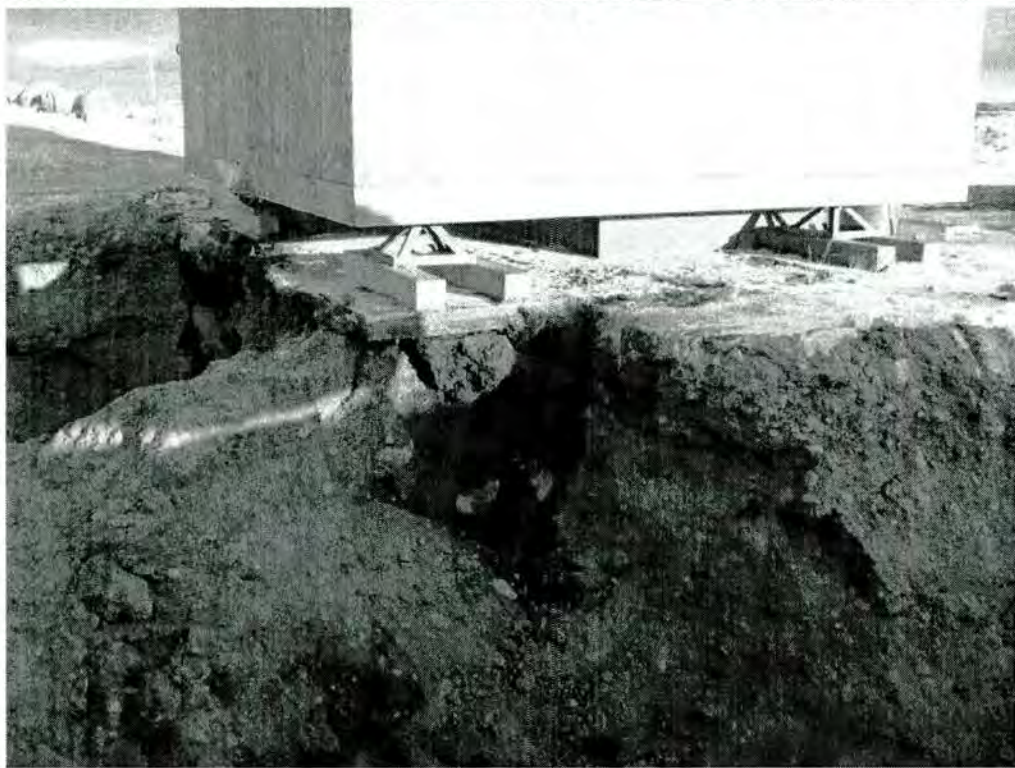
Soils sampled during excavation indicated that all floors and walls remained free or almost free of hydrocarbons, except very localized areas practiced on the south side of the building. Cause for the small remaining quantities of contaminated soils may originate from minor deviations from instructions given to the heavy equipment operator present at the site.

Photos 13 and 14 – Extra scarification work on the south side of the station

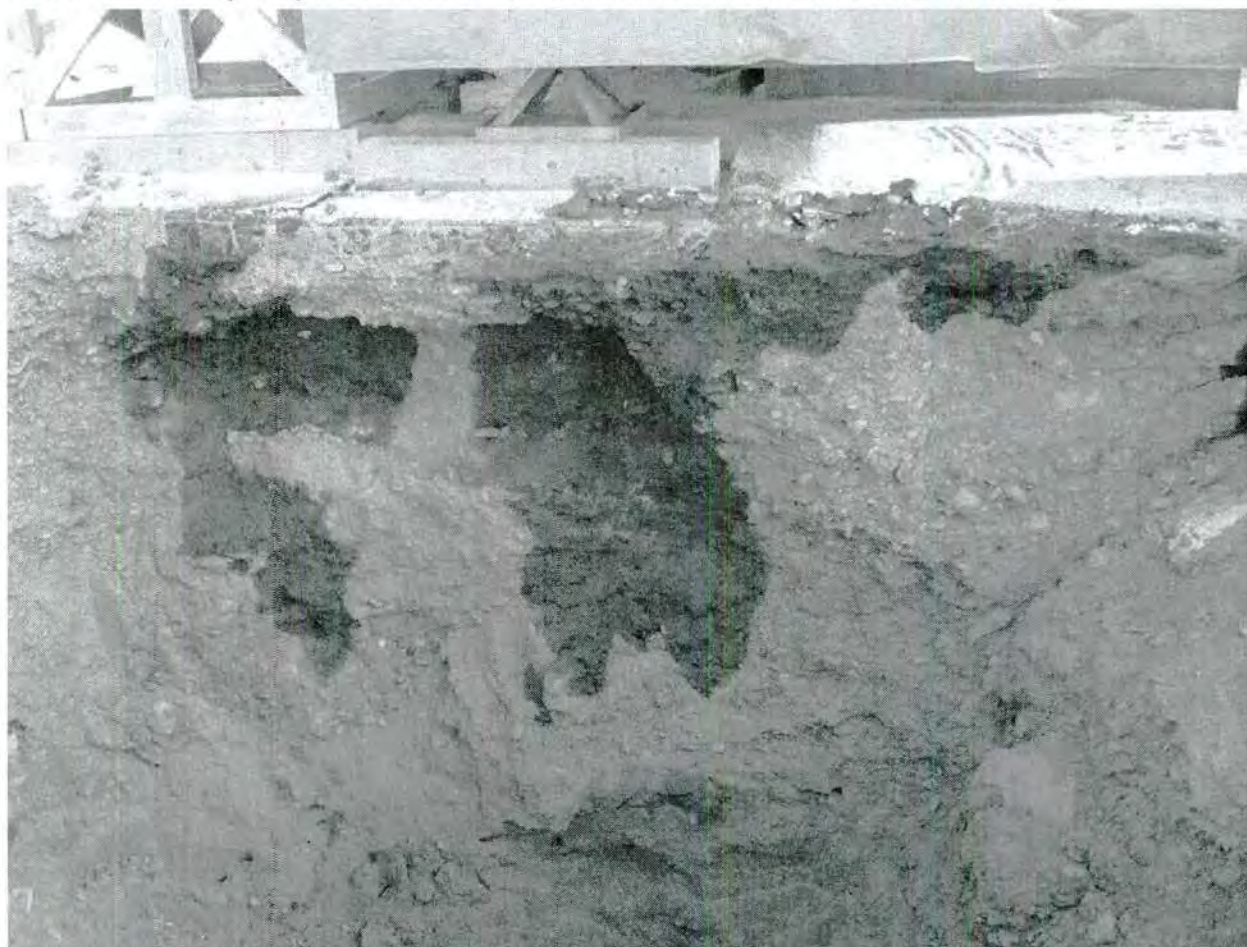
Photo 15 – Mobility of hydrocarbons on west side excavation wall after scarification work

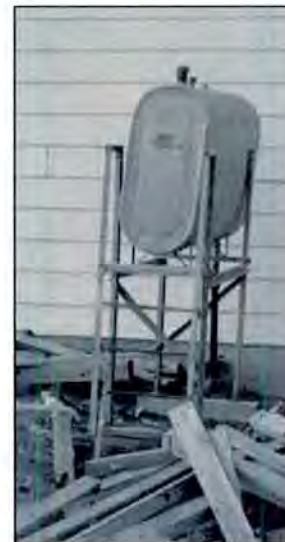
4.4a Unstable tank installation: the tank stand is not secured to a solid foundation, thus the tank and stand have a noticeable lean to the right. A good strong wind or a minor physical impact would be enough to topple the tank.

top-heavy and subject to tipping over unless properly anchored. Tank stands should be bolted to a solid footing and/or fitted with a very broad base. An ideal foundation consists of a large concrete pad onto which the metal tank stand is firmly

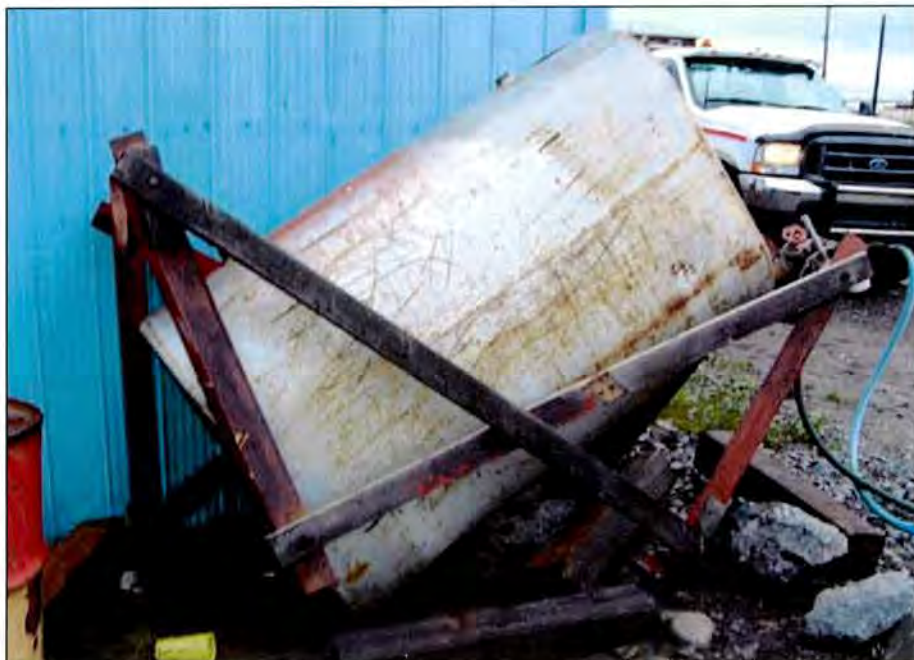
4.4b This heating oil tank was resting on a wood-metal stand, which eventually collapsed under the weight of the tank, spilling 445 litres (100 gallons) of heating oil onto the ground.

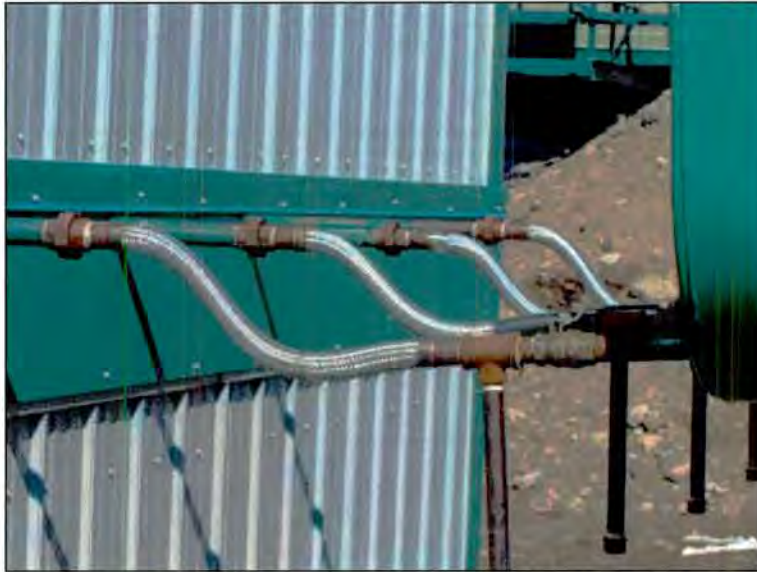
4.5a The flex connectors on this installation are out of alignment, possibly due to ground shifting. In other words, the flex connectors have served their purpose: a solid fuel line would have broken under the stress, resulting in an oil spill. Nevertheless, the flex connectors appear to have reached their limit of flexure. Now it is time to re-align the tank and fuel line fittings. This will likely require that the tank foundation be shored up and reinforced and that the flex connectors be replaced. Failure to attend to this situation in a timely manner will likely result in one or more of the flex connectors shearing and the entire contents of the affected tank(s) emptying onto the ground.

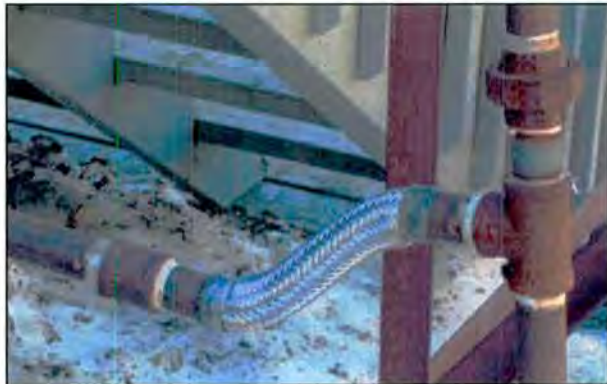
4.5b This flex connector has reached the limit of its flexure. The fittings must be re-aligned and the flex connector replaced with a new one. Any further movement will likely result in a broken flex line and subsequent release of the entire contents of the heating oil tank onto the ground.

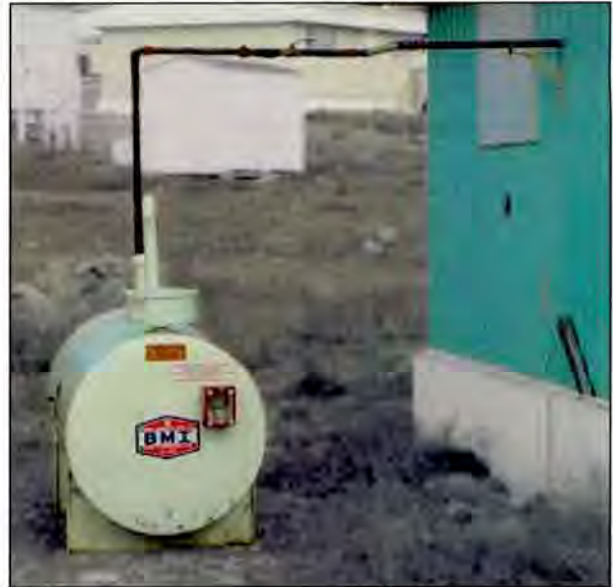
4.7 This unsupported fuel line provides a convenient monkey bar for children to play on, with predictable results.

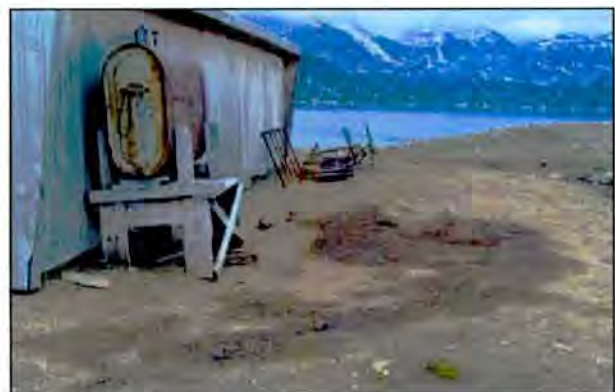
4.9 Excessive ground staining from a poorly installed and maintained oil tank.

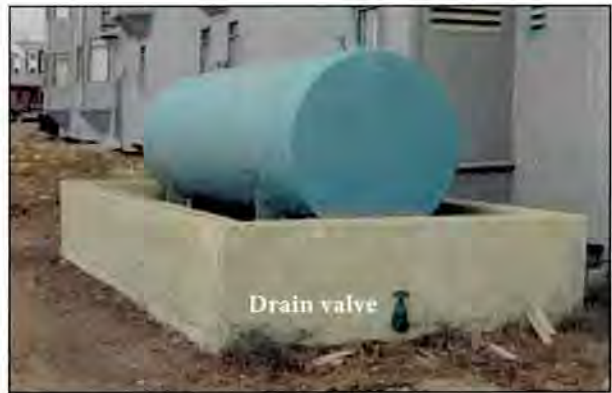
4.11 4,550 litre (1000 gallon) tank with a concrete berm. Note that the drain valve is not fitted with a lock or chain and thus can be tampered with.
