CANADIAN FORCES .
1 CONSTRUCTION ENGINEERING UNIT .

ENGINEERING STUDY 83-CEU-40
NORTHERN QUEBEC MID-CANADA LINE SURVEY
28 SEP 1983

MID CANADA LINE SURVEY PHASE II

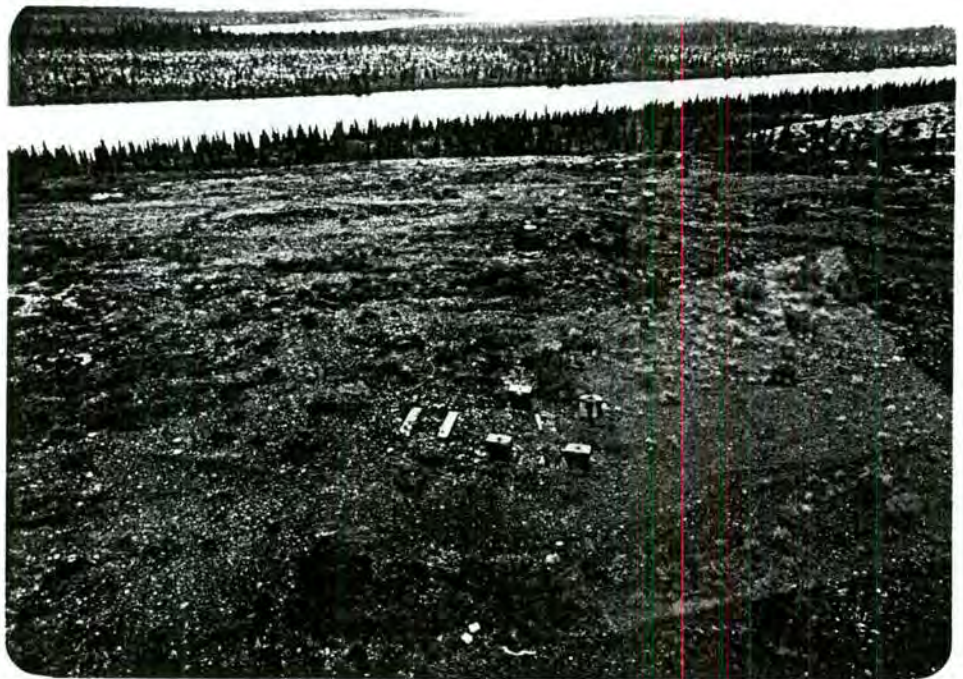
c. Pollution (Solid Waste). No solid waste remains, site has been thoroughly cleaned.

Photo 1: Remaining foundations found at Site 300.

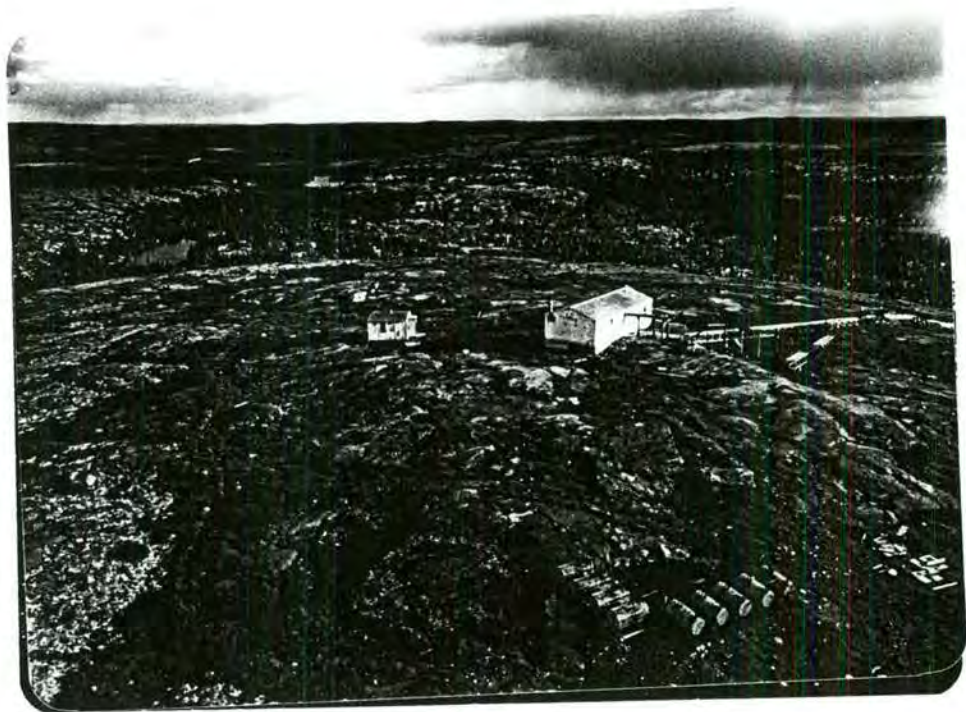
Photo 2: An aerial view of Site 312.

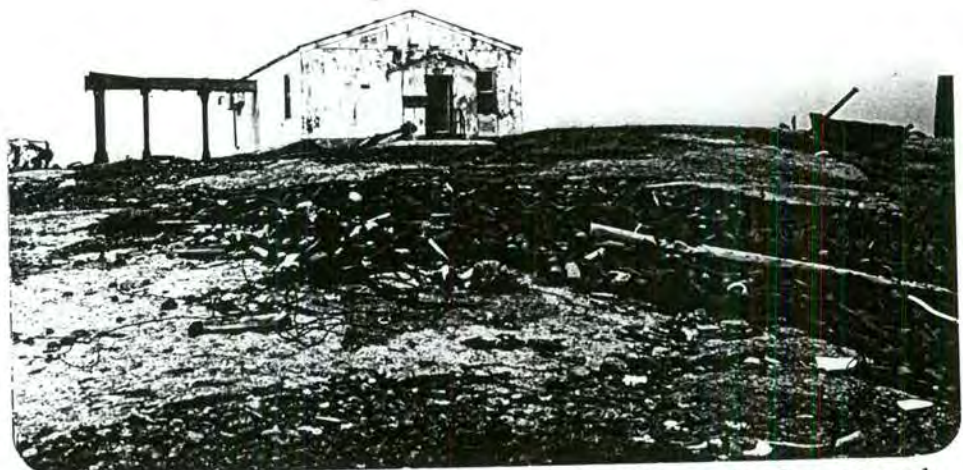
- (1) One pile of garbage consisting mainly of empty cans and bottles.
- (2) One partially stripped and rusted gas powered dozer.
- (3) Chain link fencing, piles of wood and rubble, empty cable reels and various debris scattered within a 150 m radius of the Doppler Detection Building.

Photo 3: Doppler Detection Building, note litter in foreground.

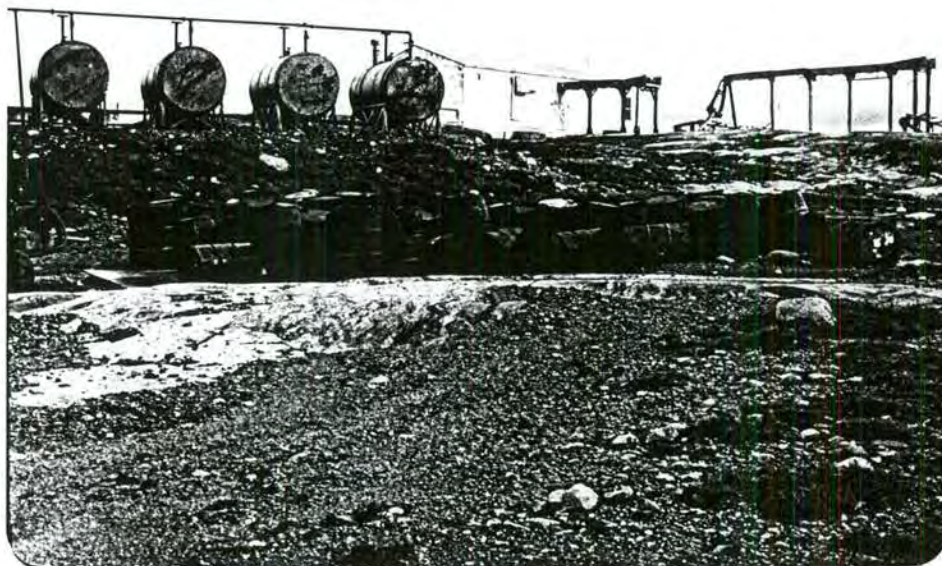
- (5) The existing POL consist of nine 22 730 L (5 000 gal) fuel storage tanks and approximately fifty 205 L (45 gal) empty rusty drums concentrated near storage tanks and helicopter landing site.

Photo 4: Fuel storage tank and drums.

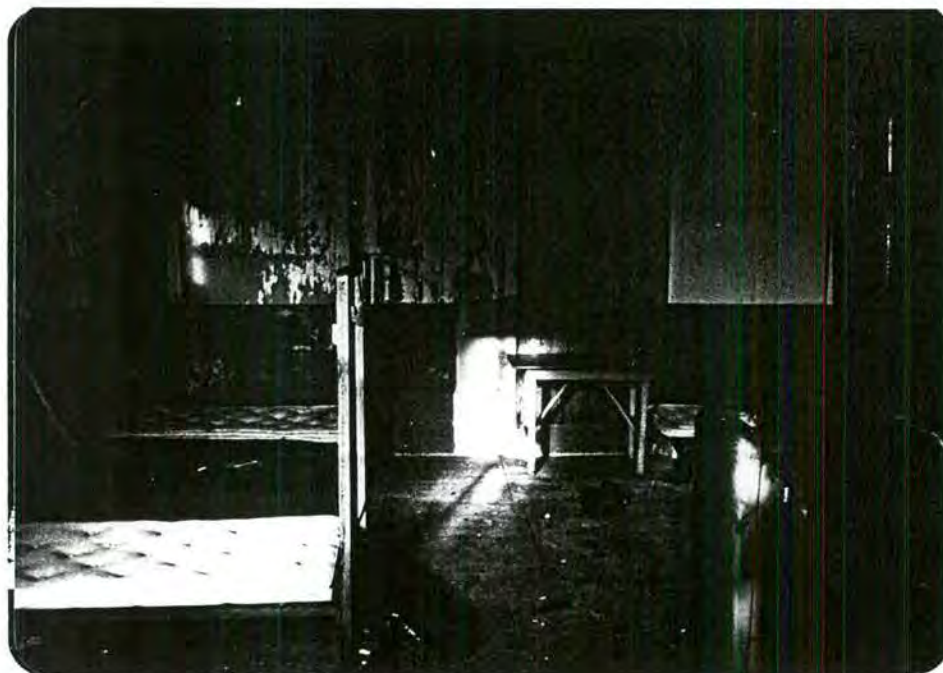
Photo 5: Inside a four man survival hut.

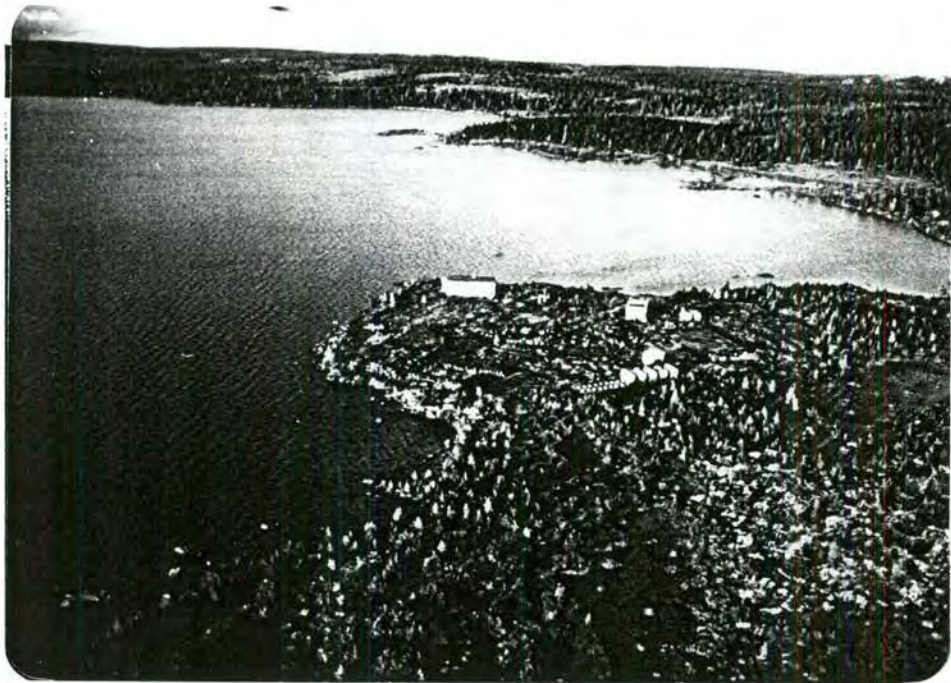
Photo 6: An aerial photo of POL cache.

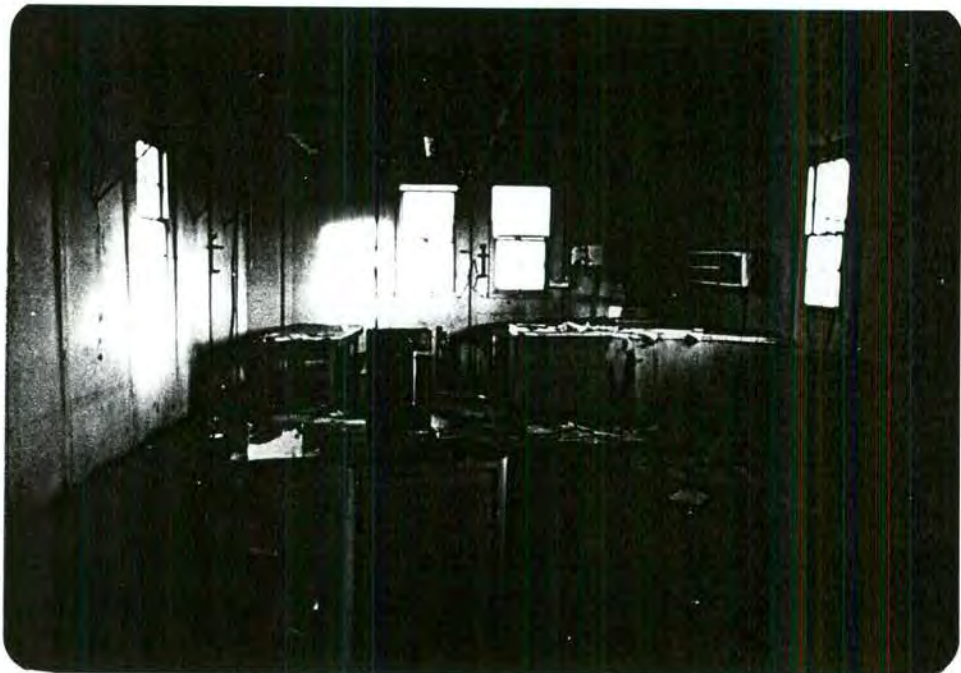
Photo 7: Inside view of survival hut.

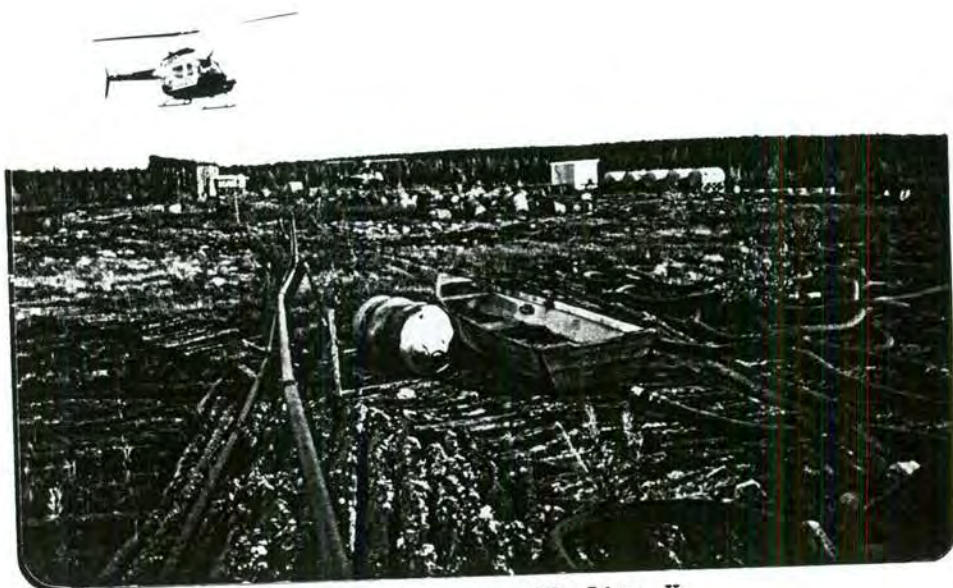
Photo 8: Pipeline to lake shore at POL Site X.

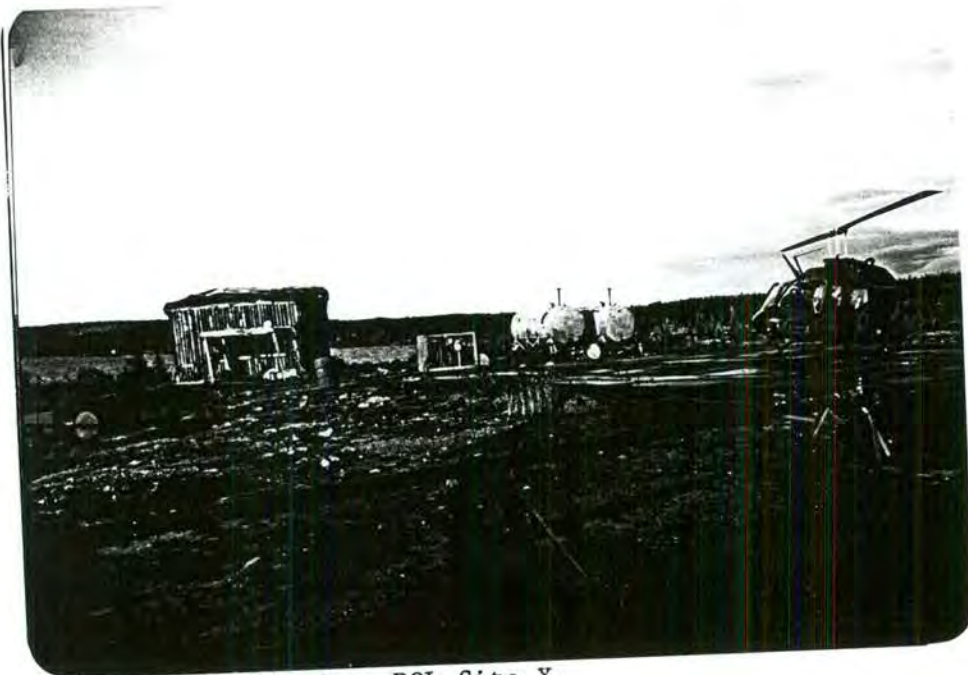
Photo 9: Wooden helipad at POL Site X.

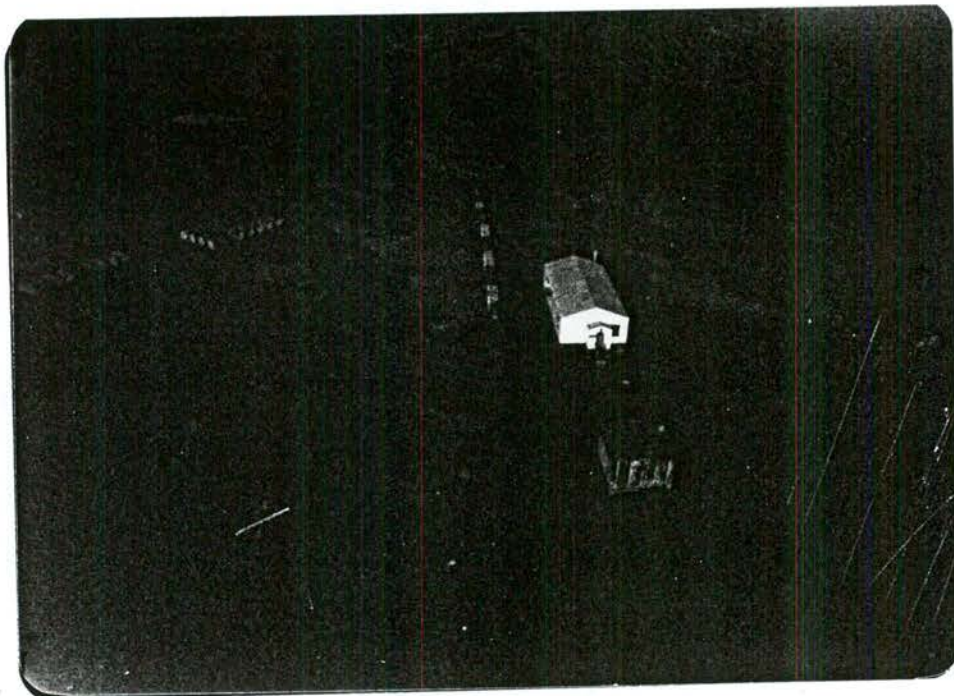
Photo 10: An aerial view of Site 309

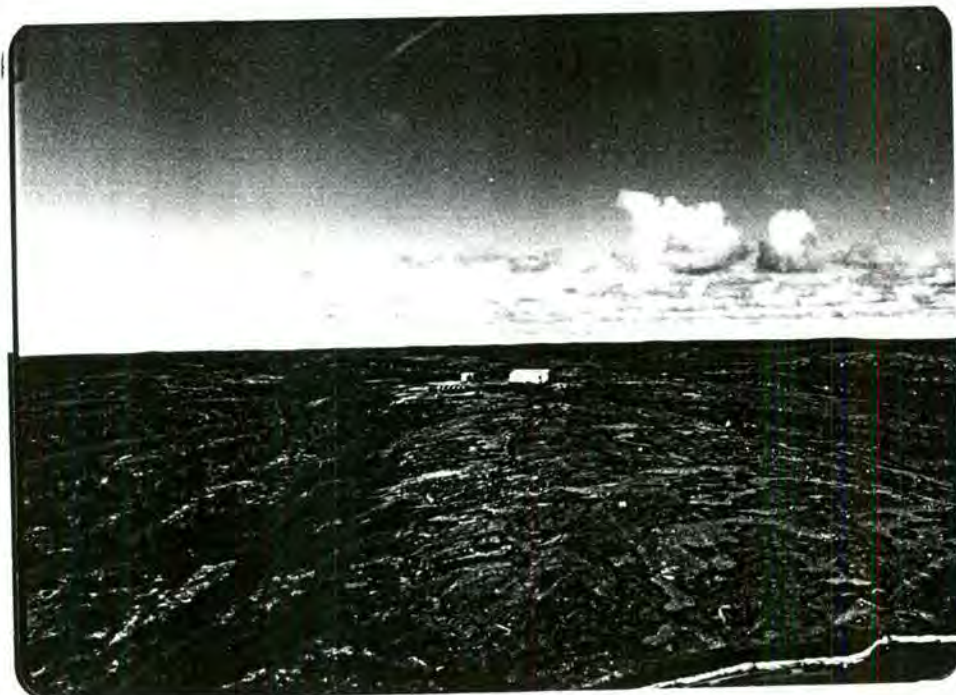
Photo 13: An aerial view of Site 306.

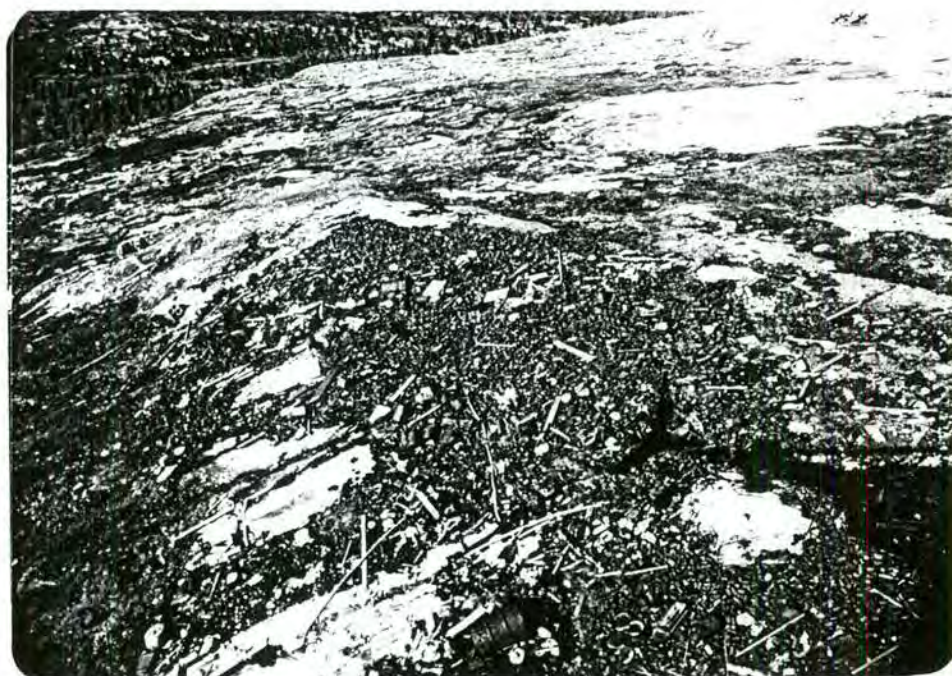
- (1) One large pile of garbage consisting mainly of empty cans and bottles.
- (2) One partially stripped swamp-buggy
- (3) chain link fencing, piles of wood and rubble, empty cable reels and various debris scattered within a 150 m radius of the Doppler Detection Building.

Photo 14: Large pile of rubble at Site 306.

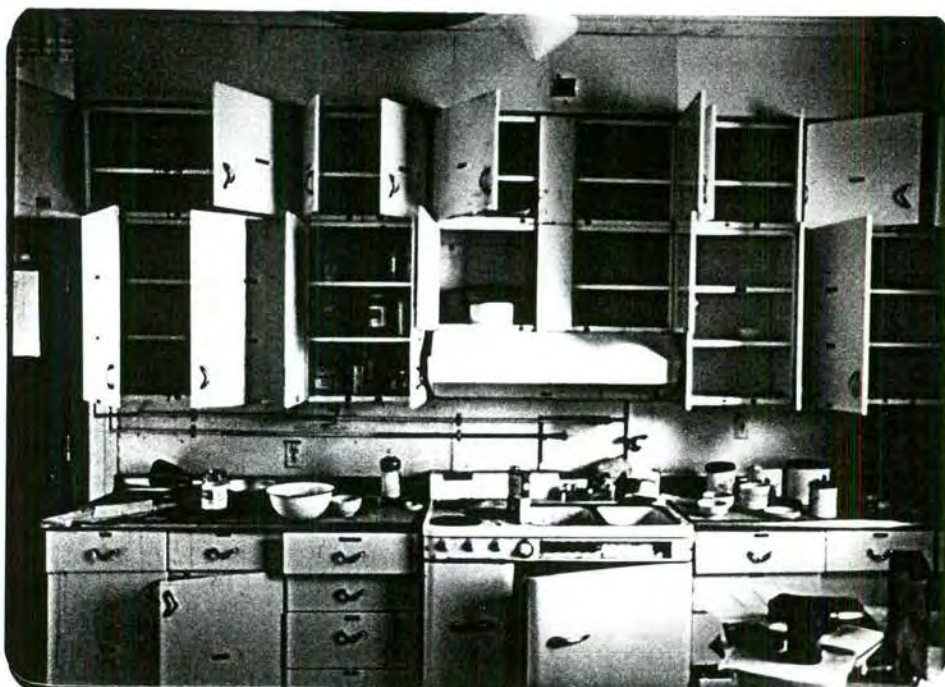
Photo 15: Kitchen facilities in Doppler Detection Building at Site 306.

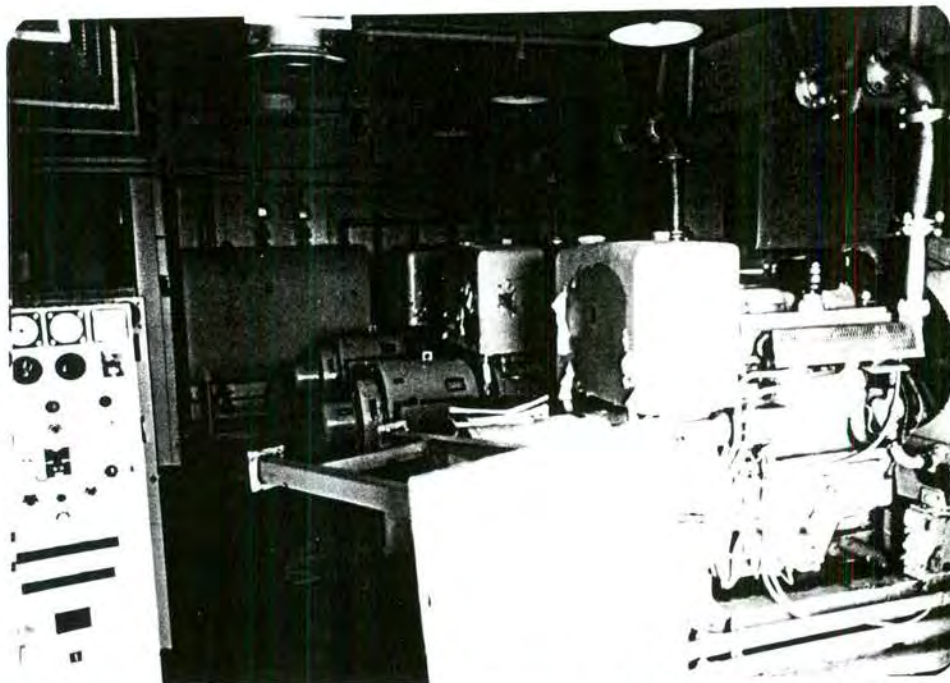
e. Electrical Equipment. Three Dorman diesel engines along with General Electric alternators and exciters were found in power generation room of the Doppler Detection Building. All equipment is on skids which is located on a concrete bed and are of the same type found at Site 312. Serial numbers of the equipment are as follows:

Photo 16: Three Dorman diesel generators in Doppler Detection Building at Site 306.

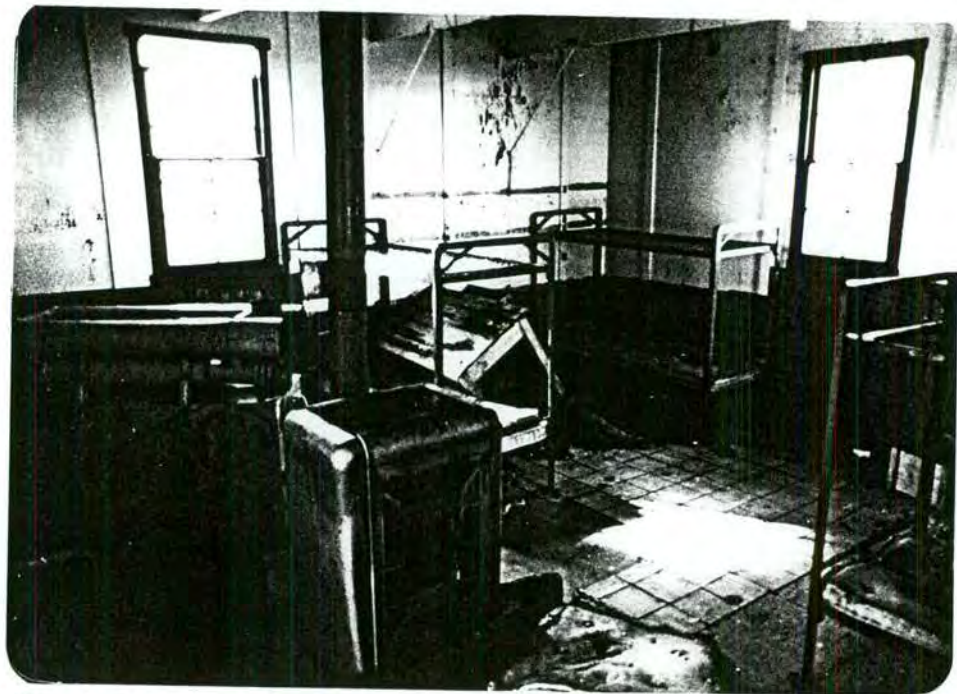
Photo 17: Interior view of four man survival hut at Site 306.

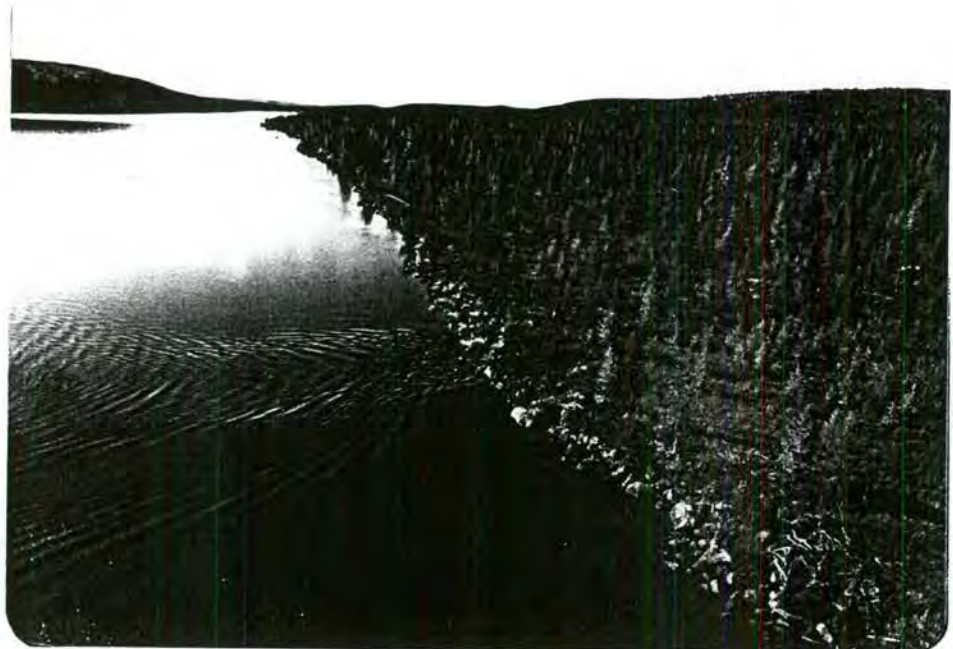
- b. Facilities. One small cabin (2m x 3m) is left with one wooden pad for helicopters and one floating dock made of logs.
- c. Pollution (Solid Waste and POL). Approximately one hundred empty 205 L (45 gal) drums and two empty 22 730 L (5 000 gal) storage tanks remain on the site. Evidence of past spills around the drums and storage tanks can be found in the form of darkened areas. The lake water is clear with no visible signs of pollution.

Photo 18: An aerial view of POL Cache Z.

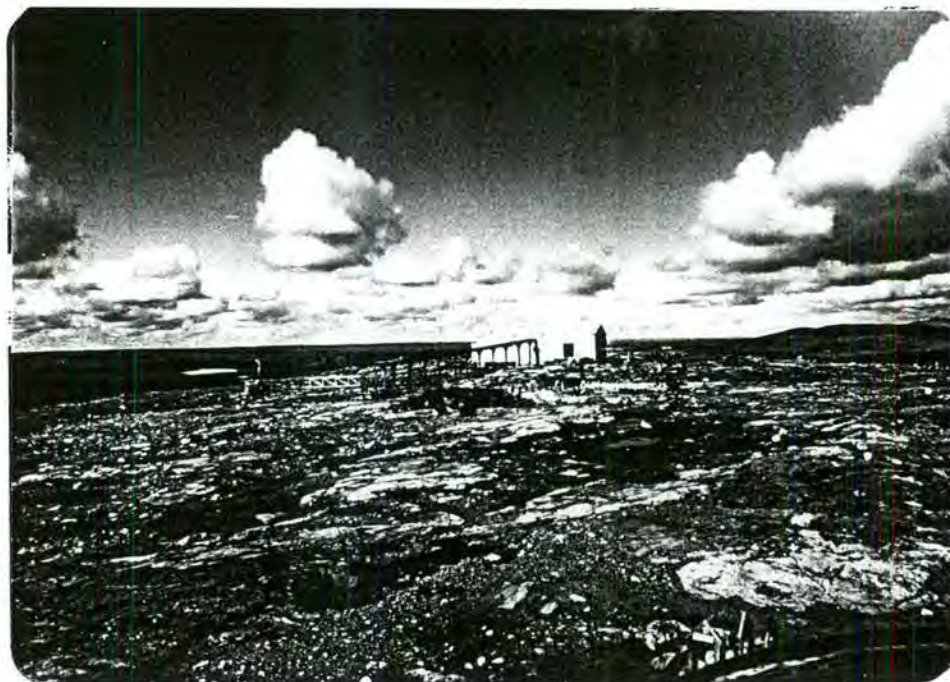
Photo 19: An aerial photo of Site 303.

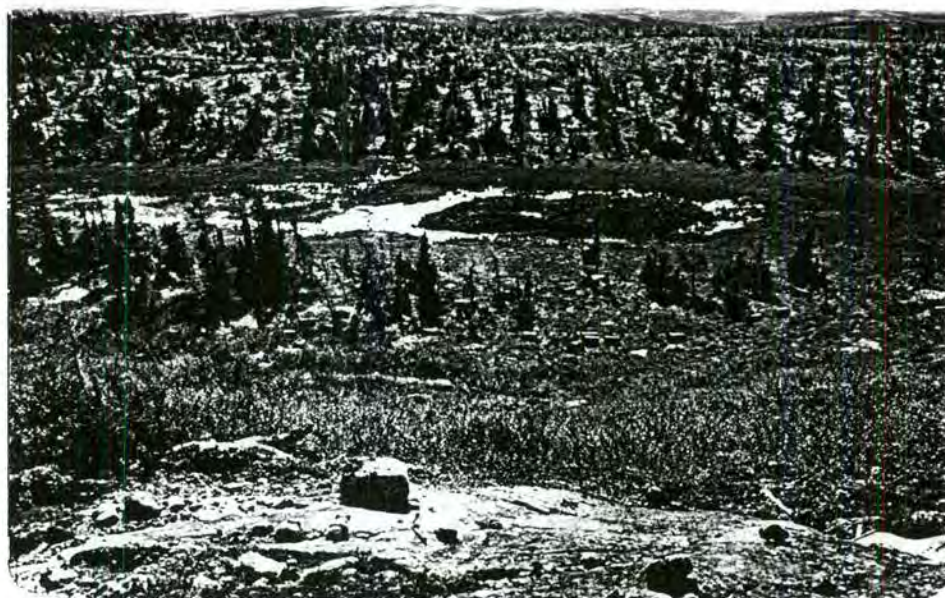
Photo 20: Drums and reels rolled down knoll of Site 303.

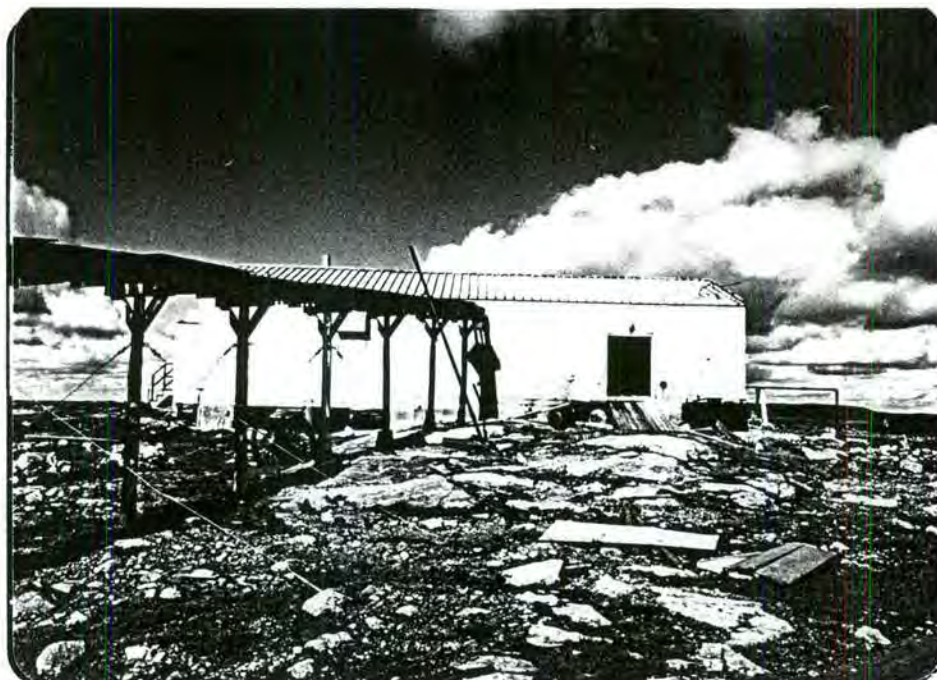
- (1) Only Doppler Detection Building remains. The building appears structurally sound but has been highly scavenged. Doors, windows, furniture and all diesel generators have been removed.
- (2) Apart from various electronic equipment everything has been removed.
- (3) Both 76.2 m and 15.2 m towers are down and the concrete anchors and main foundation remain.
- (4) The existing POL consists of approximately seventy-five 205 L (45 gal) drums. All nine 22 730 L (5 000 gal) storage tanks have been removed with only there foundations remaining.

Photo 21: Highly scavenged Doppler Detection Building at Site 303.

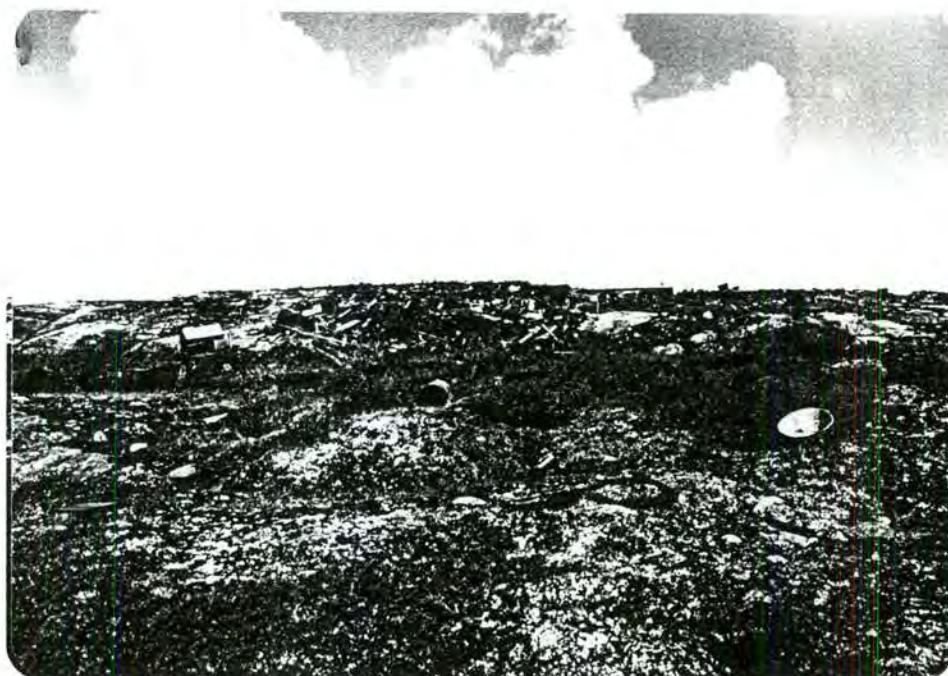
Photo 22: Pile of debris at Site 303.

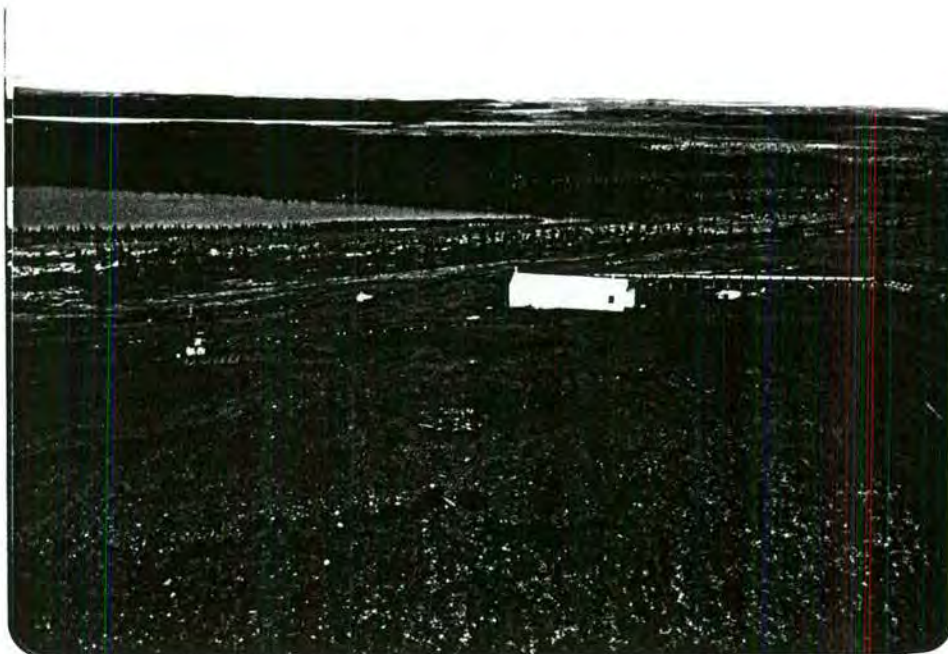
Photo 23: An aerial view of Site 227.

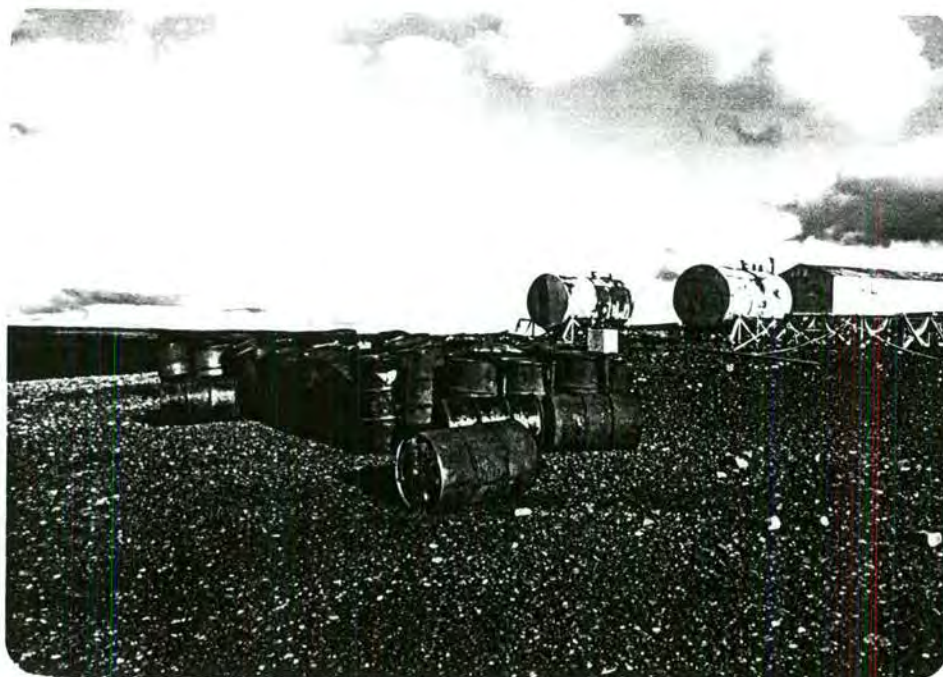
Photo 24: Two remaining storage tanks, seven having been removed.

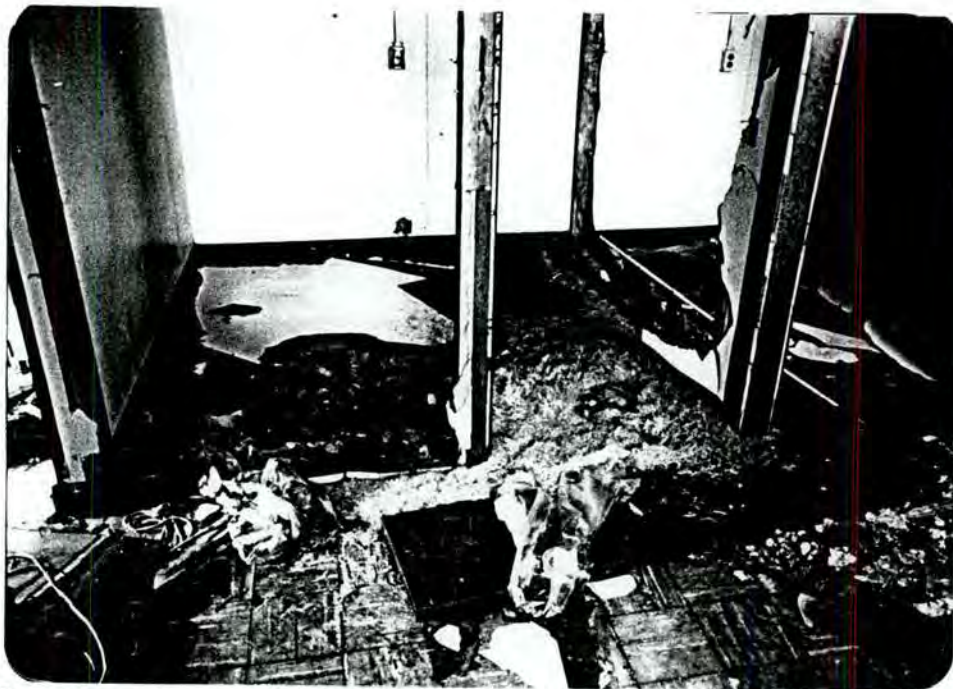
- (1) The only existing building is the Doppler Detection Building. Due to the proximity of Schefferville and the site, everything of value has been scavenged.
- (2) Both the 99 m and 15 m antennae have been knocked down and the concrete anchors and main foundation remain.
- (3) The existing POL consists of two empty 22 730 L (5 000 gal) storage tanks and approximately thirty 205 L (45 gal) empty rusty drums concentrated near the helicopter landing zone.

Photo 25: Extensive vandalism found in the Doppler Detection Building at Site 227.

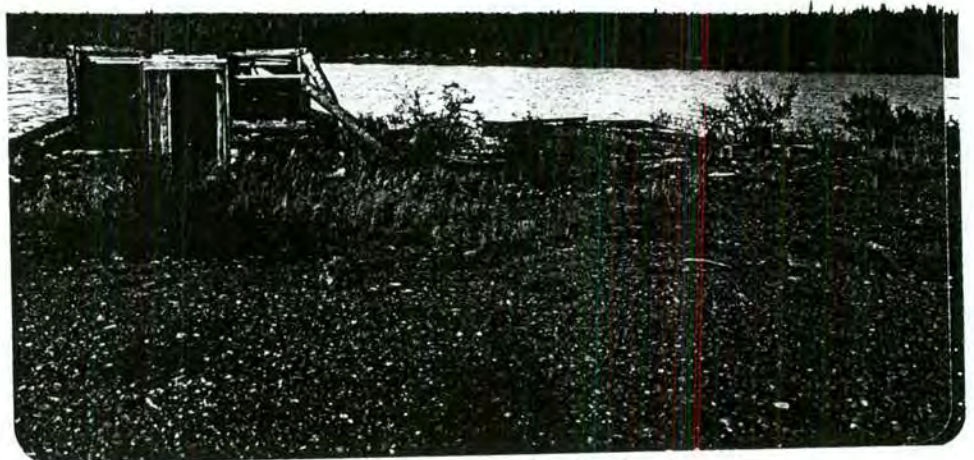
Photo 26: Broken down log cabin at POL Cache Y.

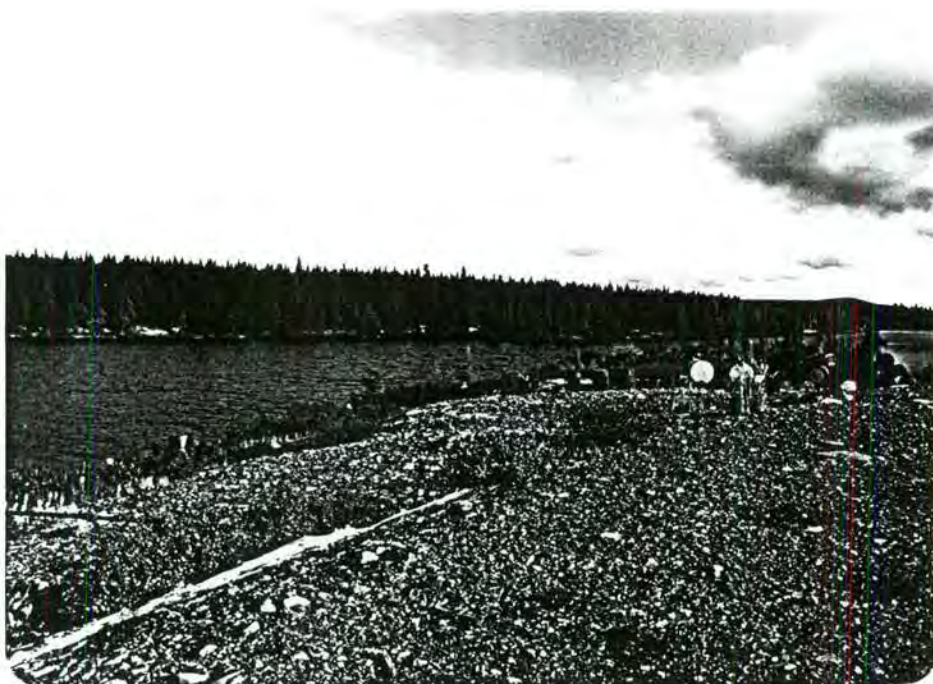
- b. Facilities. Consist of one broken down log house and one small pump by the lakeshore.
- c. Pollution (Solid Waste and POL). Approximately fifty 205 L (45 gal) drums and two 22 730 L (5 000 gal) storage tanks litter the lakeshore. All are empty. No apparent signs of water pollution was found.

Photo 27: Drums and fuel storage tanks at POL Cache Y.

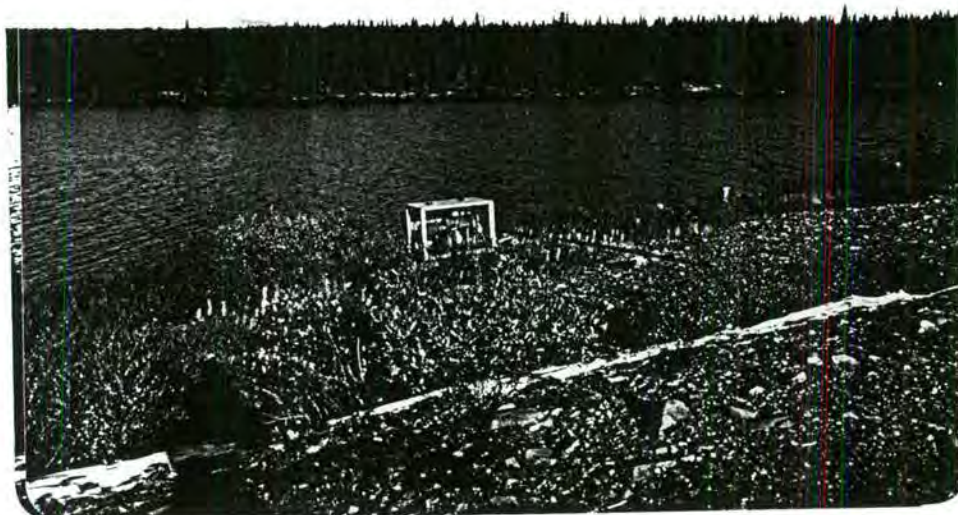
Photo 28: Pump to lakeshore at POL Cache Y.

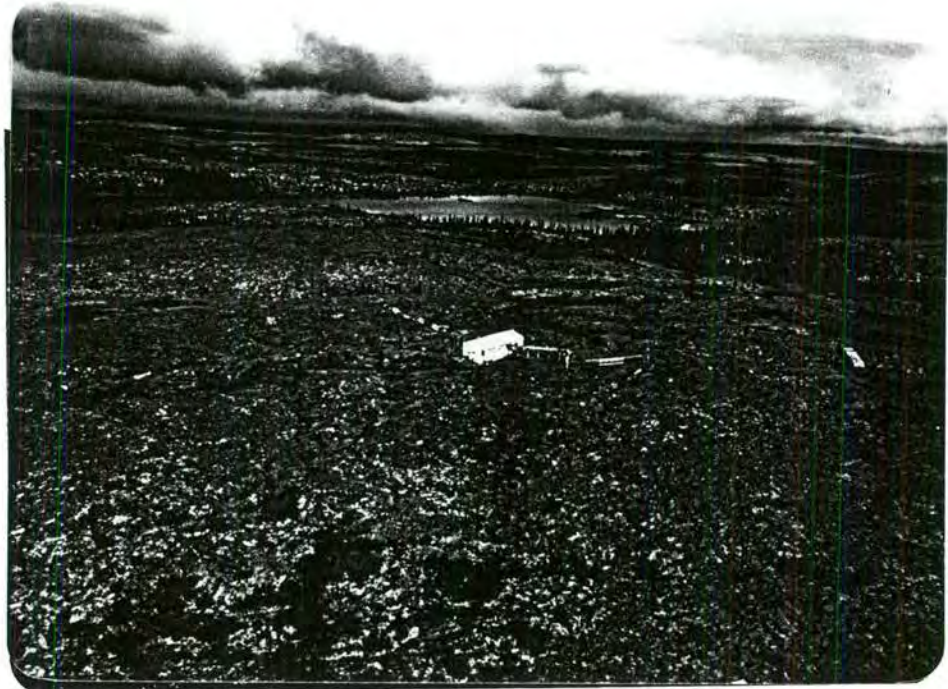
Photo 29: An aerial view of Site 224.

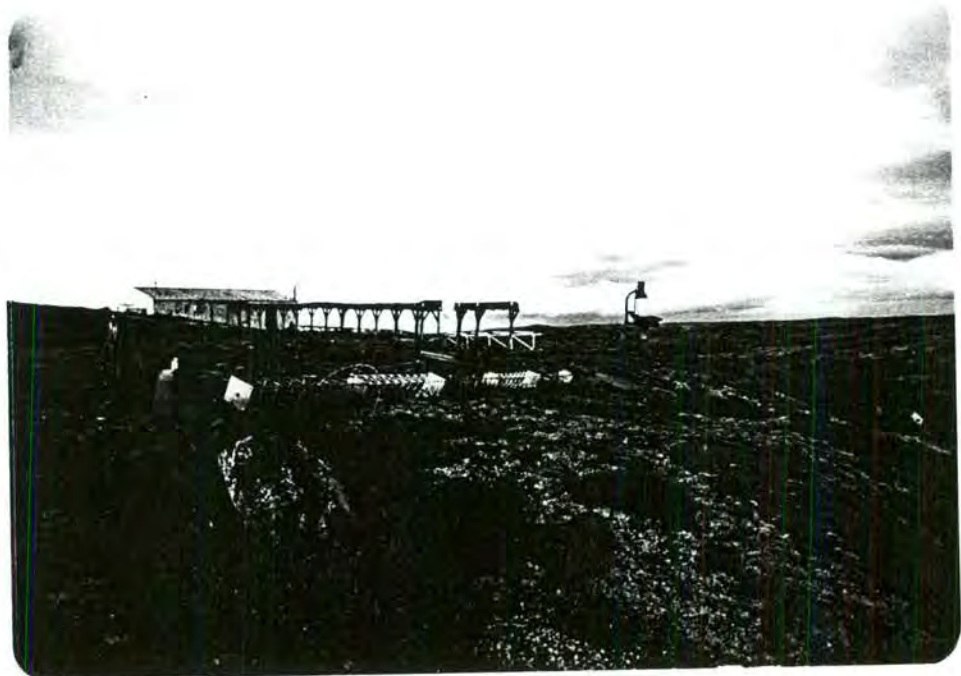
Photo 30: Downed antennae at Site 224.

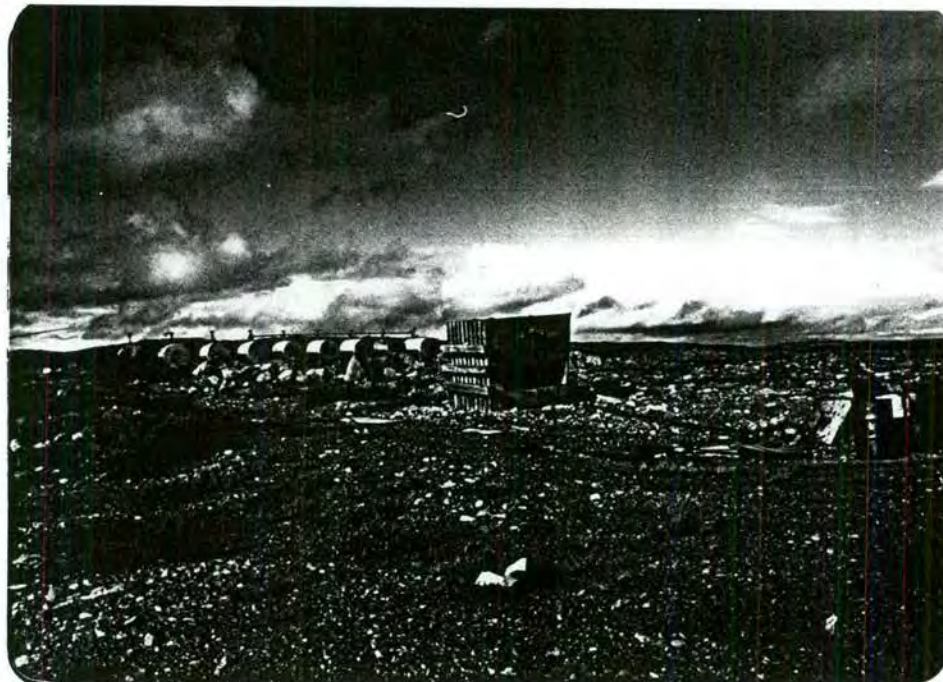
- (1) One Doppler Detection Building remains on site. Although structurally sound it has also been vandalized. All usefull equipment such as kitchen cabinets, toilet fixtures and electrical generators have been removed.
- (2) The existing POL consists of nine empty 22 730 L (5 000 gal) storage tanks and approximately one hundred 205 L (45 gal) drums. Some drums have fuel in them while the majority are empty, having rusted out.

Photo 31: POL storage tanks and drums at Site 224.

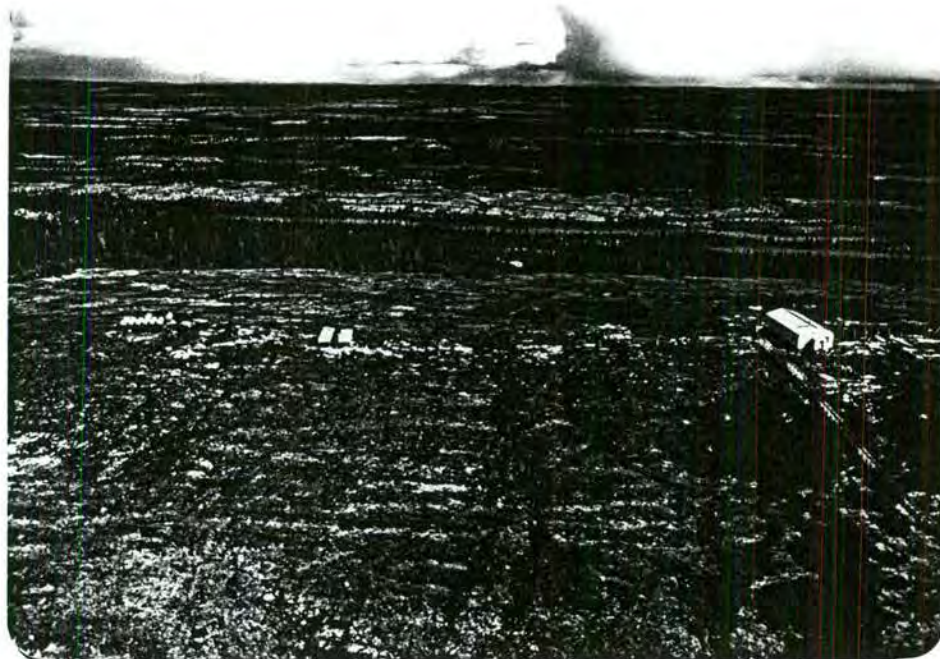
Photo 32: An aerial view of Site 221.

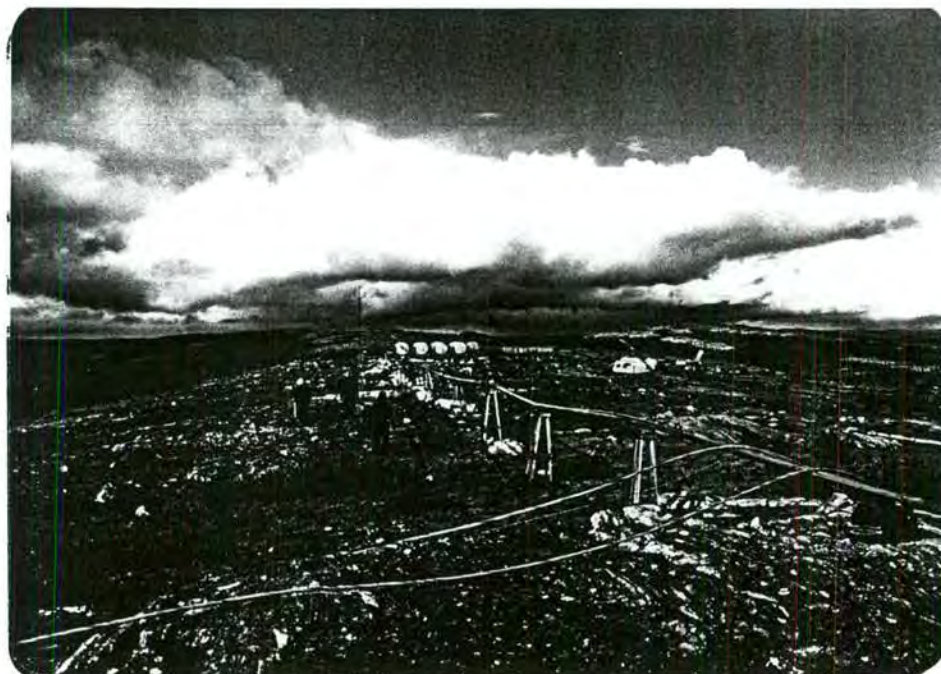
Photo 33: Pipeline to POL storage tanks at Site 221.

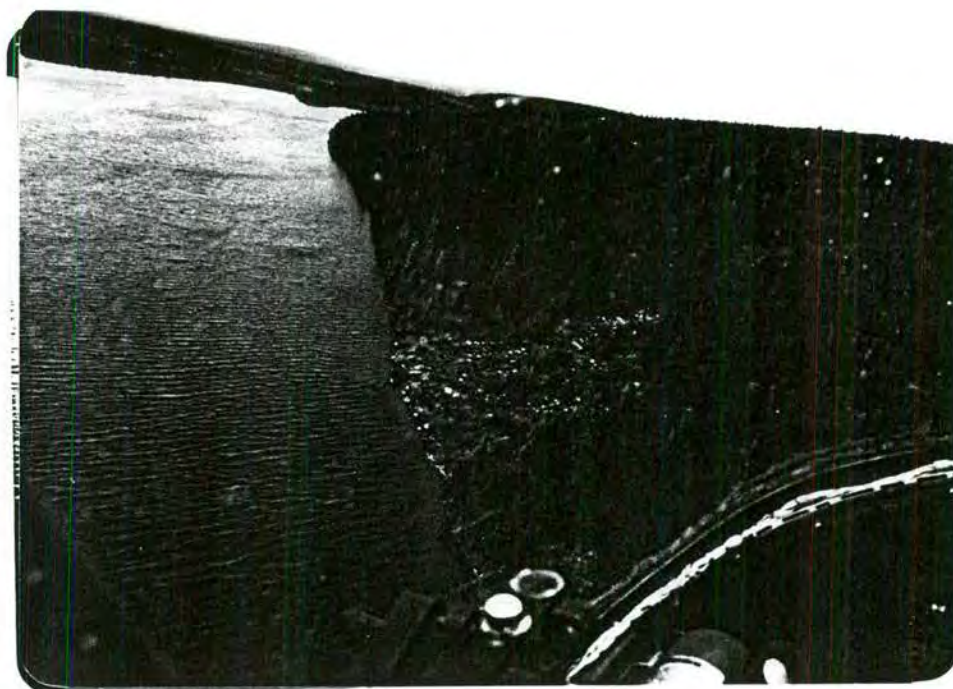
Photo 34: Aerial view of POL cache by lakeshore. Note trail leading to Site 218.

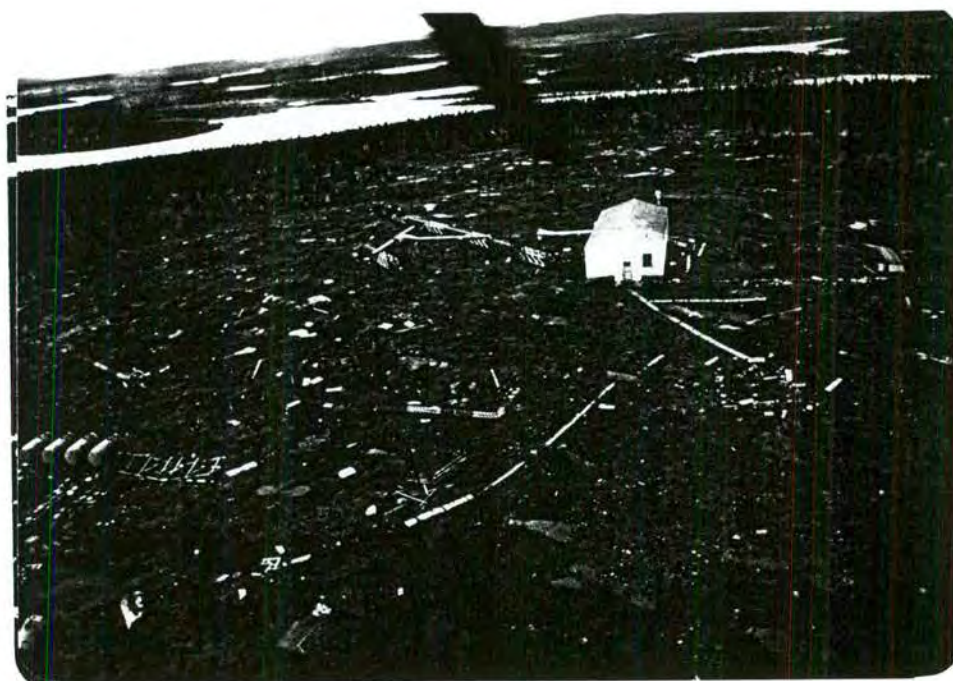
Photo 35: An aerial view of Site 218.

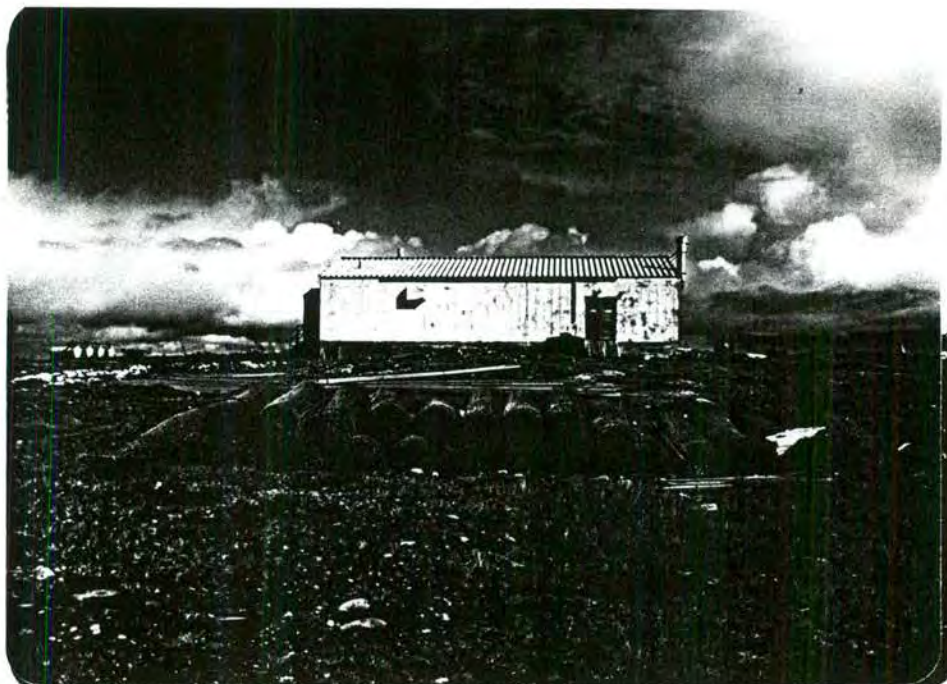
Photo 36: Chain link fencing equipment found at Site 218.

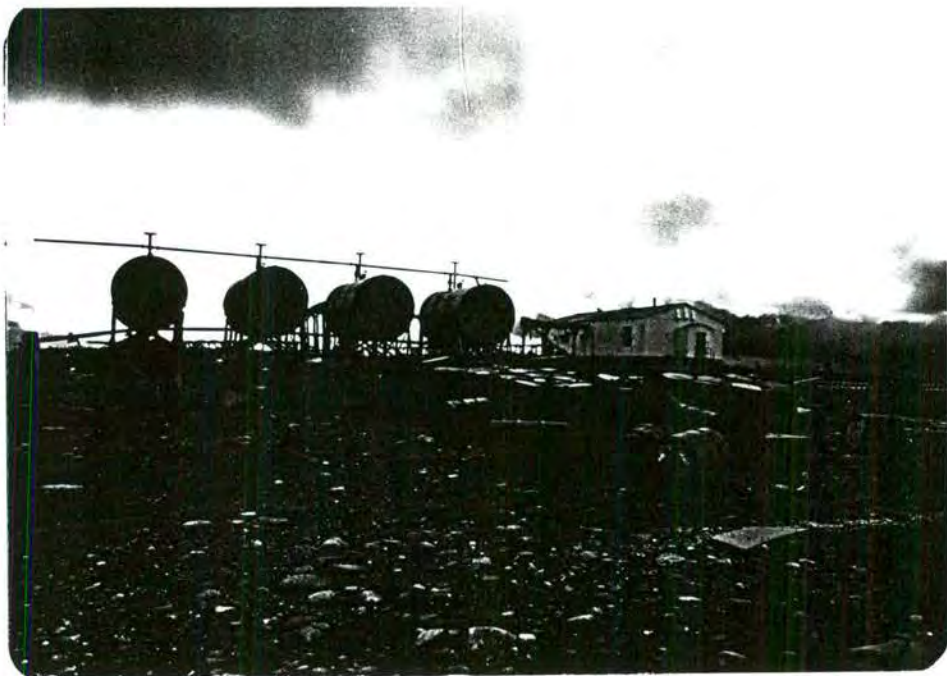
Photo 37: POL storage tanks and drums at Site 218.
