CANADIAN FORCES .
1 CONSTRUCTION ENGINEERING UNIT .

ENGINEERING STUDY 83-CEU-40
NORTHERN QUEBEC MID-CANADA LINE SURVEY
28 SEP 1983

MID CANADA LINE SURVEY PHASE II

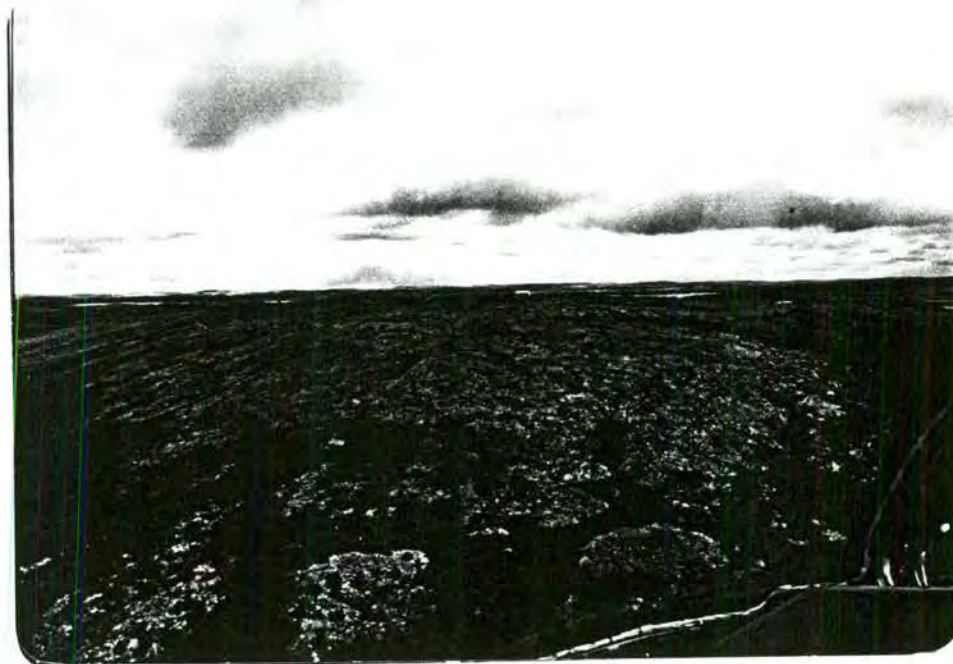
Photo 38: A distant aerial view of Site 215.

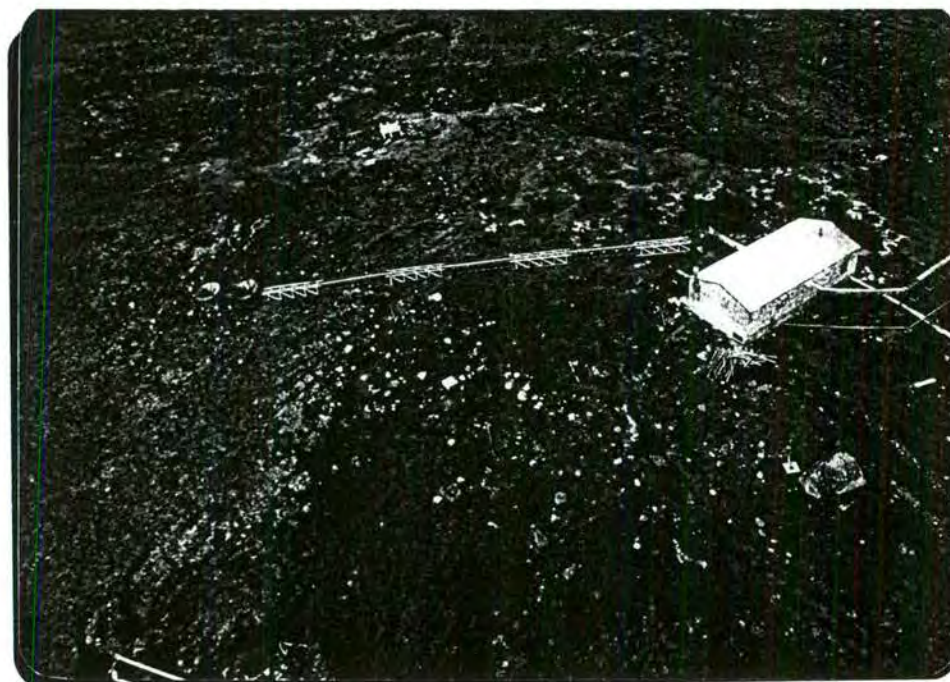
Photo 39: Close-up aerial view of Site 215.

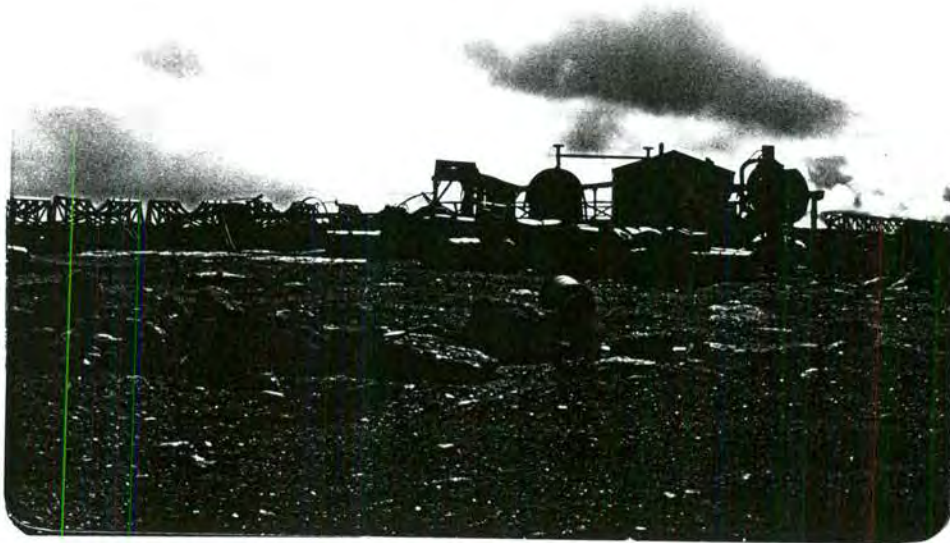
Photo 40: POL storage tanks and drums at Site 215.

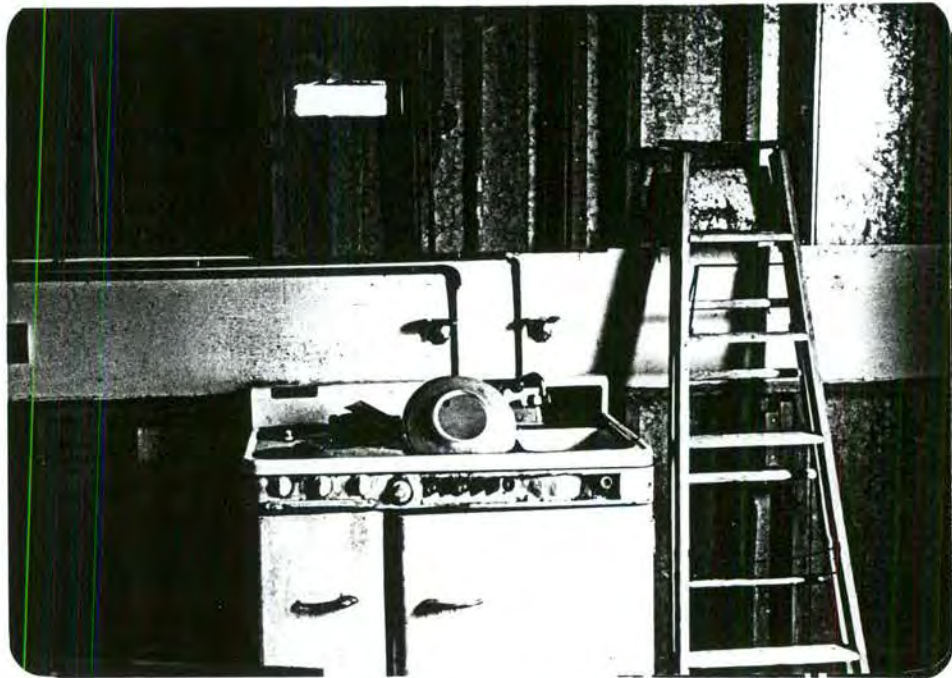
Photo 41: Interior view of kitchen at Site 215 with cabinets removed.

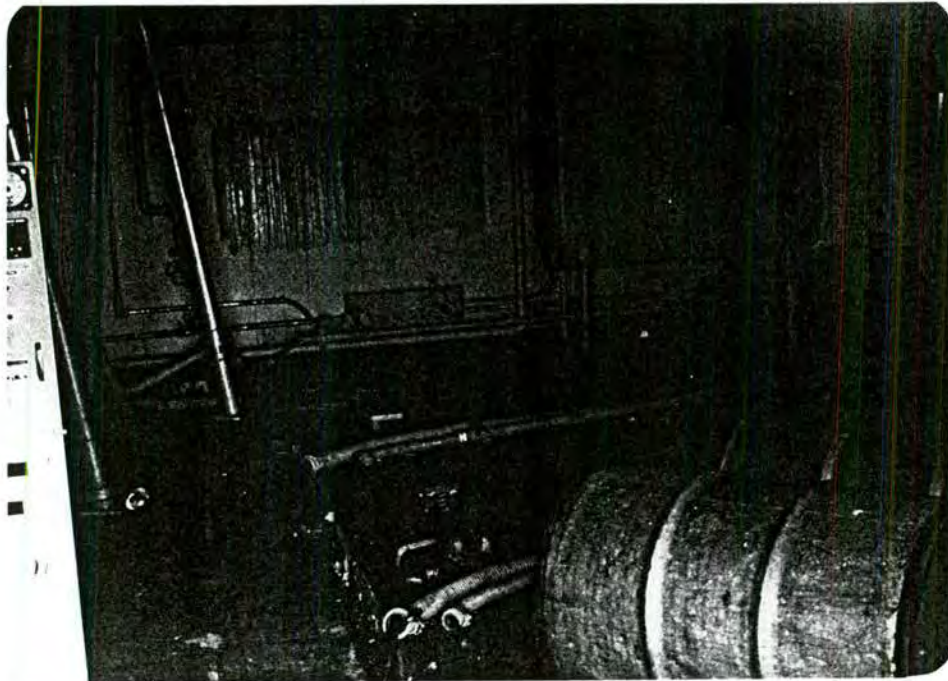
Photo 42: Interior view of power generation room at Site 215 with all three generators having been removed.
