**MID-CANADA LINE  
CLEAN-UP PROJECT - PHASE 2**

**1999-2000**

**Report on Completed Clean-up Work**

**Kativik Regional Government  
Kuujjuaq, Québec**

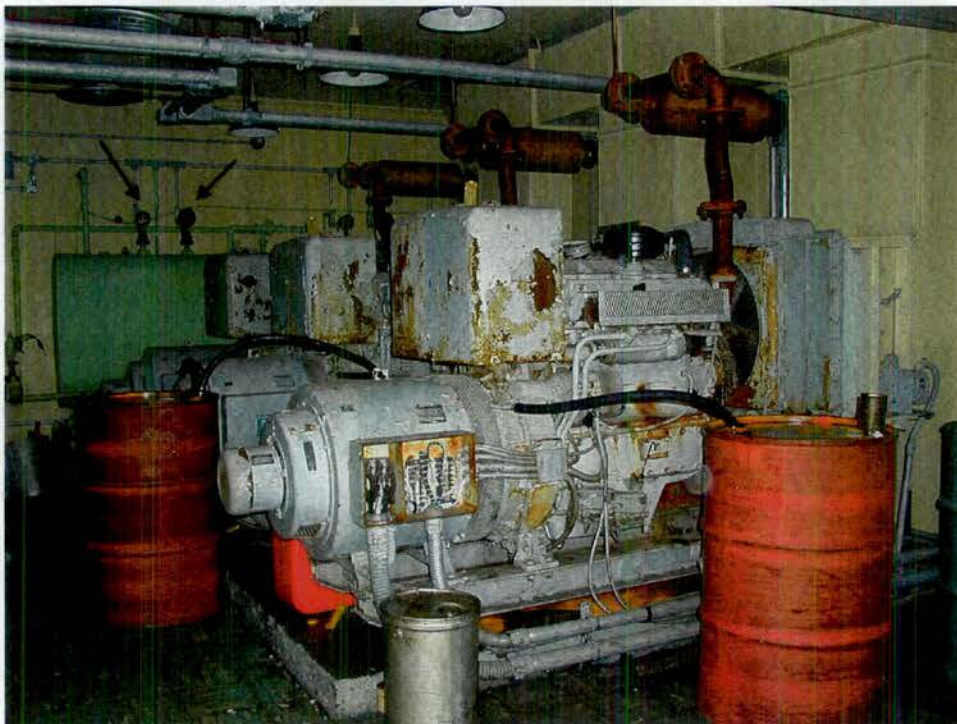
A person was assigned to systematically search for mercury switches in the following locations: panels located in the generator and control rooms; above the generator diesel tanks (Photo 2, Appendix 5); above the canisters in the equipment rooms; and on the warm-air ducts in the generator rooms (Photo 4, Appendix 5). In 2000, a few mercury switches were found in places inspected in 1999. The mercury switches were carefully removed, placed in heavy-duty containers and transported by helicopter or airplane to Schefferville or Whapmagoostui-Kuujuaraapik. The switches from both communities were then transported to Kuujuuaq where they are safely stored before being sent to an authorized recycling centre.

**Photo 2.** Draining generator oil tanks at Site 321 (September 8, 2000). Note: round metal boxes (arrows) on one of the tanks located at the end of the room contain mercury switches.

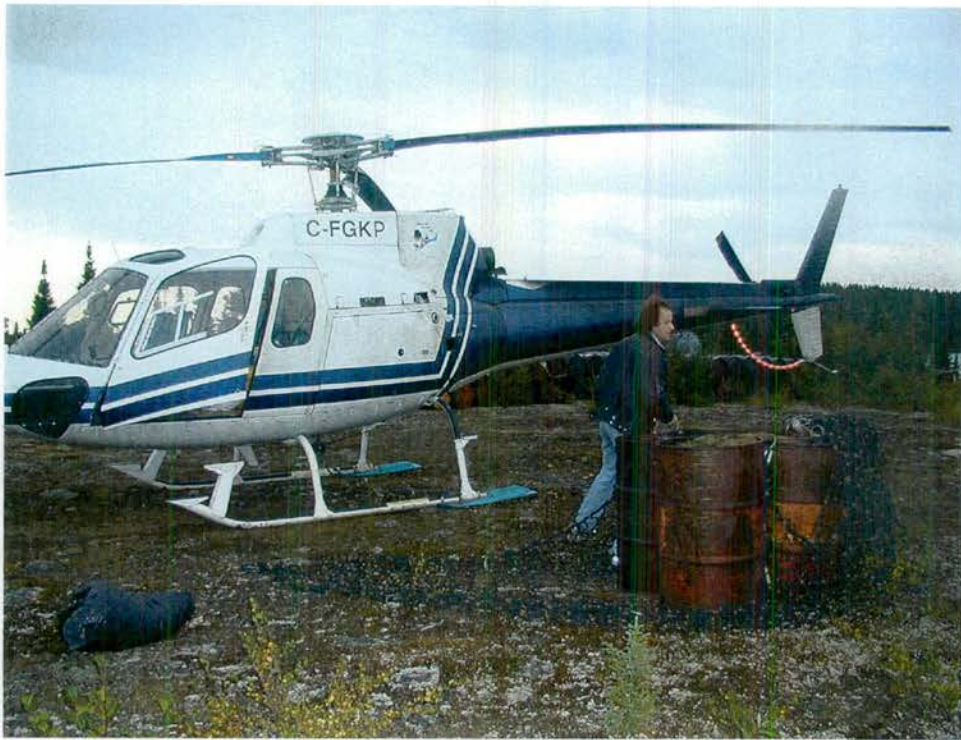
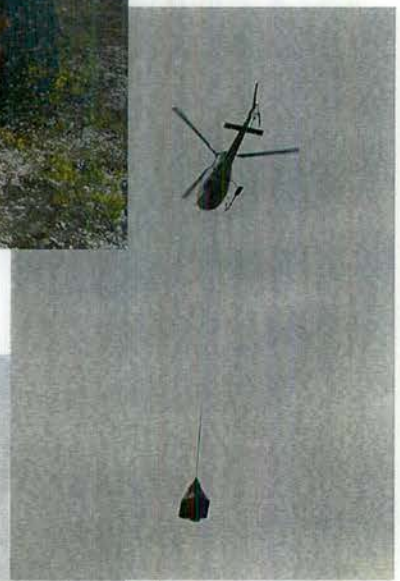
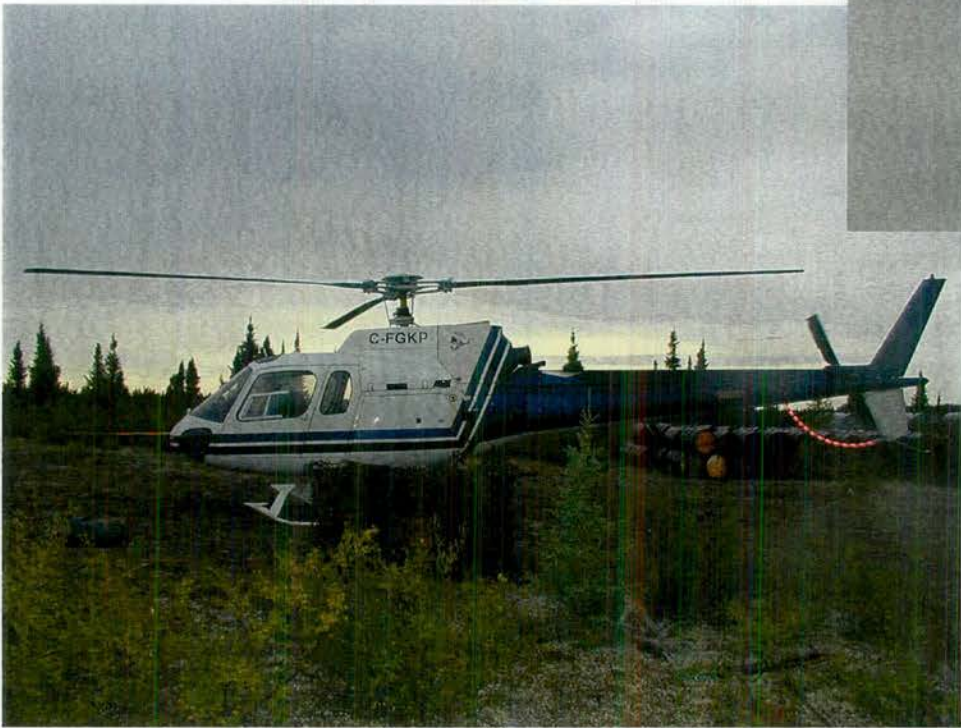
**Photo 3.** Setting barrels containing hydrocarbons in a net at Site 330A, and transportation by sling to the outfitter camp at Mollet Lake (September 10, 2000).

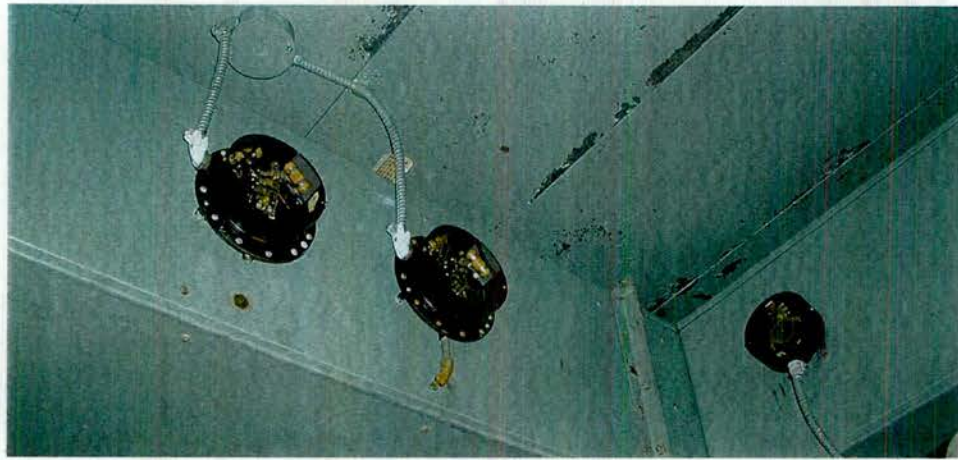
**Photo 4.** Black metal boxes containing mercury switches on warm-air duct in the generator room (Site 330, September 6, 2000).

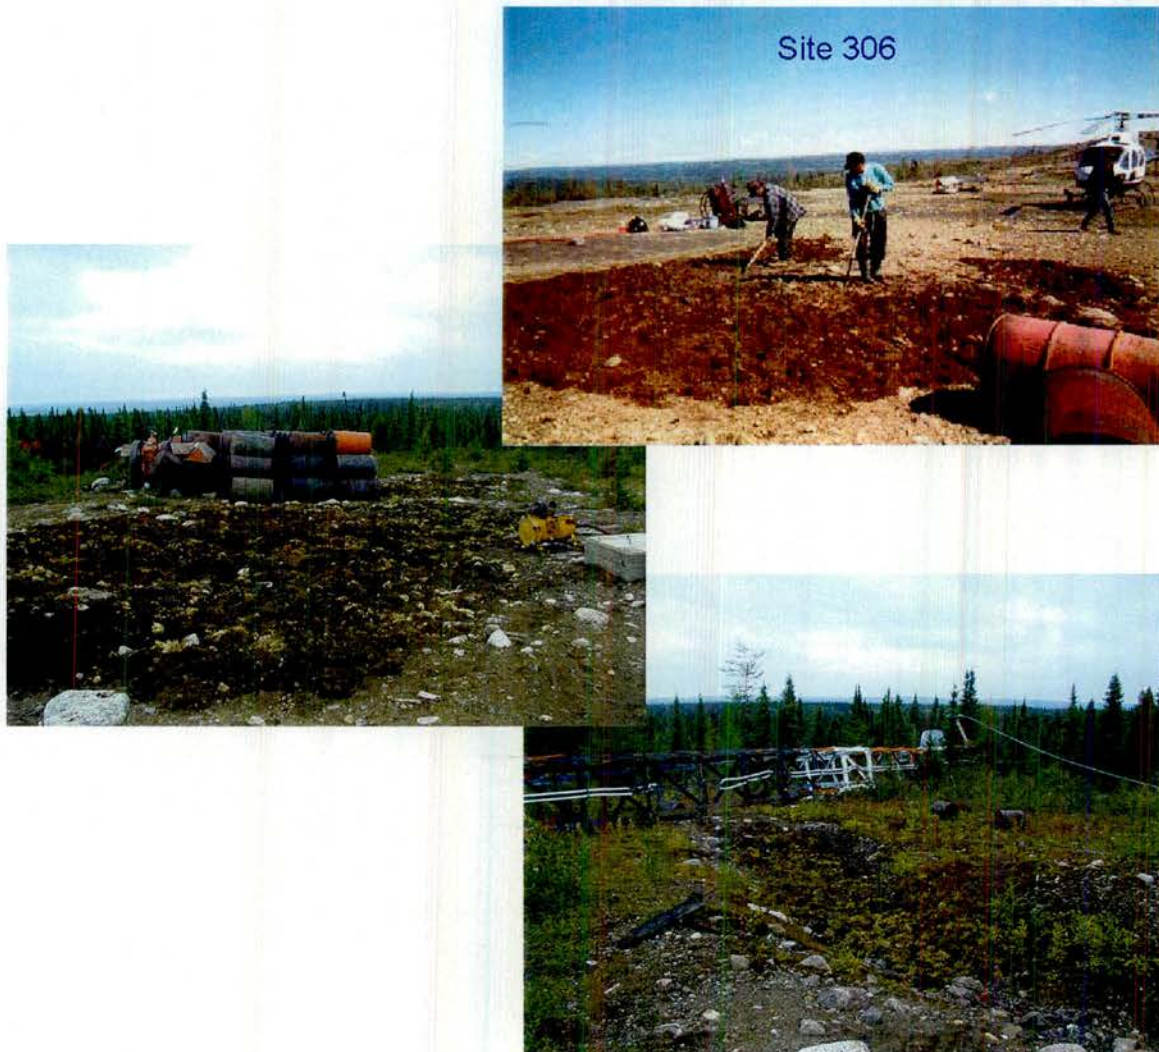
**Photo 5.** Biological degradation process applied at Site 306 (June 28, 2000) and two areas which underwent biological treatment at Site 330 (September 6, 2000).

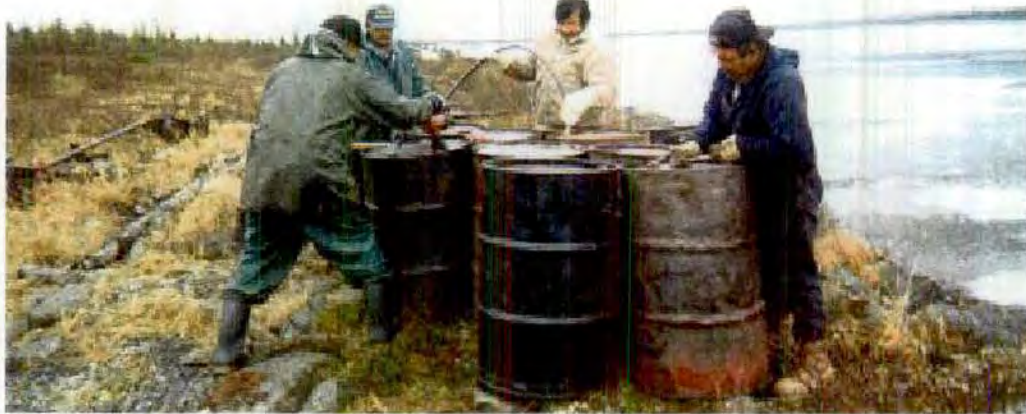
At Site 224A for example, when the waste liquid from 12 barrels was transferred into five, it was noted that the liquid was more than 90% water (Photo 6, Appendix 5). These five barrels were carried by sling to the top of a nearby hill where they were emptied into a hollow in a rocky area without vegetation. This water carried only a faint smell of hydrocarbons and no iridescent film was visible.

**Photo 6.** Transfer of waste liquid from barrels using a pump at Site 224A (June 26, 2000). Water constituted more than 90% of the waste liquid.

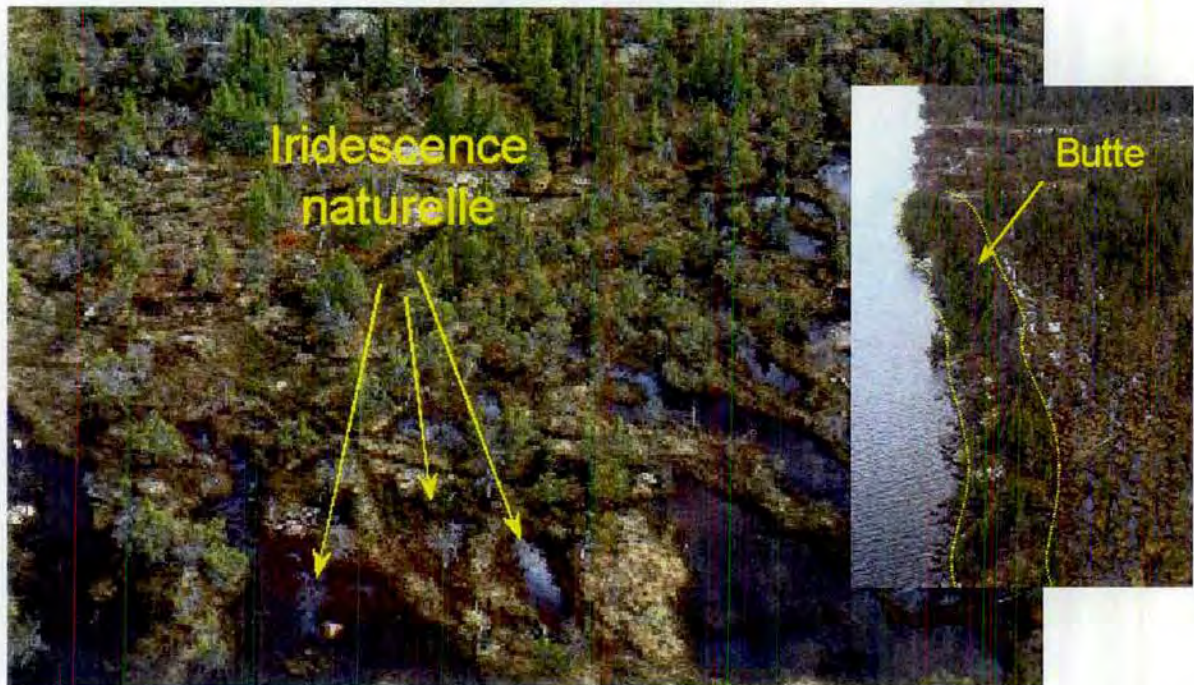
Site 218A is classed priority A. It is located in a bog, that is pockmarked with pools of water. An iridescent film was visible on a few pools. However, it was noted during the on-site review on June 20, 2000, that drainage of the film into the lake seemed to be impeded by a mound of sphagnum along the shore, a natural barrier between the lake and the bog (Photo 7). No ecological impact was noted in the places where the film was visible. The iridescent film may, in fact, be caused by a natural phenomenon and not by the spilling of any hydrocarbons.

Laboratory analysis of water samples taken from the slope next to the former burning site on June 20, 2000, shows that the concentration of hydrocarbons C10-C50 is less than 0.1 ppm. This confirms the hypothesis that the iridescent film noticed on the surface of the pools of water is a natural phenomenon.

**Photo 7.** Naturally-occurring iridescent ("Iridescence naturelle") film on surface of pools in peat area about one kilometre from Site 218A. Mound ("Butte") of sphagnum and shrubs forms a natural buffer zone between the lake and the bog (June 20, 2000).

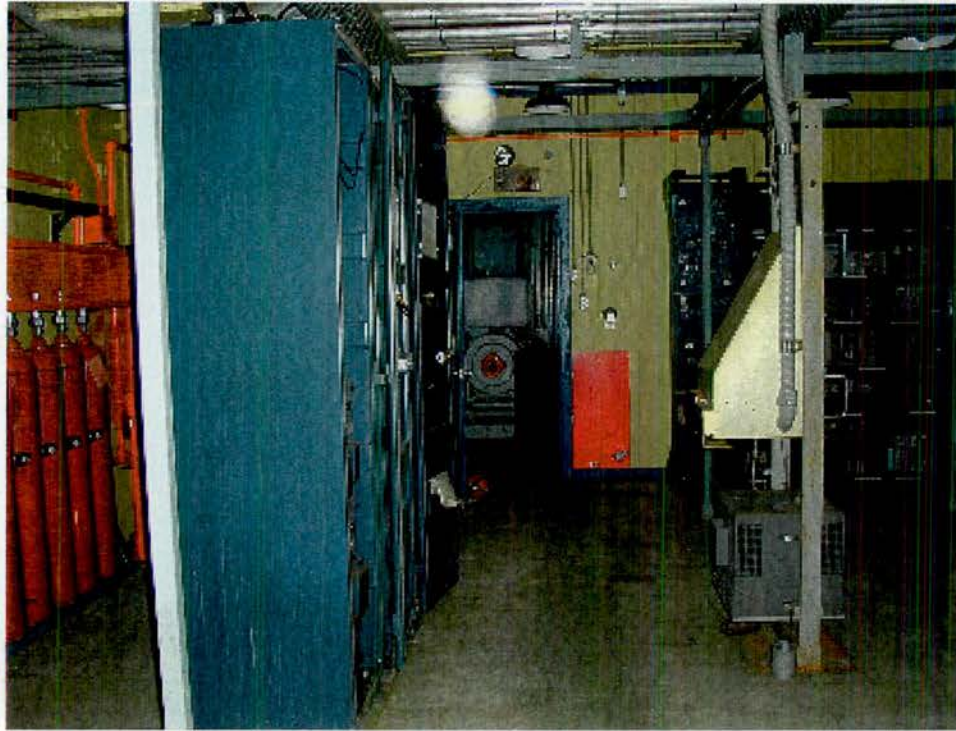
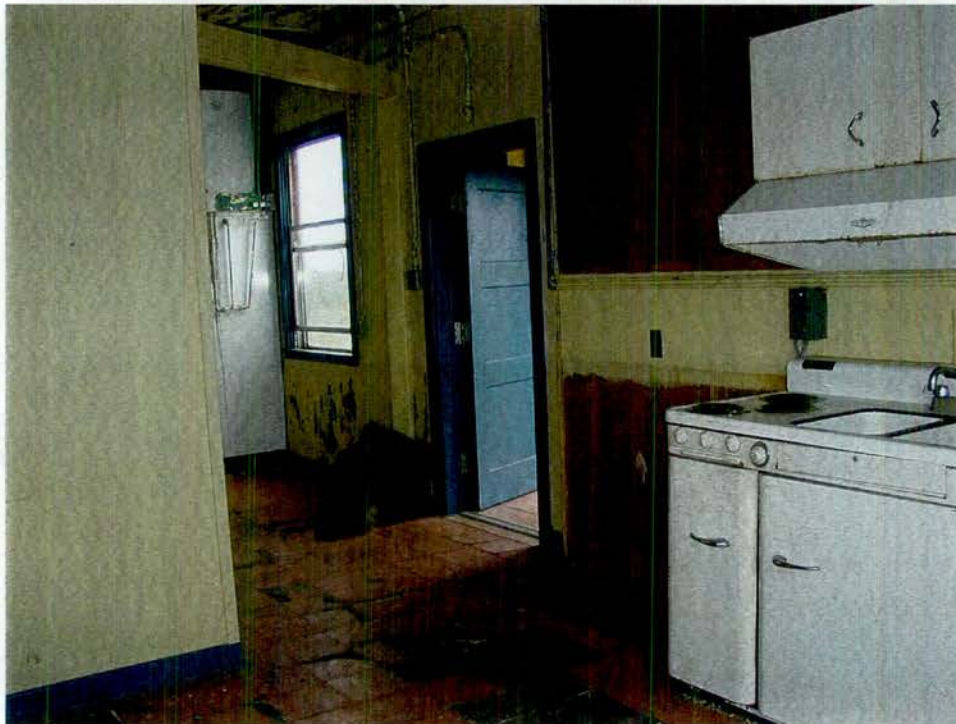
**Photo 8.** Equipment room and kitchen at Site 330, after clean-up (September 6, 2000).

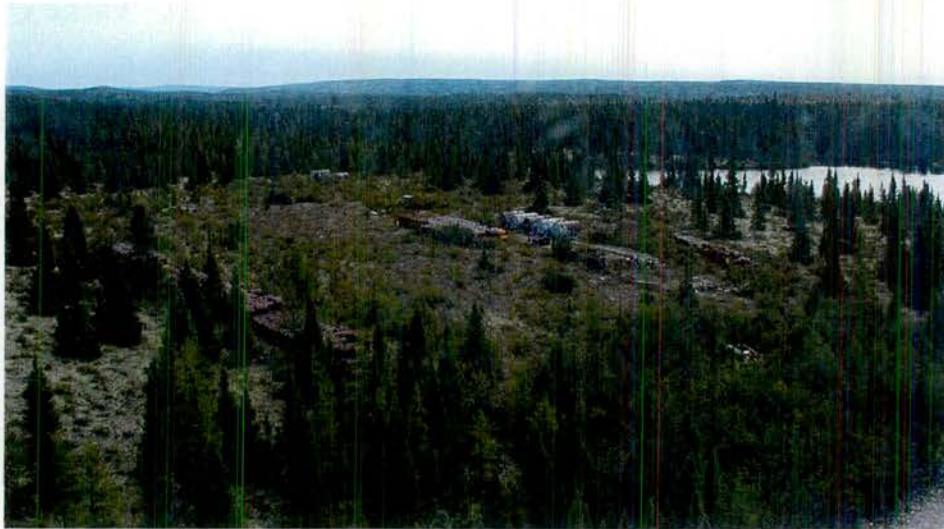
**Photo 9.** View of a section of Site 330A, after clean-up (September 10, 2000).

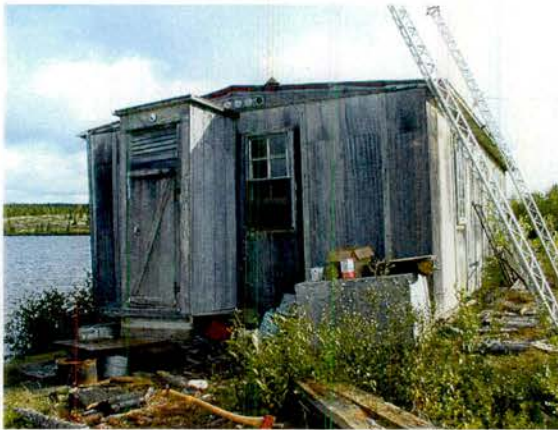
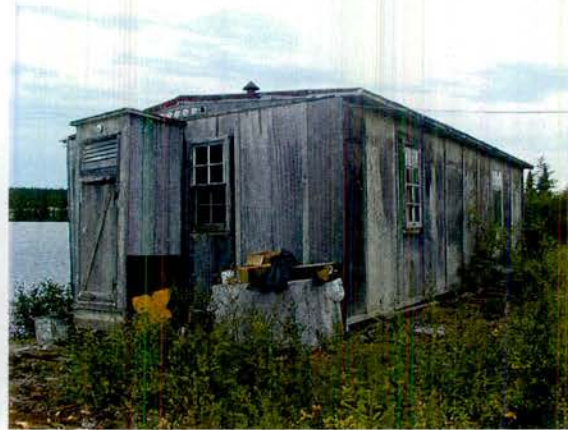
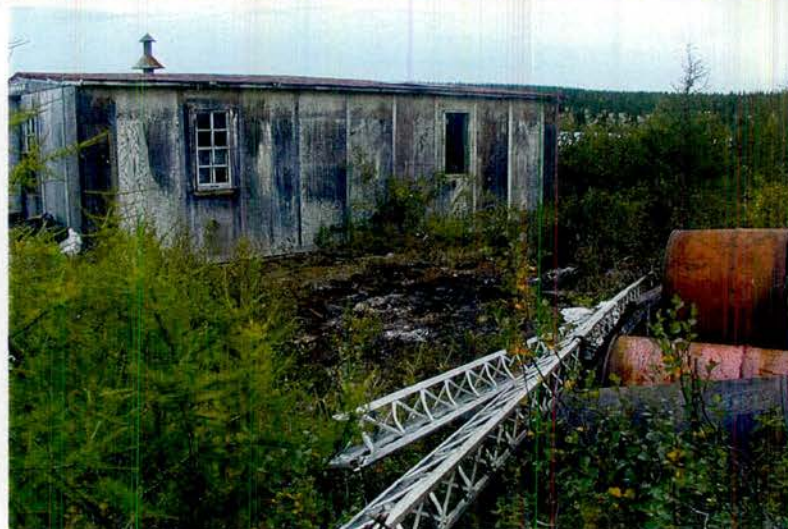
**Photo 10.** View of a building at Site 330A: before (top left) and after clean-up (two other photos) in September 2000.

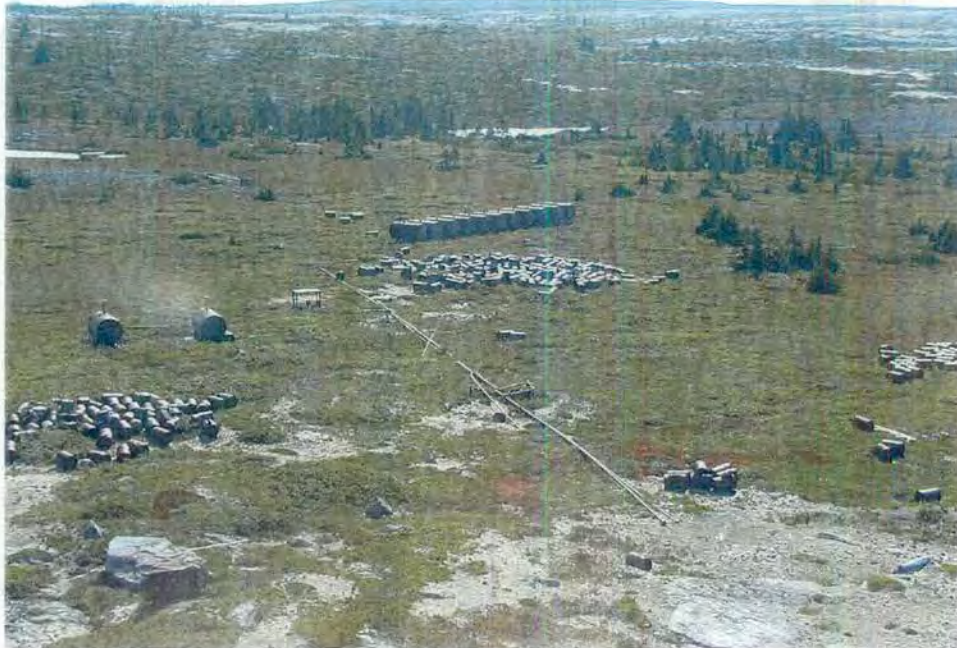
**Photo 11.** View of Site 403A before clean-up (September 12, 2000). Compare with diagram in Appendix 3.

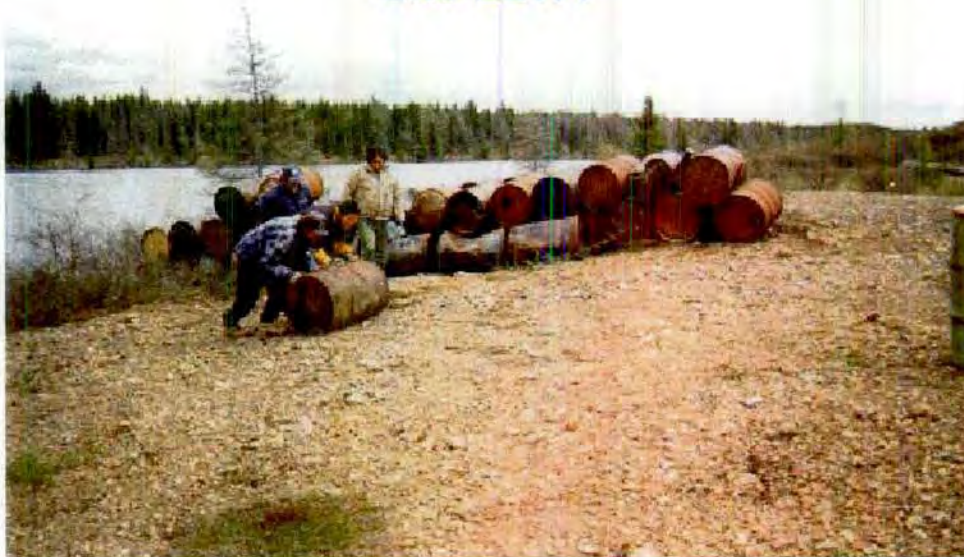
### Site 227A

**Photo 12.** Relocation of empty barrels and four barrels containing oil to the top of the slope in order to move them away from the lake (June 23, 2000). The barrels containing oil will be removed from the site in 2001.

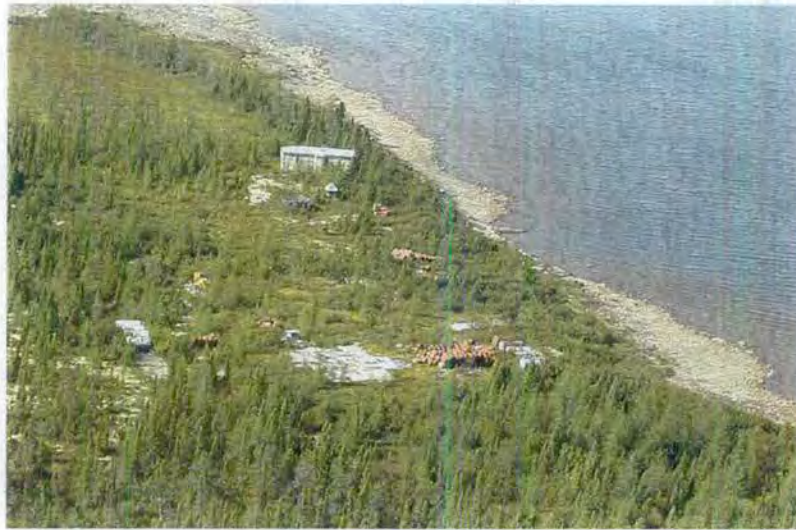
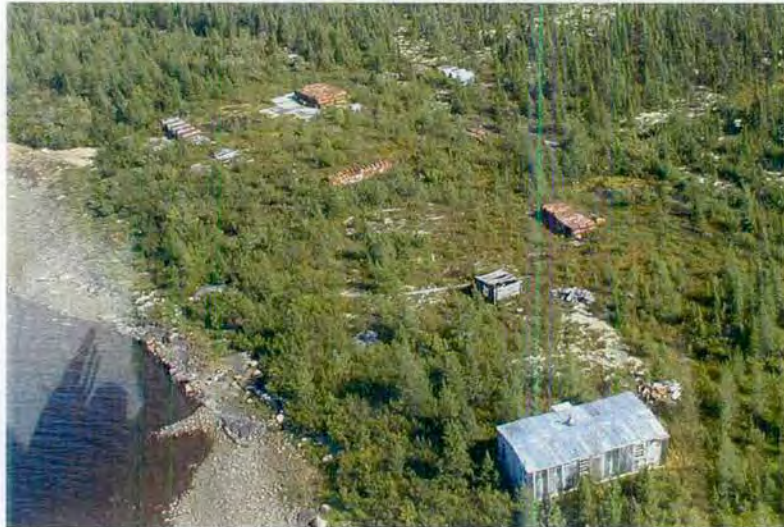
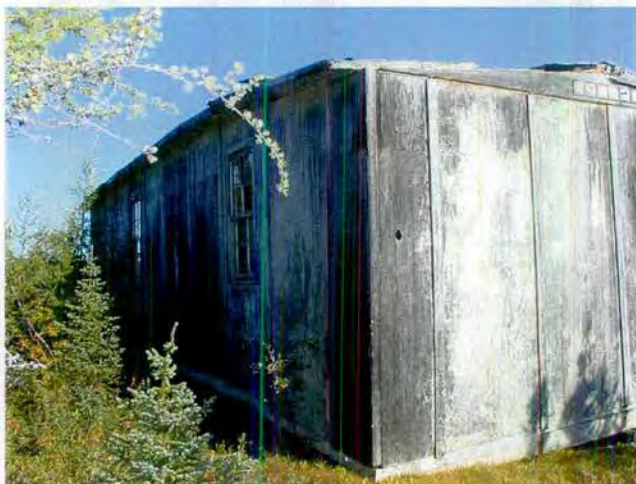
**Photo 13.** Aerial view of Site 321A before (September 8, 2000) and after clean-up (September 11, 2000). View behind building where the foundation has collapsed.
