Brunelle, J. and M. Barrett. 2002. *Mid-Canada Line Clean-up Project – Phase 2. 2001-2002*. Report submitted to the Ministère de l'Environnement du Québec. Kativik Regional Government. Kuujjuaq, Québec.

MID-CANADA LINE (Québec)

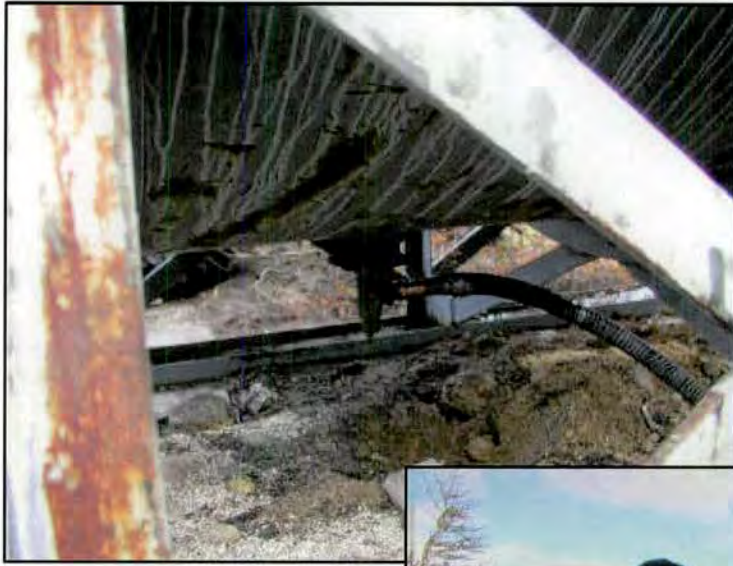
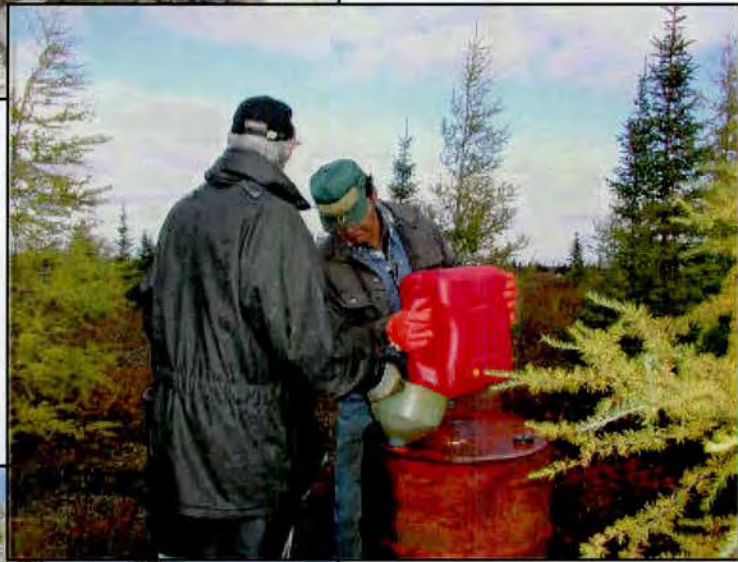
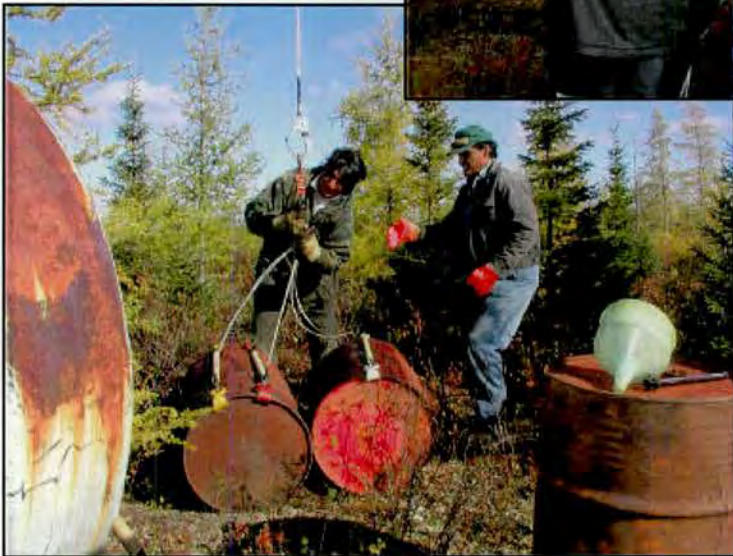
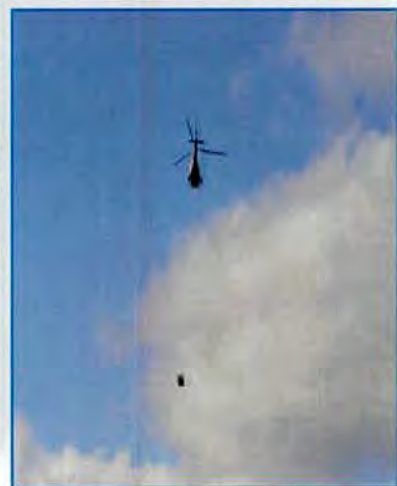
Photo 1 Draining hydrocarbons from fuel tanks into barrels at site 327A and removal of barrels from the site by helicopter (27 September 2002).

Barrels and fuel tanks: The approximately 200 barrels at this site are stacked beside a group of four fuel tanks and a section of the pipeline. The nine fuel tanks at the site are empty and their drain valves have been removed. There are no waste hydrocarbons in the pumping station. On 27 September 2002, the five barrels containing 850 L of diesel drained from four of the nine fuel tanks were moved from the site by helicopter and sling to the Lake Mollet outfitting camp (photo 1). The diesel will be used to operate oil-burning heaters.

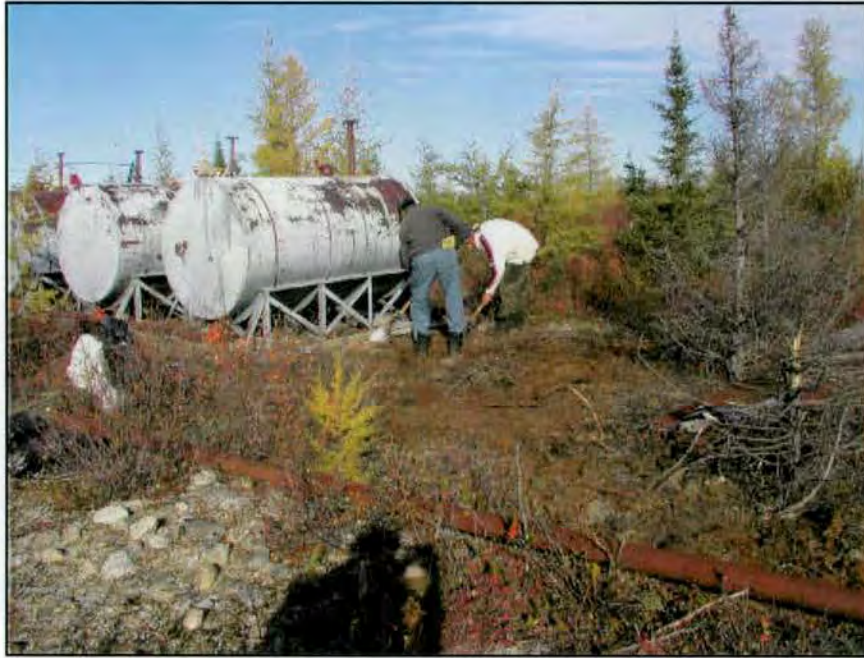
Photo 2 Application of the biological degradation process next to the fuel tanks at site 327A (27 September 2002).

In 2001, the biological degradation process was applied to four small areas possessing contaminated soil (Appendix 3). The first area (1 m²) is located next to the lake near the dock, two other small areas (1 m x 1.2 m) are located within a larger contaminated area (10 m x 10 m) covered by vegetation and with a thin layer of soil next to a stack of barrels, and the fourth small area (0.5 m²) is located under the pipeline, also near the barrels. The biological degradation process could not be applied to a small contaminated area (1 m²) near the lake as it is located on a slope. In 2002, the biological degradation process was applied to an approximately 8 m² area on the slope next to the fuel tanks (photo 2) where there was no vegetation and where the soil was at least 15 cm deep (Appendix 3).

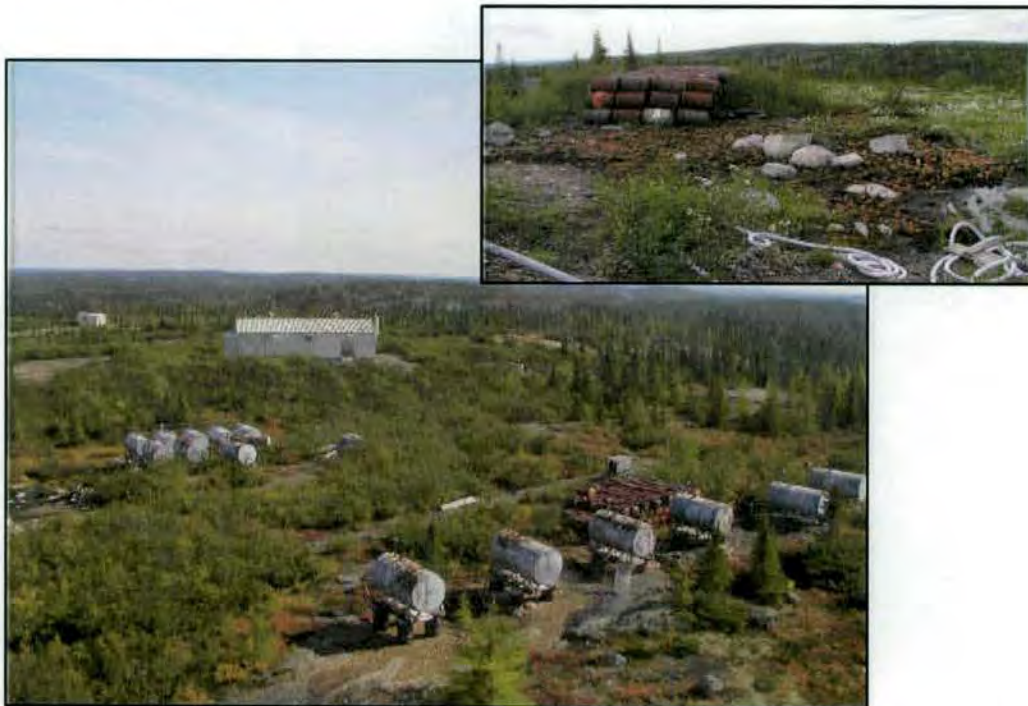
Photo 3 Aerial view of part of site 333 (19 September 2002) and contaminated area after restoration; the soil still needs to be turned with sphagnum (9 July 2002).

The biological degradation process was applied to approximately 142 m² of contaminated soil. Most of the contaminated soil is located on the slope next to the fuel tanks (Appendix 3). The areas restored range in size from 1 m² to greater than 80 m². The biological degradation process was applied to soil that was not covered by vegetation and that was at least 15 cm deep. The other areas restored are located near the survival shelter (1 m x 3 m and 1 m x 1 m) and near a communication antenna laying on the ground (5 m² area where burning had been carried out, Appendix 3).

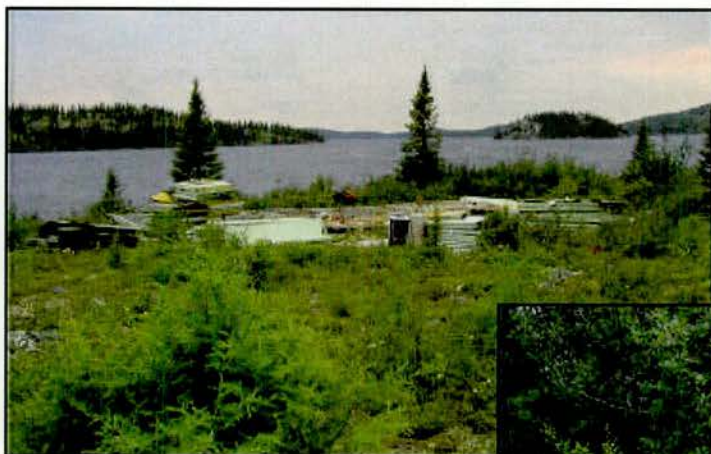
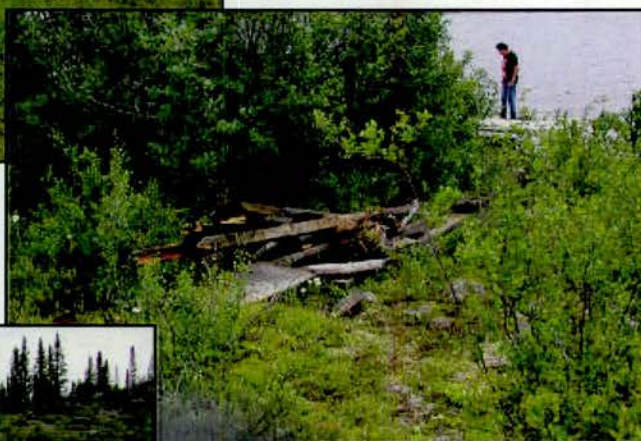
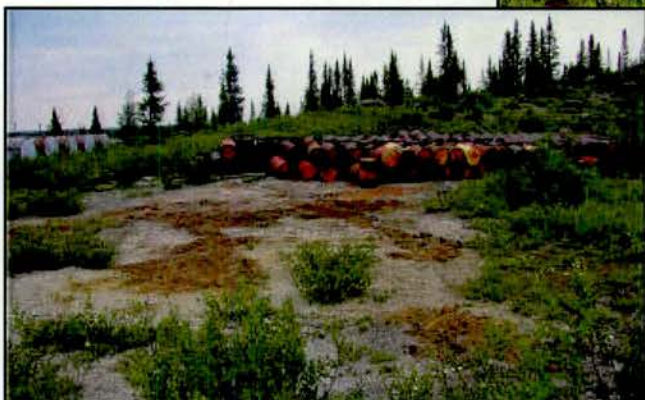
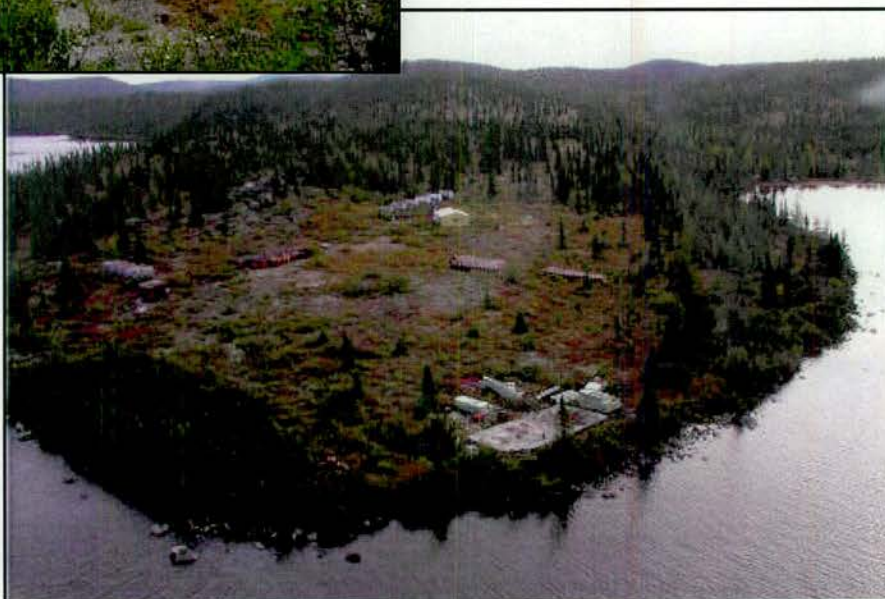
Photo 4

Site 333A: piled debris from the survival shelter, wood from the dock pulled from the lake (barrels from the dock were stacked with others) and contaminated area near a stack of barrels after restoration (11 July 2002); aerial view of site 333A (19 September 2002).

The biological degradation process was applied to contaminated soil over a total area of 55 m². The substrate comprises sand for the most part. The areas restored were two areas (1 m x 1 m and 7 m x 7 m) near a pile of barrels (photo 4), two areas (1 m x 1 m and 1 m x 2 m) near a cabin made of tin, and two small areas (1 m²) near the lake.

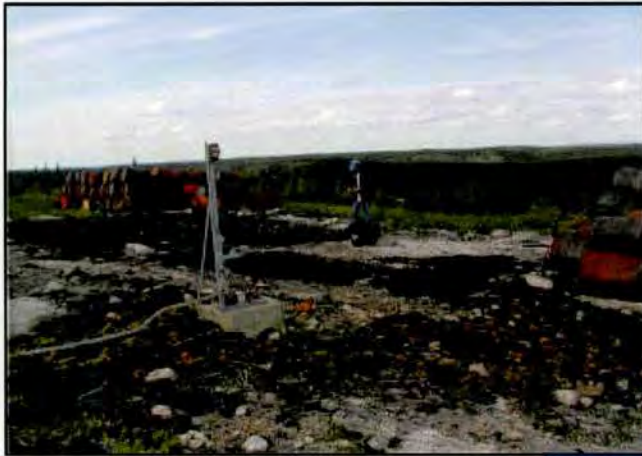
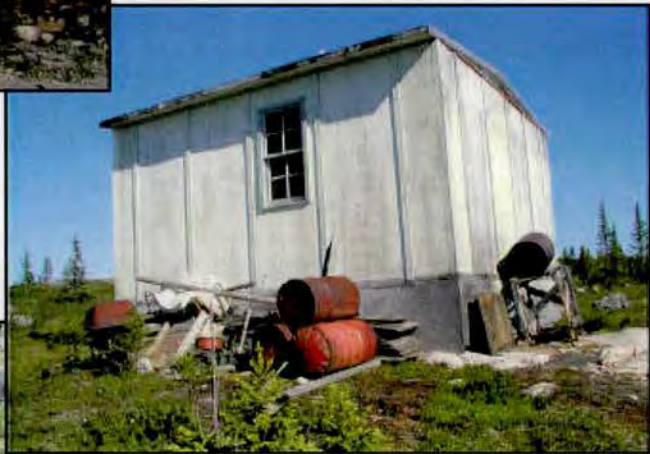
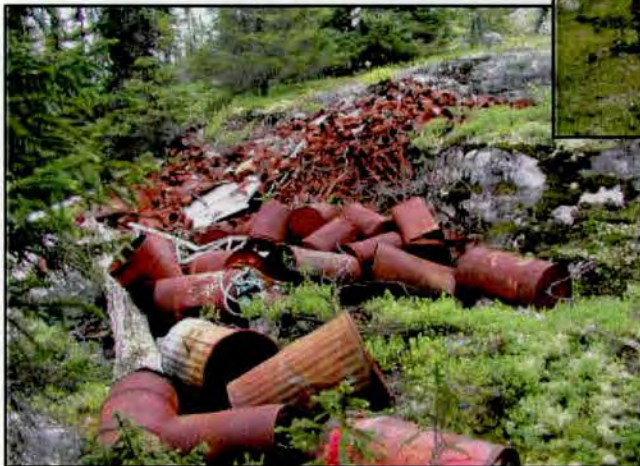
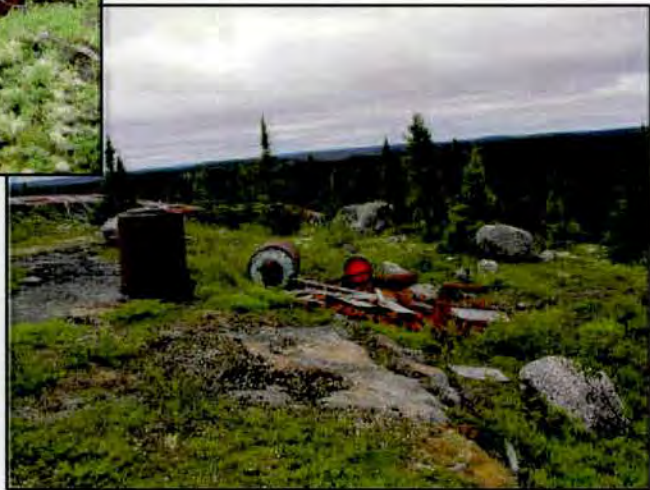
Photo 5 Site 336: contaminated areas during restoration (3 July 2002); garbage piled near the survival shelter; disposal area containing cans, small barrels and pails; and an oil-burning stove, barrel and other debris near the antenna (9 July 2002).

Outside, clean-up work involved stacking the empty barrels together, collecting the garbage into piles, cutting cables as well as identifying and restoring contaminated soil (photo 5). The nine fuel tanks were verified to be empty and their drain valves were removed. The biological degradation process was applied in contaminated areas totalling approximately 357 m² on the slope next to the fuel tanks and barrels, in two contaminated areas totalling approximately 9 m² (2 m x 3 m and 1.2 m x 2.5 m) where barrels had once been located, and in two small contaminated areas totalling a little less than 2 m² near the survival shelter. The biological degradation process was applied to loose contaminated soil where there was no vegetation cover and where the soil was at least 15 cm deep (Appendix 3).

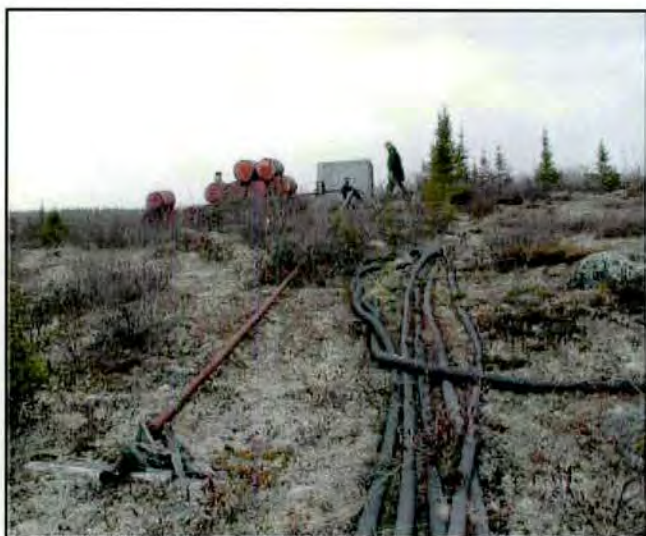
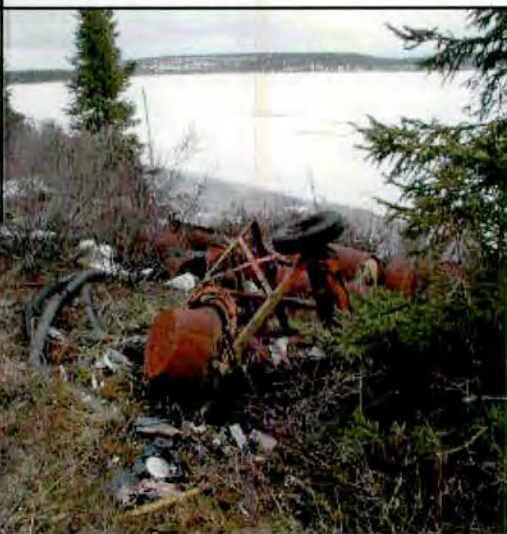
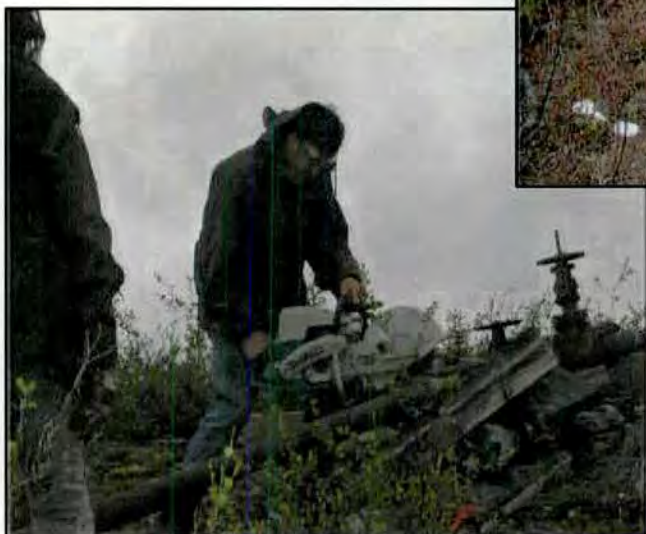
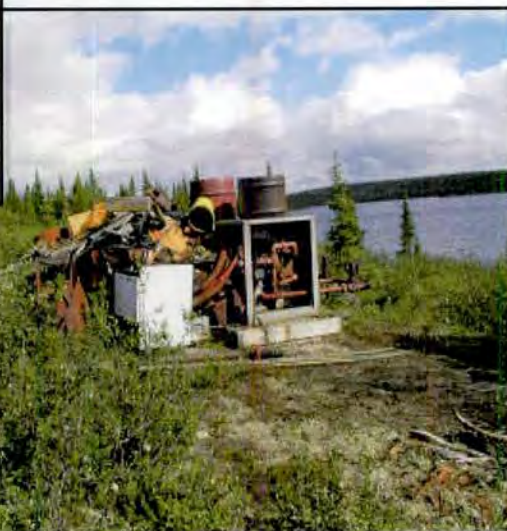
Photo 6 Site 336A: pipeline, hoses and debris near the lake before clean-up work (5 June 2002); worker dismantling the pipeline and debris piled near the pumping station (8 July 2002).

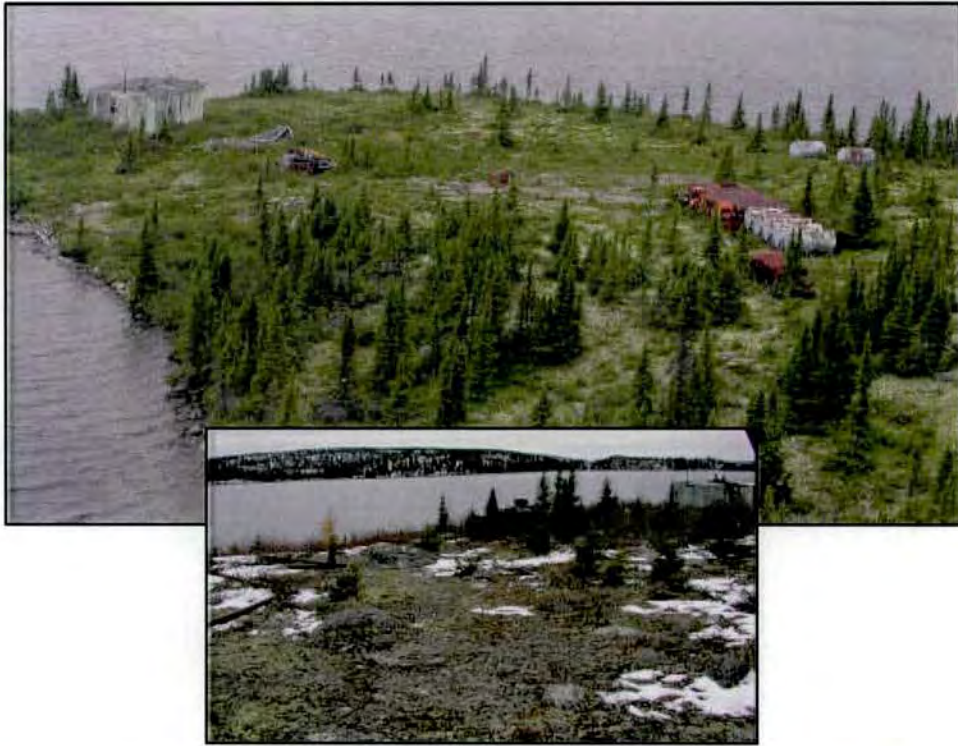
Photo 7 Aerial view of site 336A (9 July 2002) and former location of the three barrels of hydrocarbons, the containers of oil and the battery from site 336A (10 October 2002).

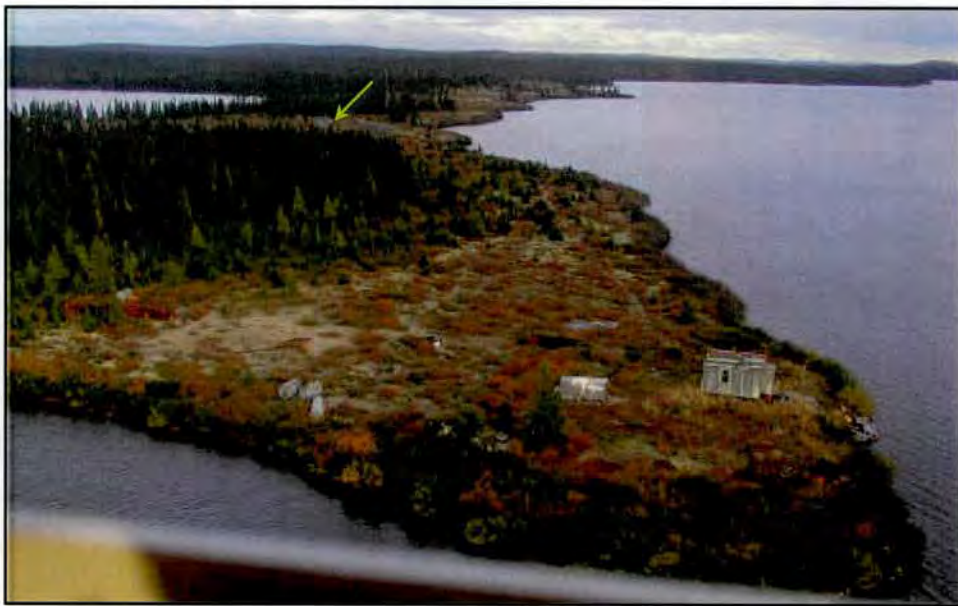
Photo 8 Aerial view of site 339A before clean-up work (24 September 2002). The arrow indicates the location of the Cree camp.

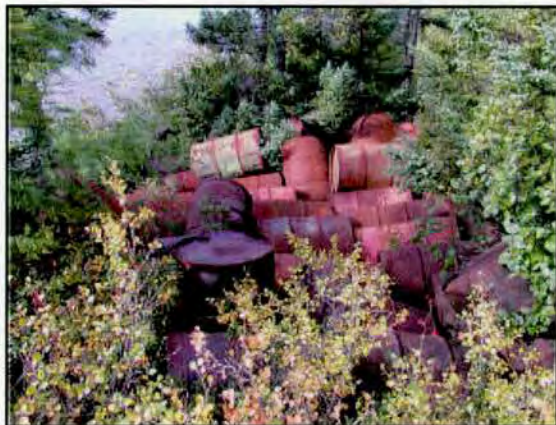
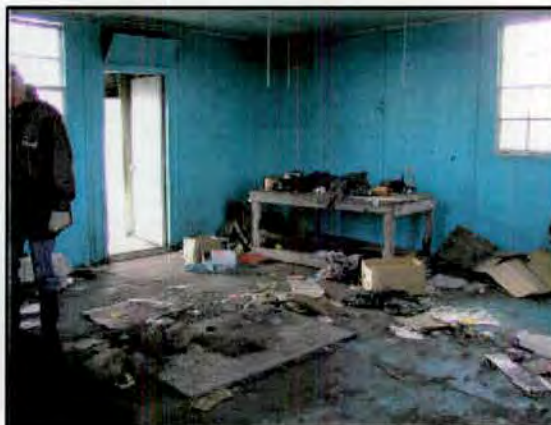
Photo 9 Barrels near the lake and the survival shelter at site 339A, before clean-up work (24 September 2002).

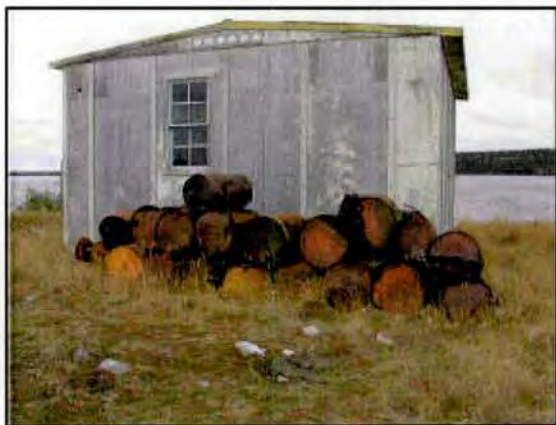
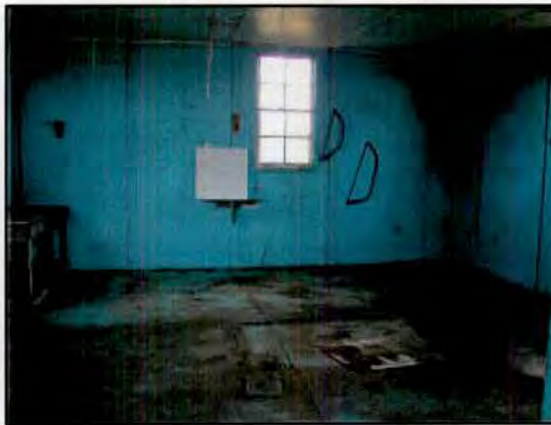
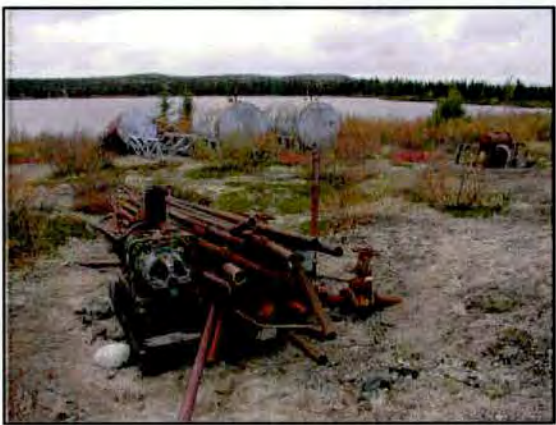
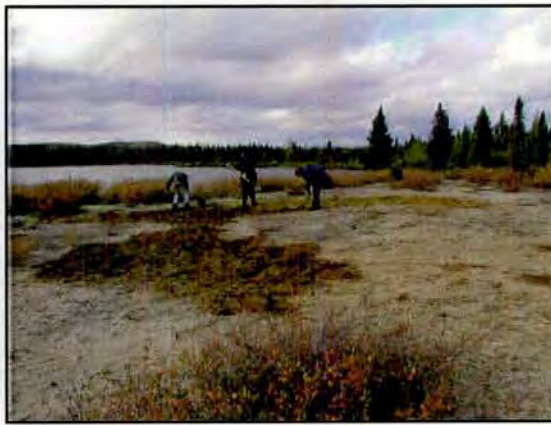
Photo 10 Site 339A: barrels from the dock now stacked behind the survival shelter; survival shelter after cleaning; stacked sections of dismantled pipeline; application of the biological degradation process in contaminated areas (26 September 2002).

this area which were bare of moss and lichen and where the depth of the soil permitted (photo 10). This restored area is roughly 60 m². The biological degradation process was also applied in two smaller sandy areas totalling 3 m² where the four barrels of diesel were located and a final area 3 m² near a pile of 20 barrels (Appendix 3).
