MID-CANADA LINE

INVENTORY

Prepared by: Daniel Berrouard - Environment Quebec
Normand Lysotte - Quebec Department of Recreation,
Fish and Game
Gérald Girouard - Environment Canada

February 10, 1986

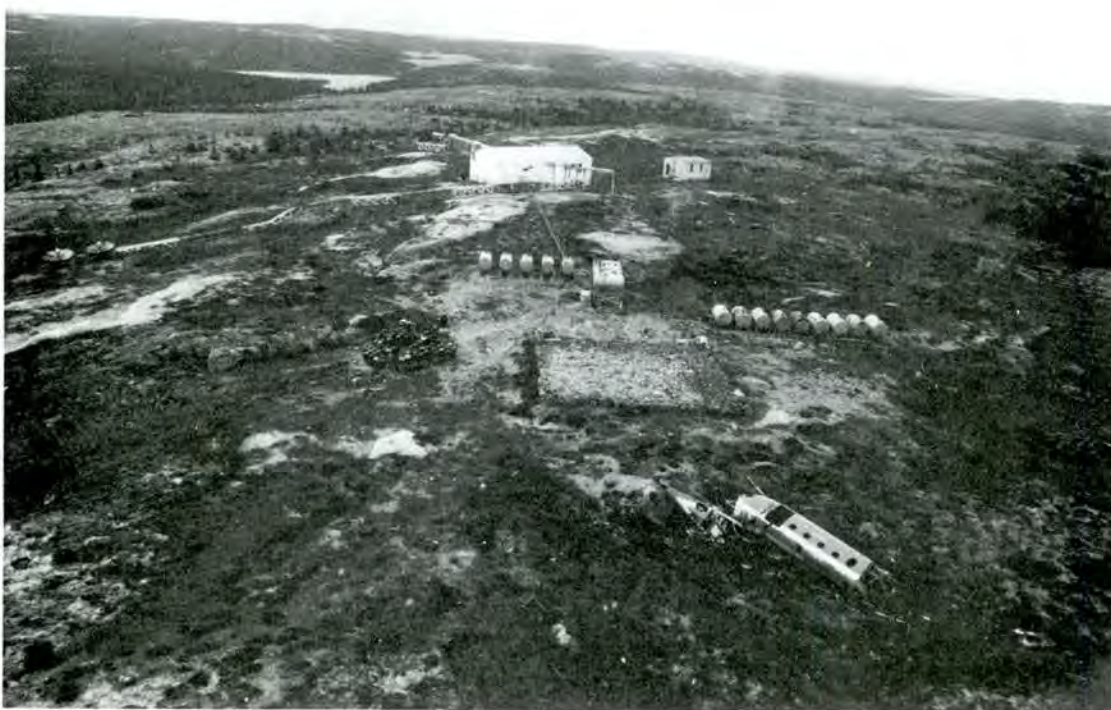
The detection sites differ from the supply sites in that they contain more equipment of all types. A photograph of a typical detection site (309) is presented on the following page, and the typical layout of a main building interior is shown in Appendix IV.

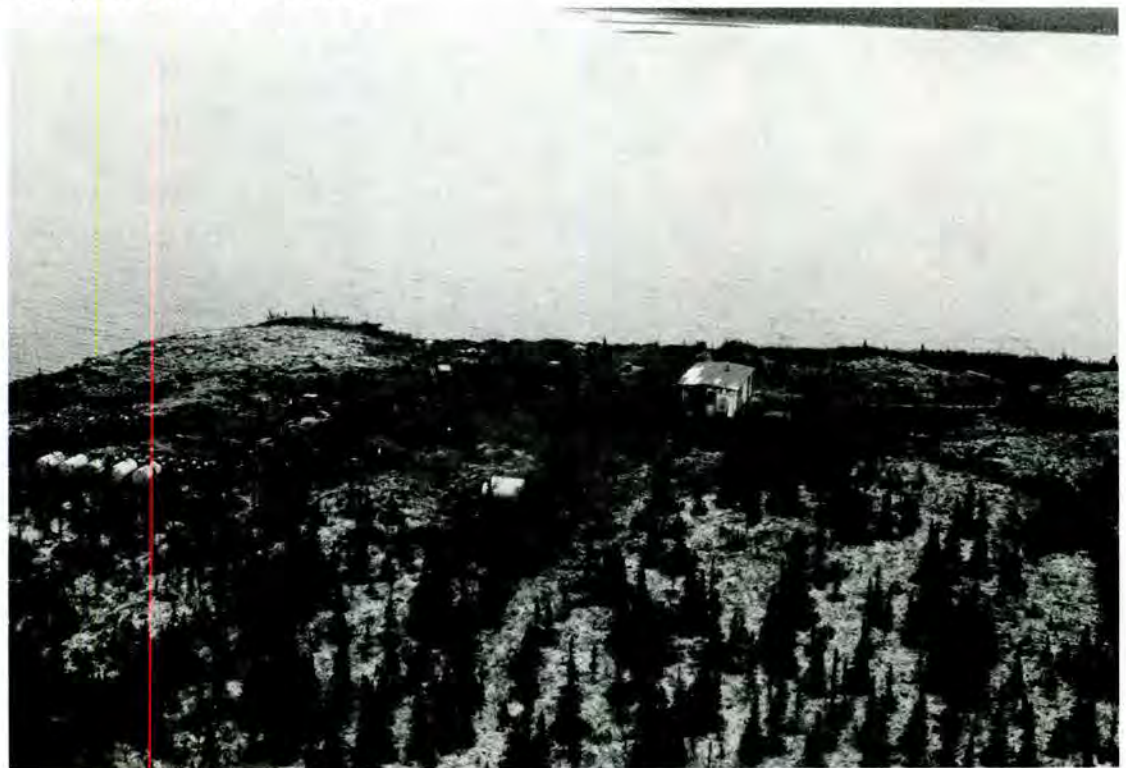
The 21 supply sites cover about the same area as the detection sites but their facilities are limited mainly to fuel storage tanks and a dwelling hut. A photograph of a typical supply site (318A) is presented below.
