**Mid-Canada Line Project: Phase 2, 1999
Interim Report**

Kativik Regional Government
Kuujjuaq, Quebec
December, 1999

Interim Report Mid-Canada Radar Line Project Phase 2, 1999

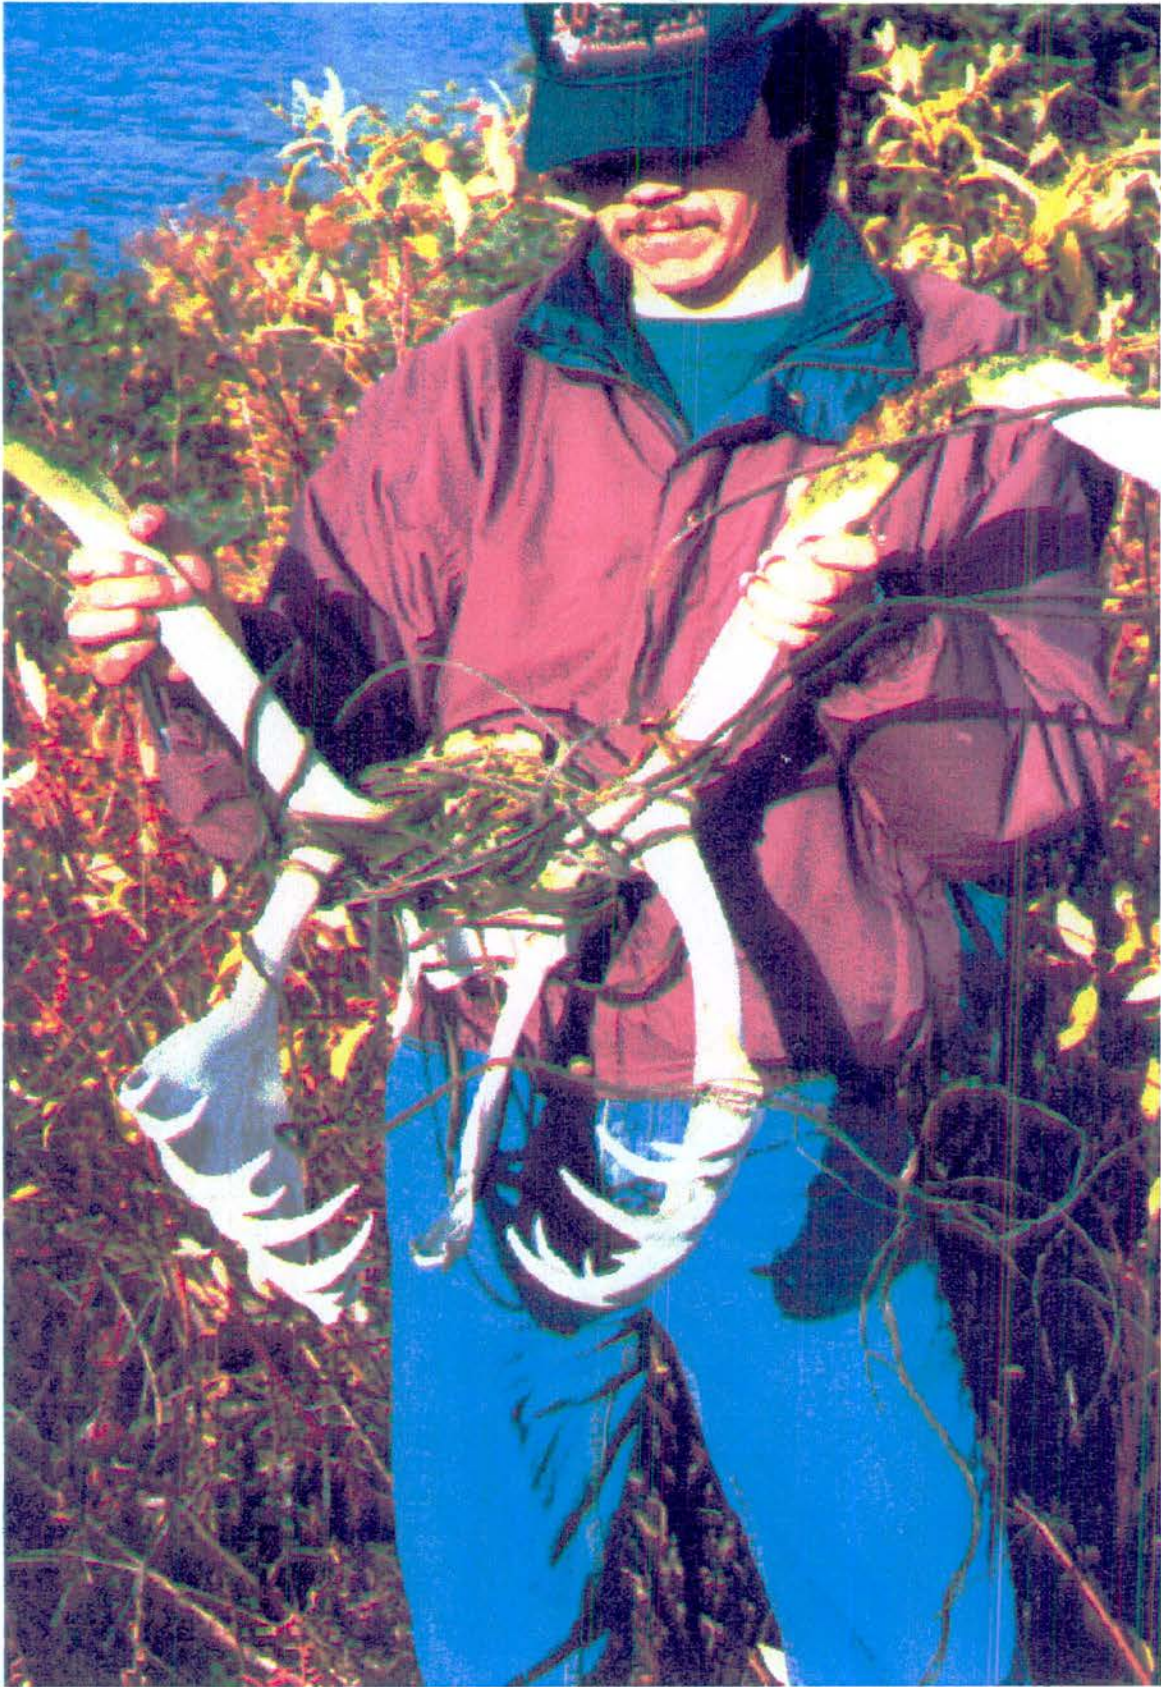
Site 333A. Caribou entangled by scattered cable.

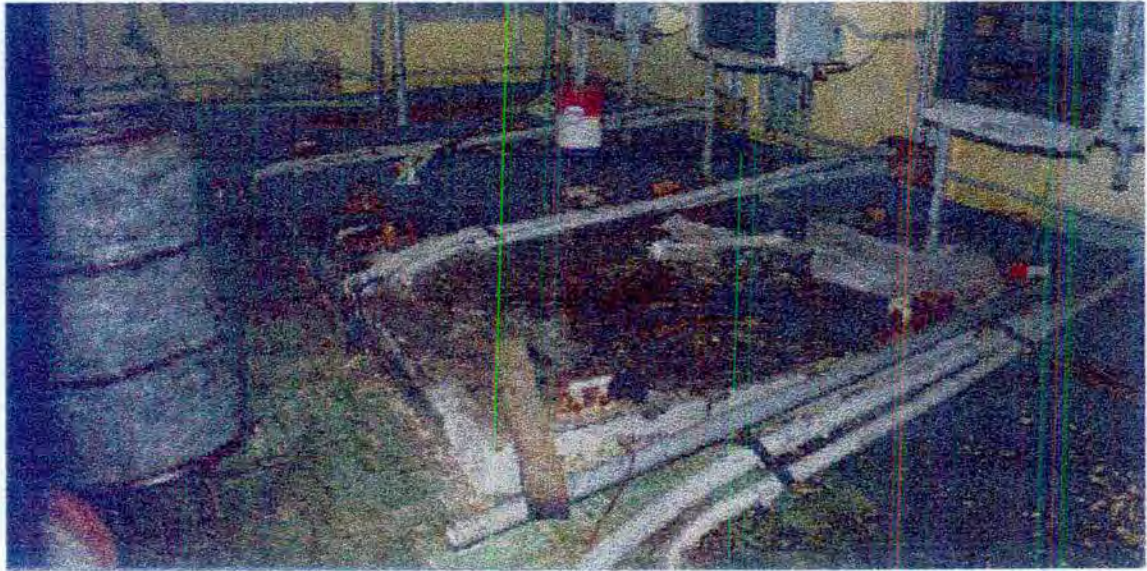
Site 215 Power room (Note:) Generators removed prior to 1980.

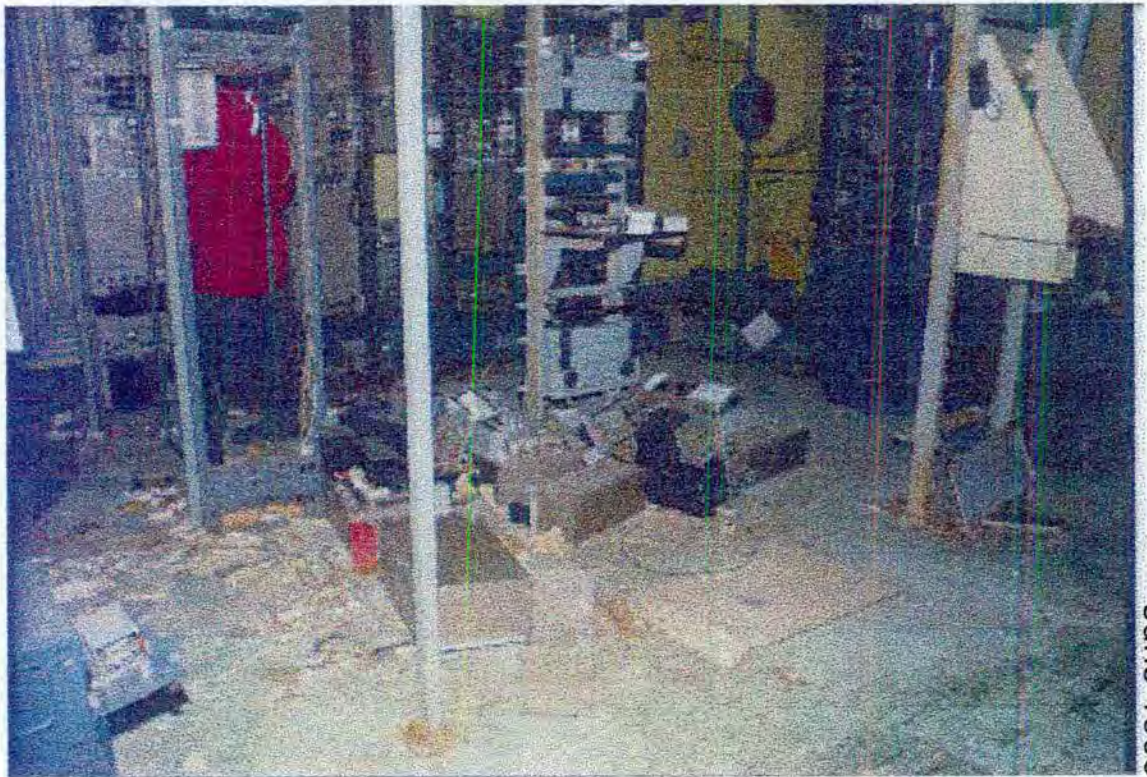
Site 215 Electric room before clean-up.

The building was inspected and cleaned up. The larger debris were put alongside the back wall of the electric room and the pathway between the living quarter and the power room was cleared of all debris. In the living quarter, the paint, which was peeling off in the living quarter, was scraped off after the initial cleanup of the building. The windows in the living quarter and in the power room were repaired using LEXAN sealed with silicone caulking. The door leading to the living quarter was also fixed using plywood found on the site.

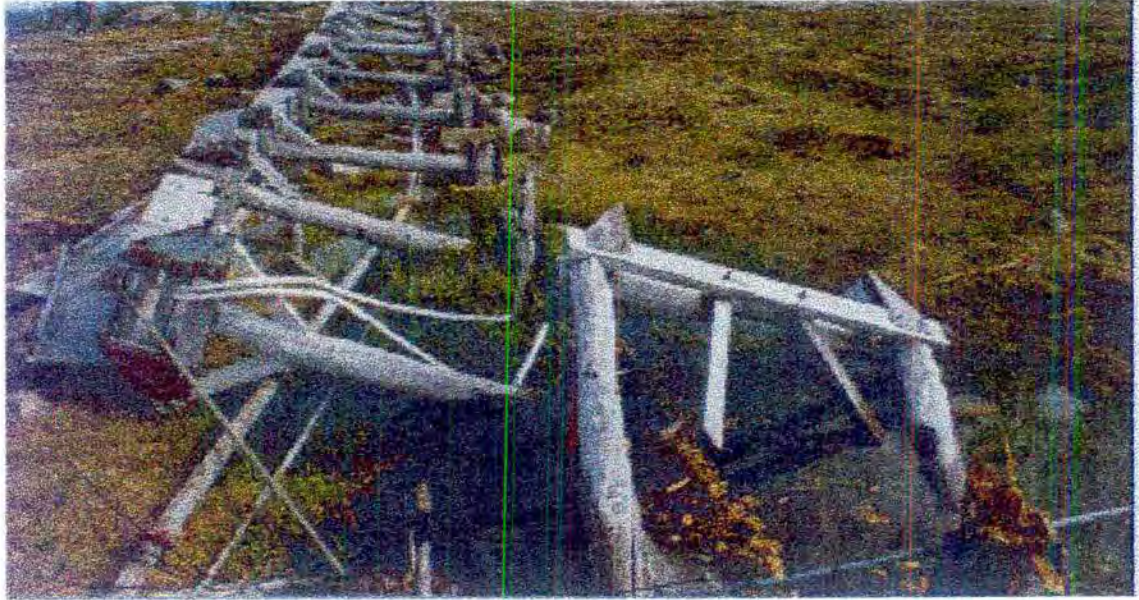
Right outside the building, the overhead cable conduit leading to one of the detection towers was identified as a serious safety hazard because most of the poles used to support the overhead structure were broken. In fact, only the three poles closest to the building were still standing.

Site 215 Overhead cable conduit taken down.

The overhead cable was identified as a clear hazard and had to be put down for safety reason. The structure was brought down safely using the basic tools at our disposal (axe, bow saw, and a hacksaw). The work, however, required several hours to complete.

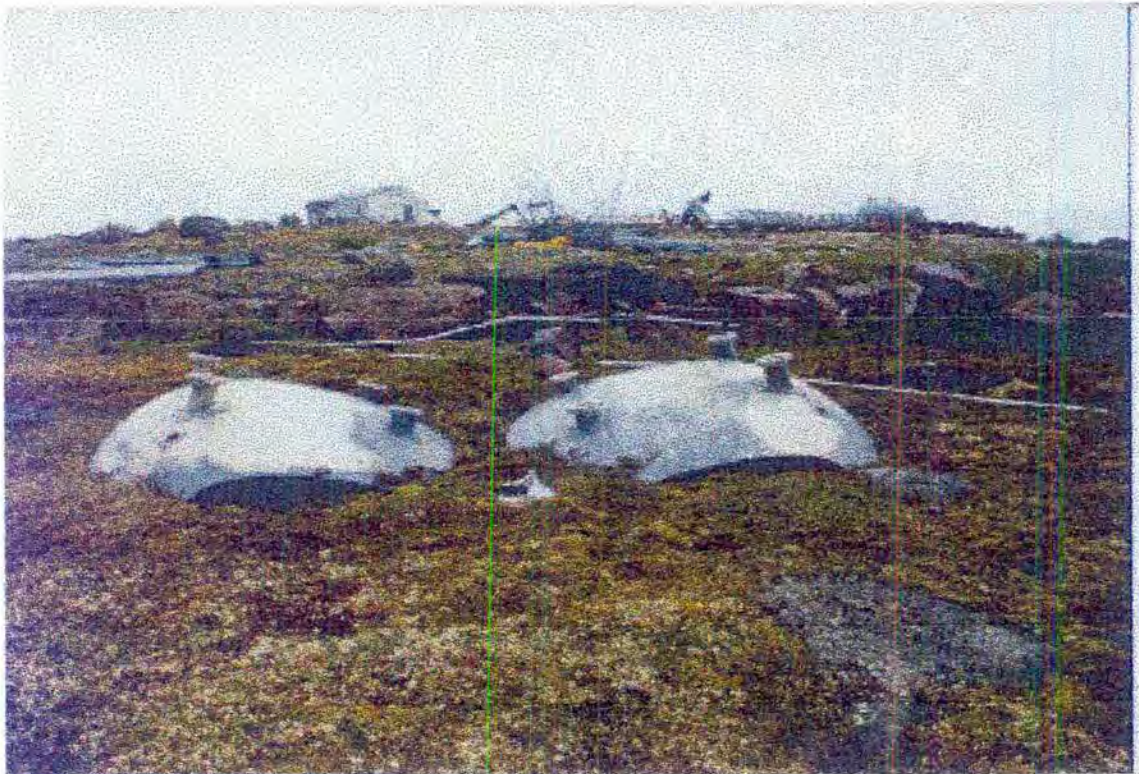
Site 215 Largest dumpsite (heavy metallic debris)

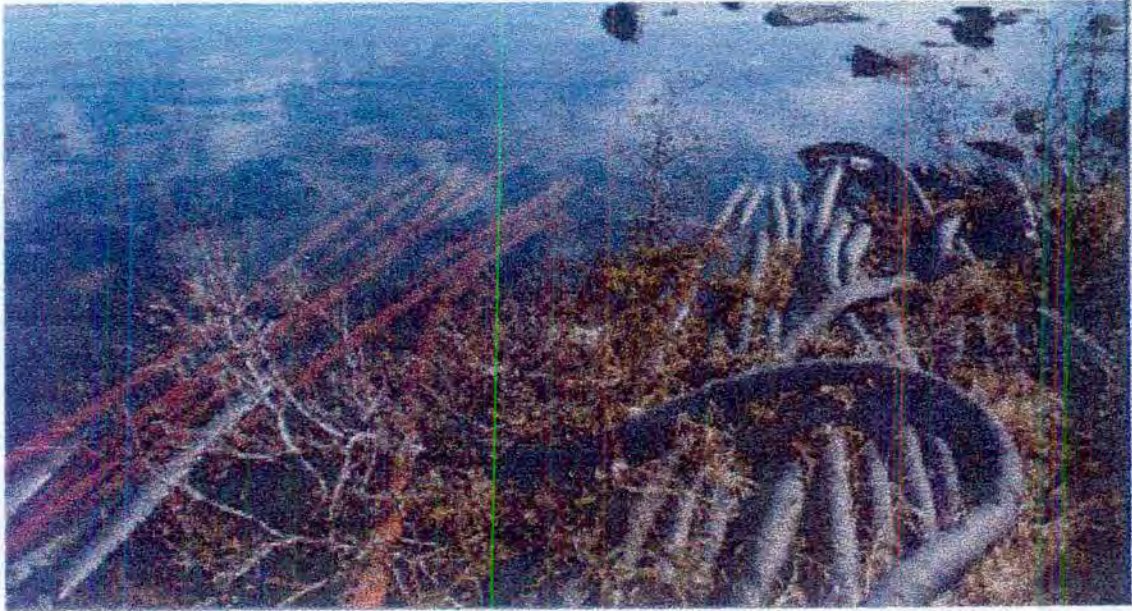
Site 218A Flexible pipes in the water before removal.

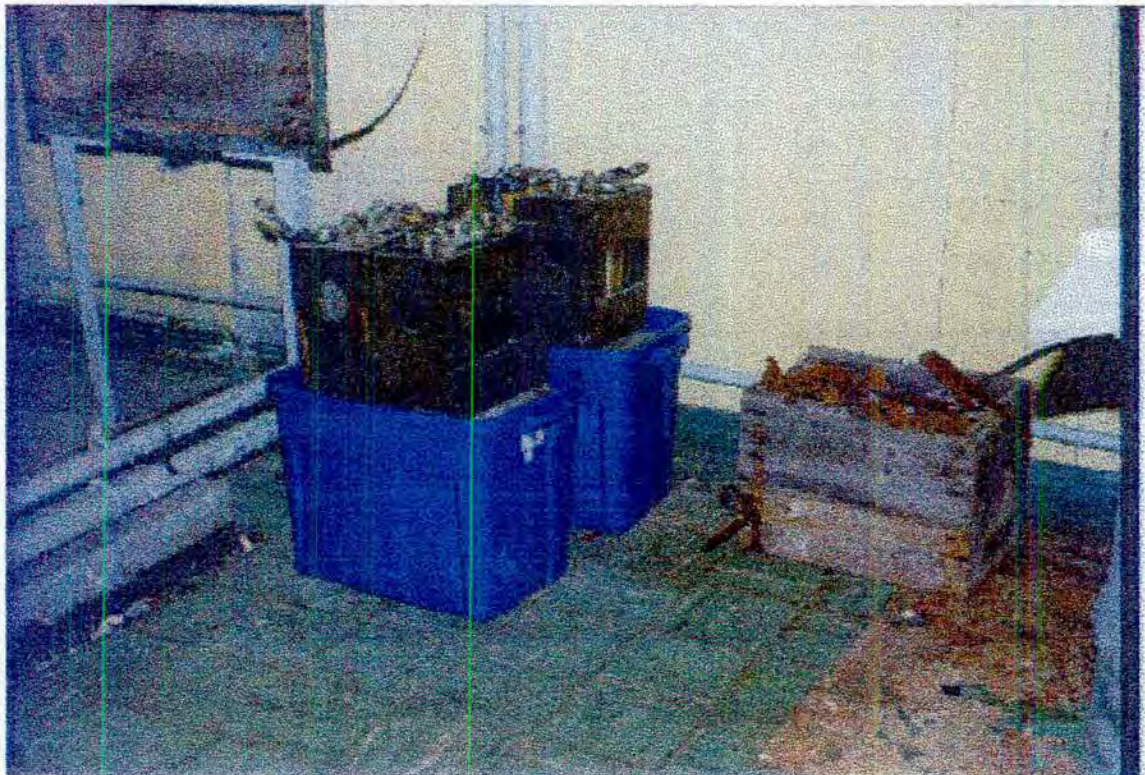
At this site, 8 sets of 3 batteries (24 units) were found. Acid was still present in nearly all the cells checked. Altogether, these batteries weigh well over 150 kg. A decision was made to leave them inside the building. However, in order to contain any potential leaks, the batteries were all put into two large and sturdy plastic containers specially bought for this purpose.

Site 218 Safely stored batteries.

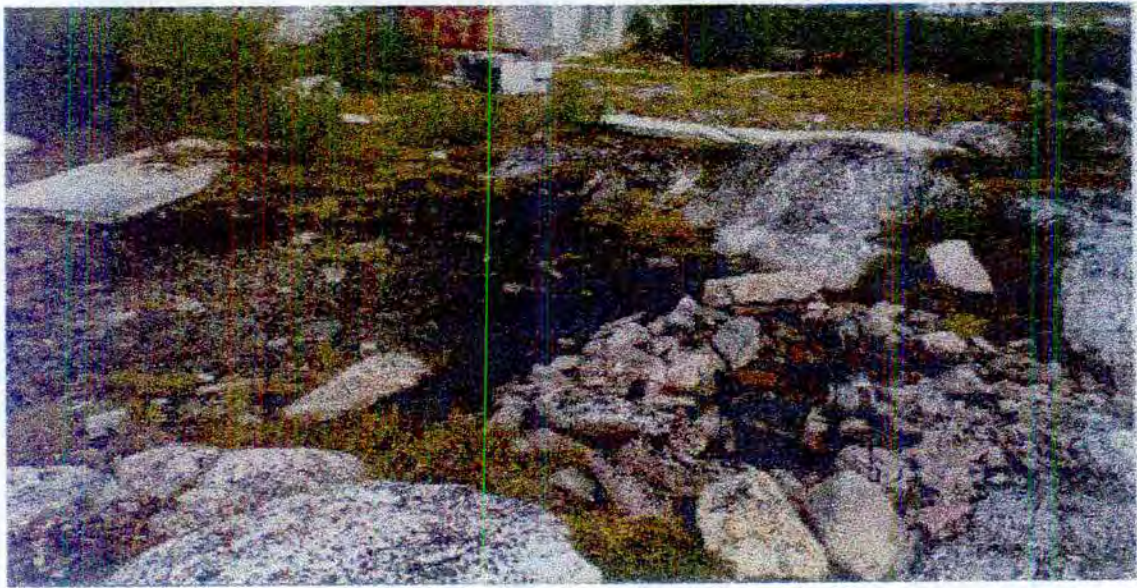
An area 10 meters away from the building was likely contaminated with heavy oil. The contaminated area is on rock and measures about 25 m². Diesel leaks were also observed here and there around the large reservoirs and the main barrel depot.

Site 221 Contaminated soil (heavy oil)

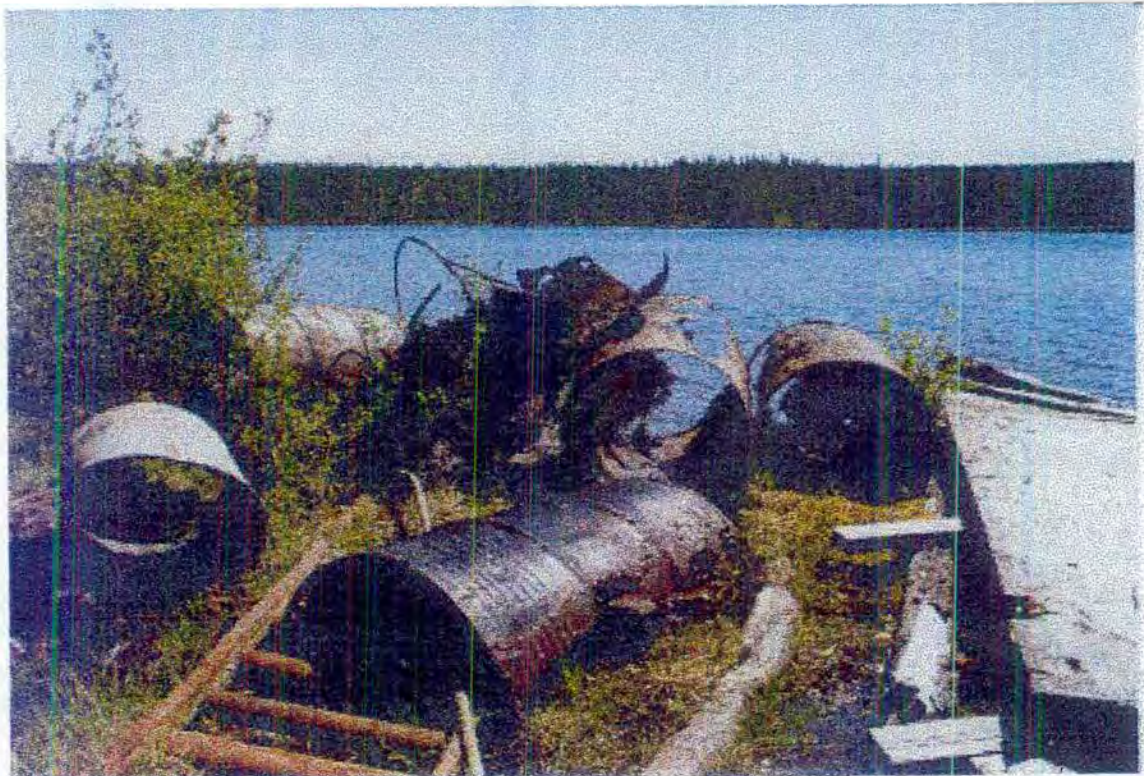
Site 221A Barrels taken out the lake.

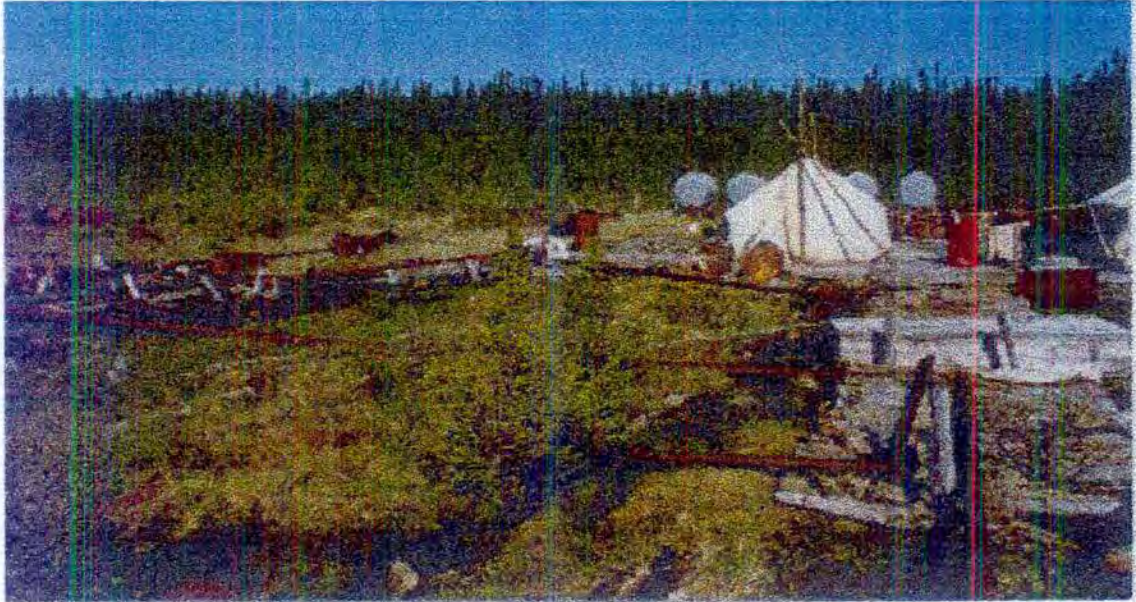
Site 221A Campsite before clean-up.

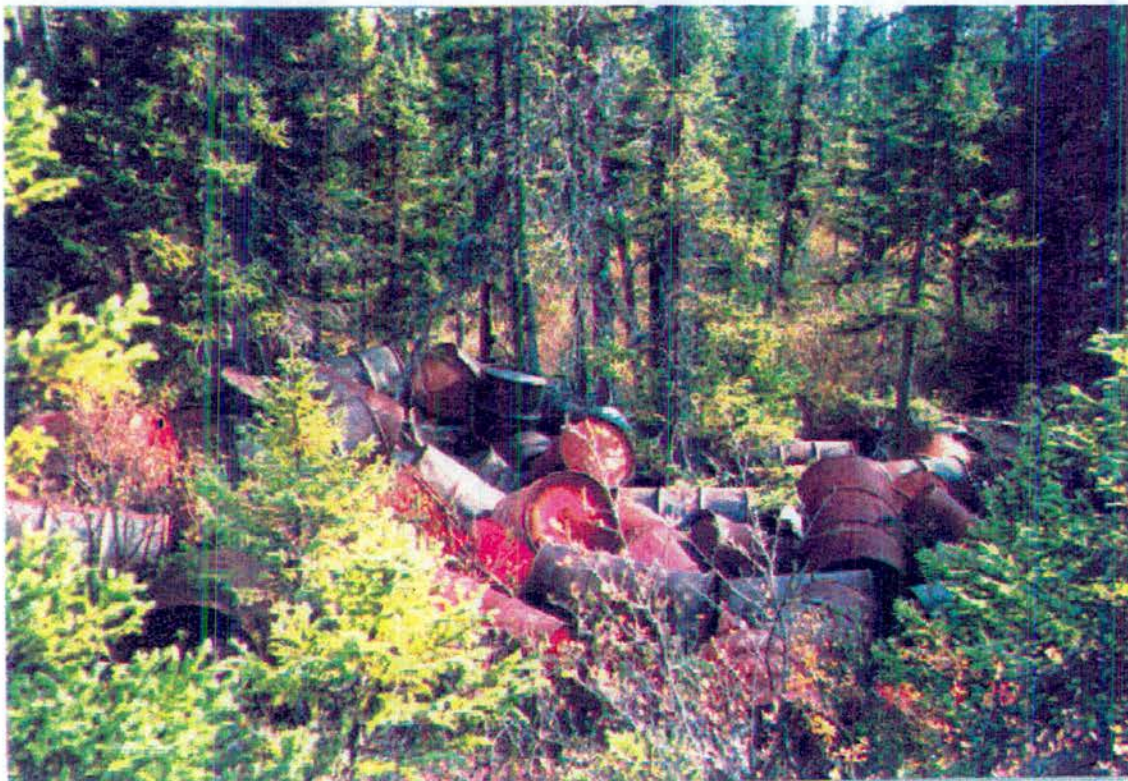
Site 330. Barrel dump at the foot of the hill.

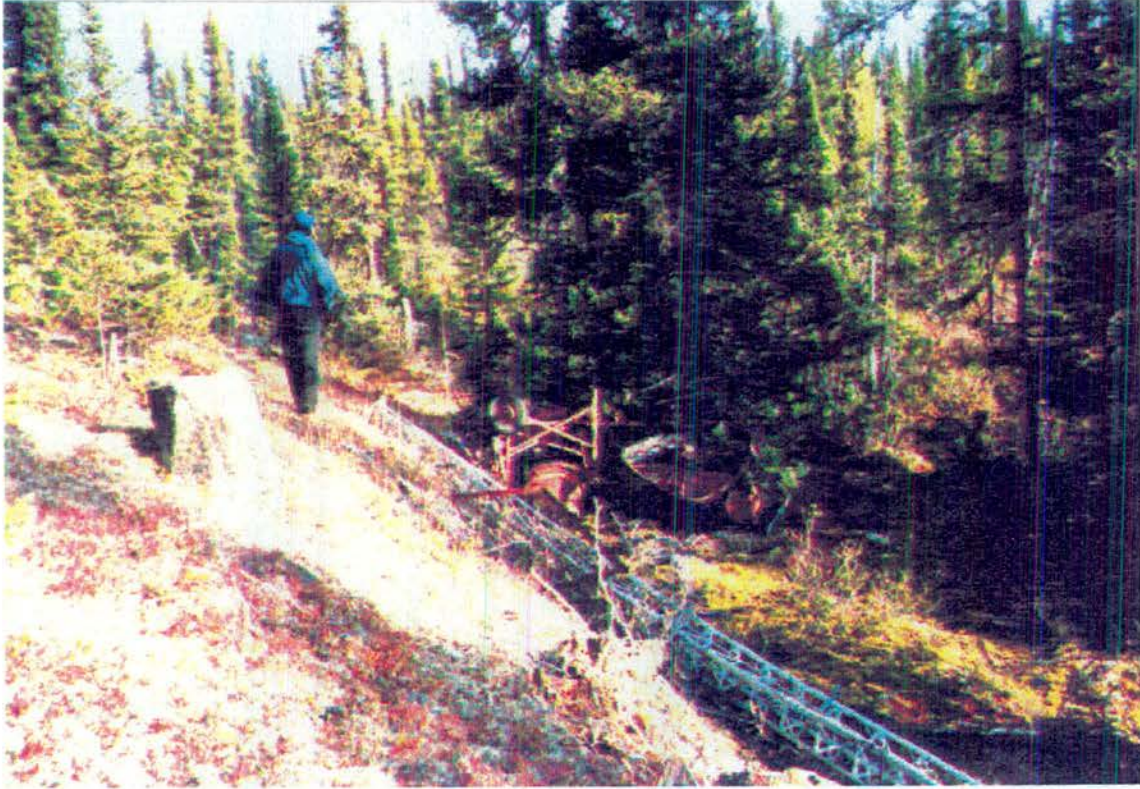
Site 330. One of several dumpsites in the surrounding forest.

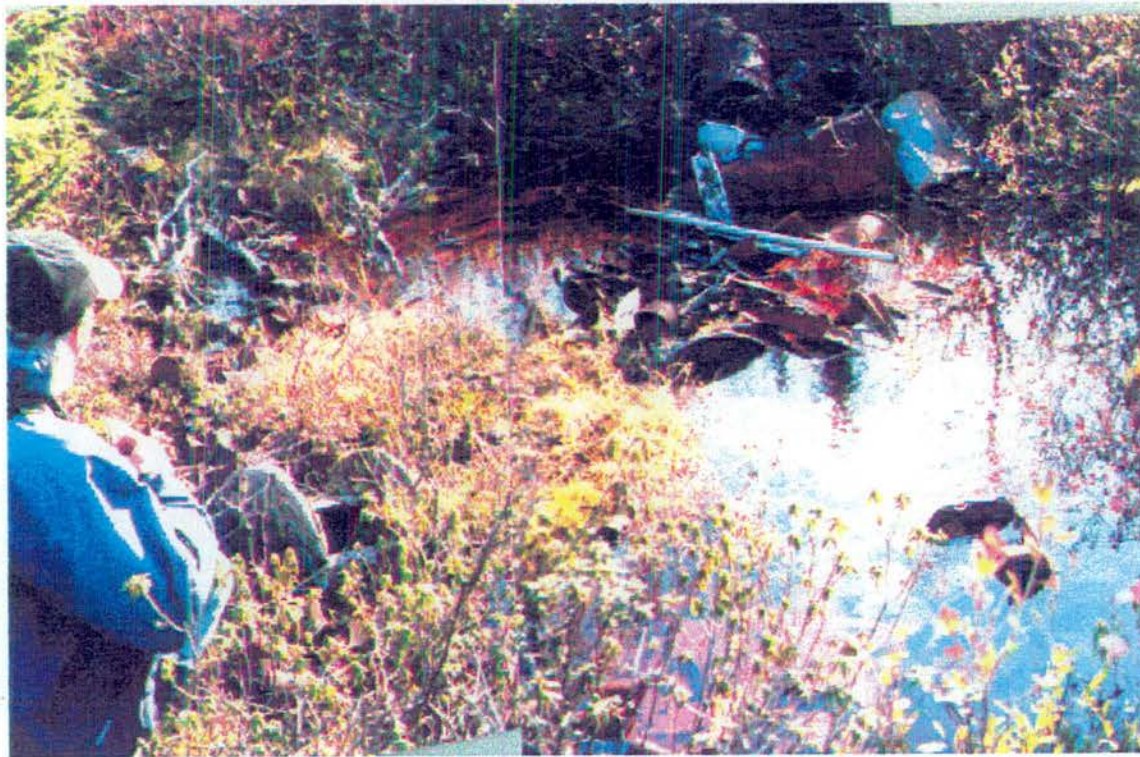
Site 330. Dump to be cleaned up behind operations building.

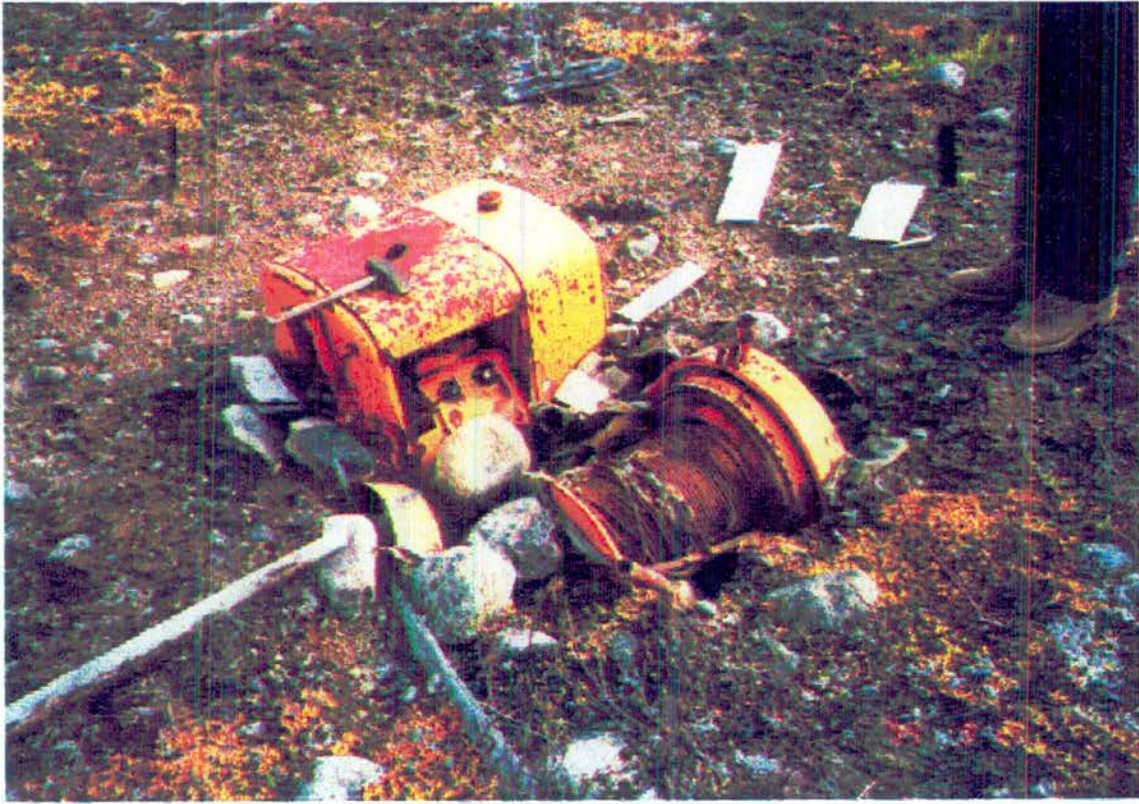
Site 330. Buried winch by bunkhouse.

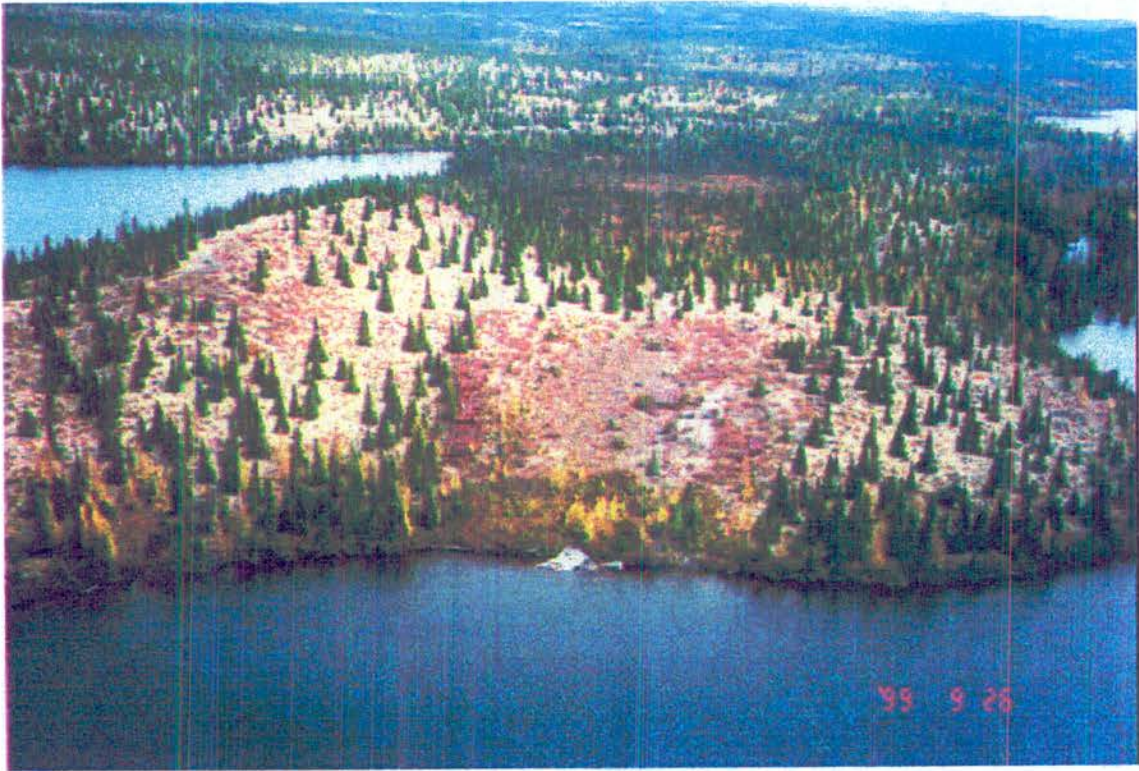
Site 330A. Barrels and rotting dock in foreground.

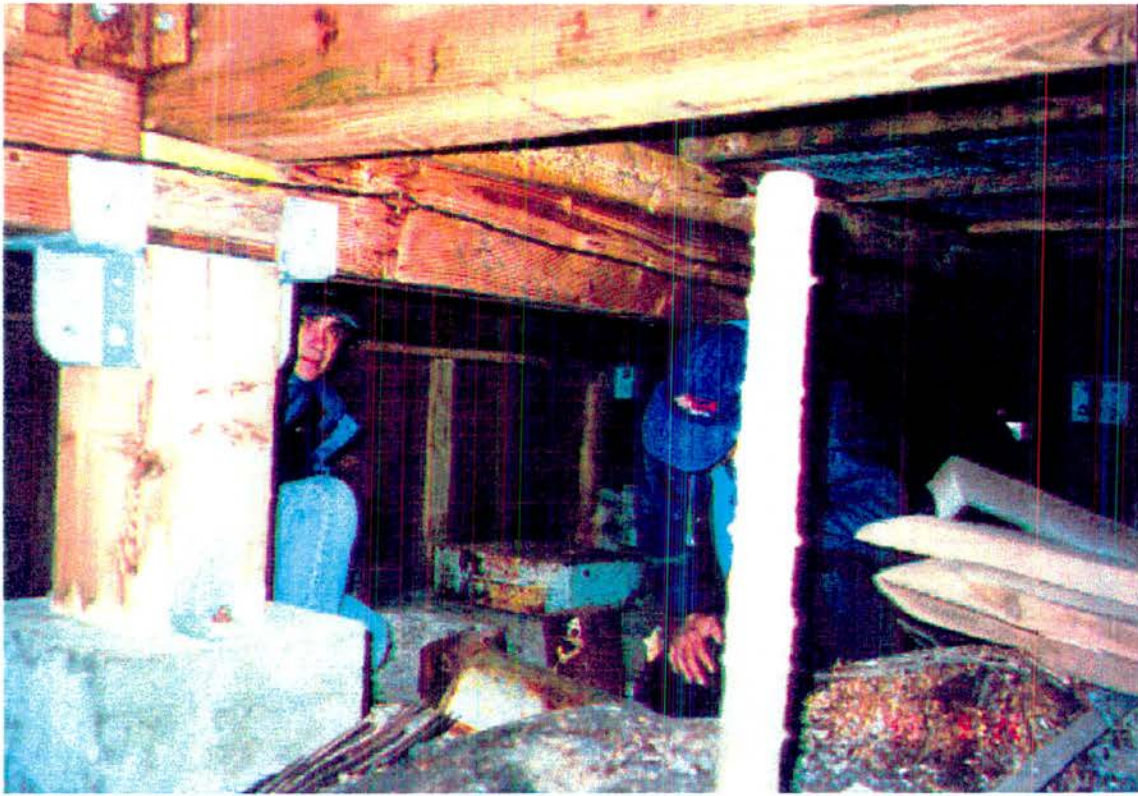
Site 333. Substructure of operations building and stored chemicals.

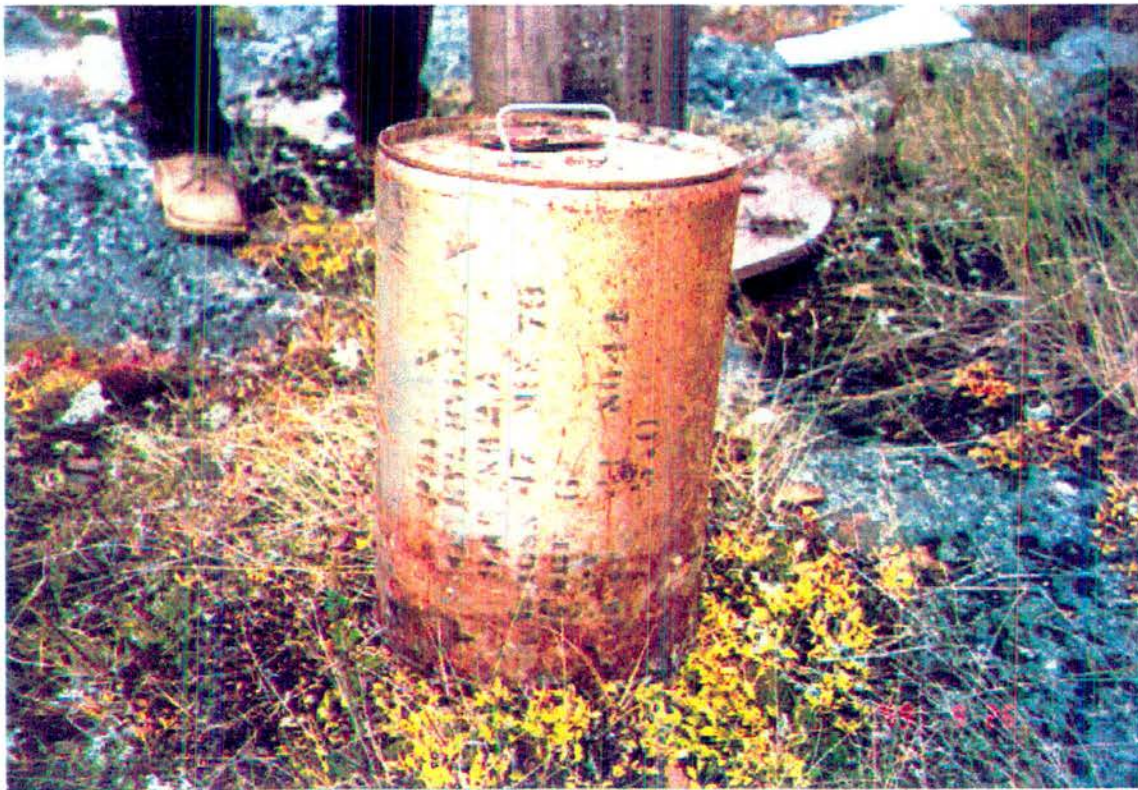
Site 333. Can of ethyl hydrate from beneath operations building.

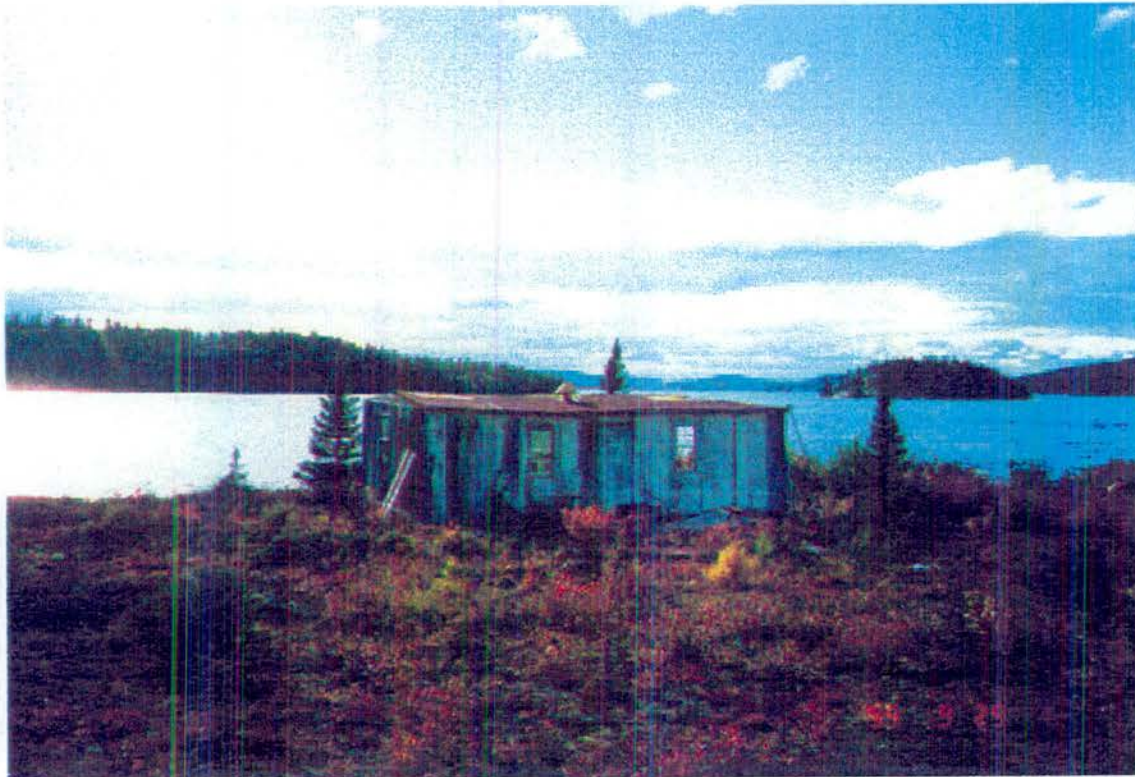
Site 333A. Cabin. Lakeward half of the roof and one wall is missing.

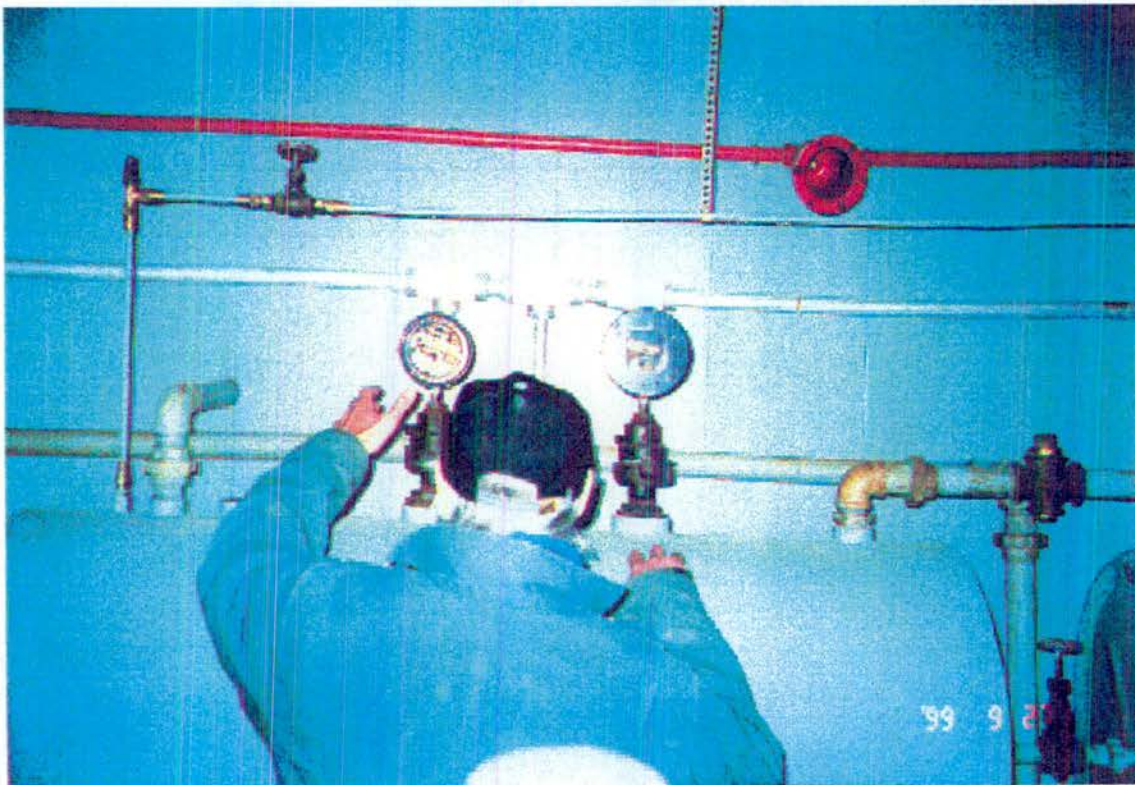
Site 339. Mercury switches in the generator room of the operations building.

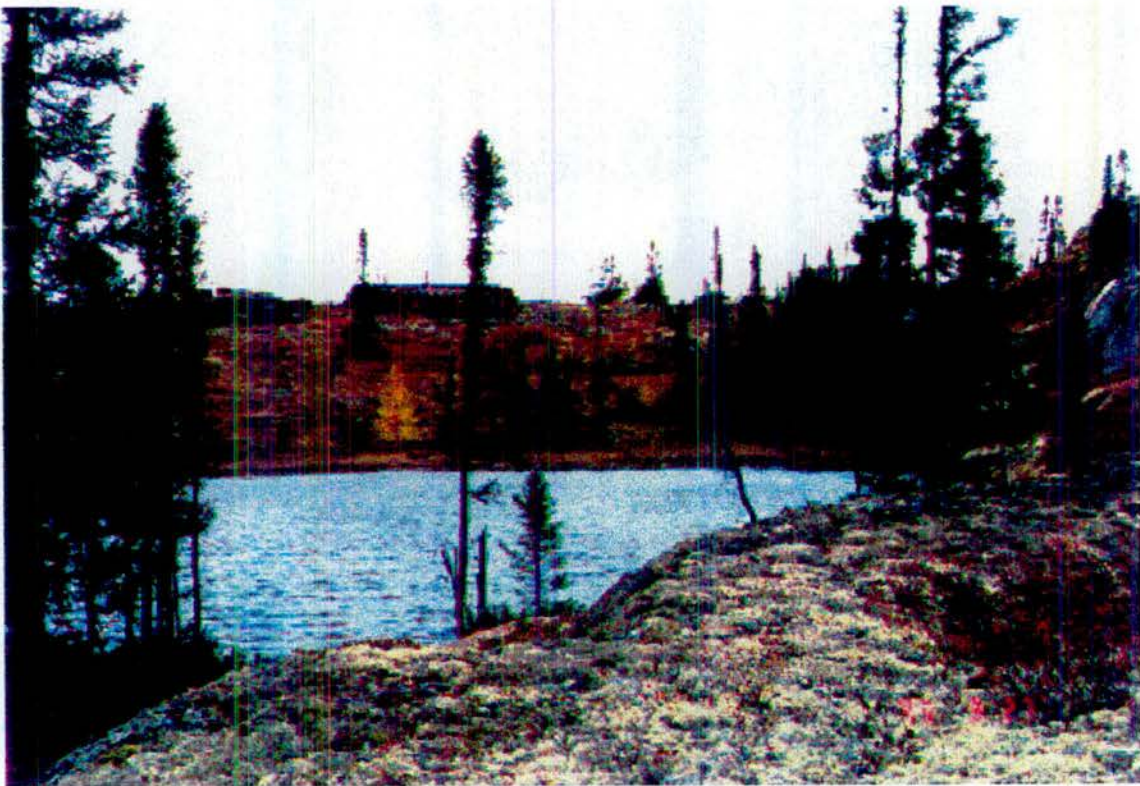
Site 339A. Barrels piled above lake near bunkhouse.
