Titre Environmental Emergency Reports

Notes Document: Site Evaluation Report-Drinking Water pumping station Tasiujaq for Kativik Regional Government; 30 Novembre 2006

Potable Water Pumping Station
Tasiujaq, Quebec

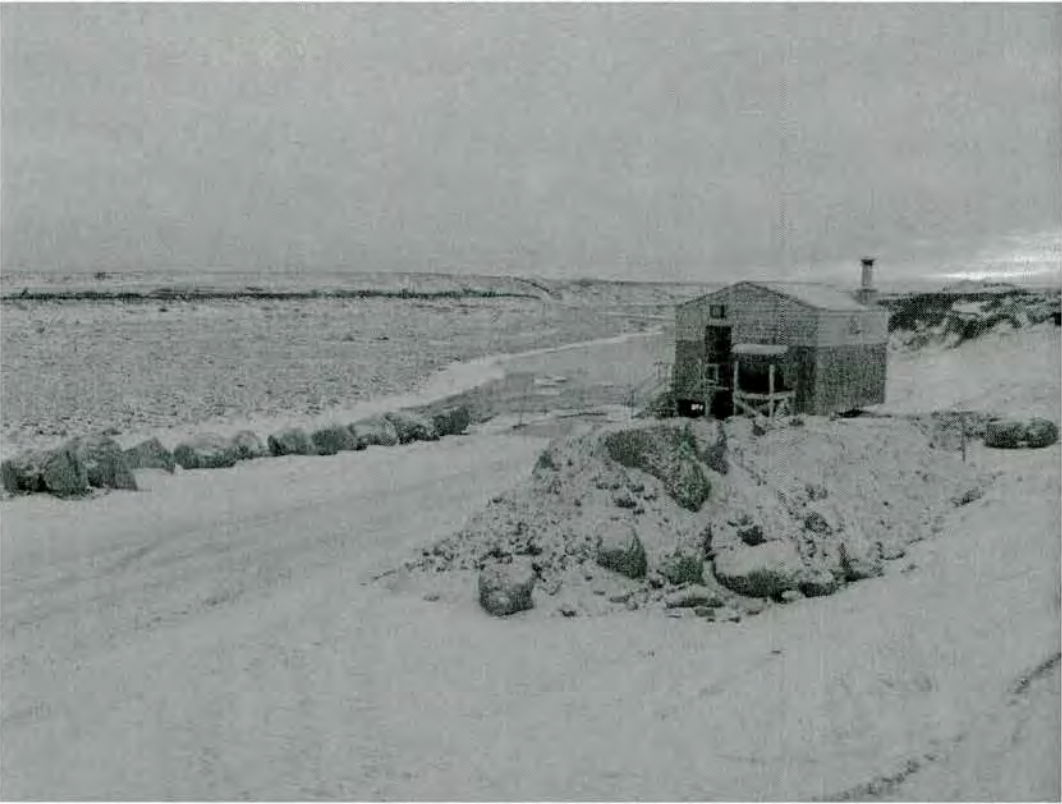
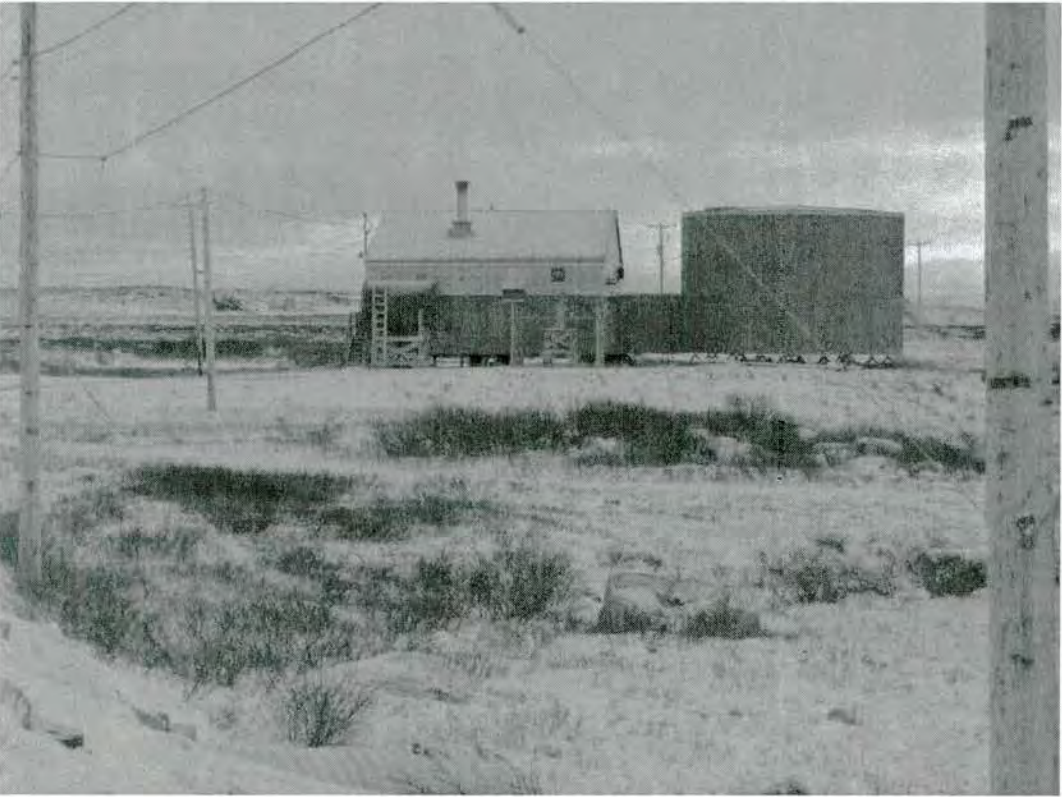
The building itself lays on four (4) stands and reinforced pyramidal steel supports which are lying on standard wooden pallets. The whole sits on one-meter deep fill that was put into place on top of the natural ground (see general view photo 1 from Appendix C and photo 5 showing the structures on which the pumping station stands). The walls of the well of the pumping station stand above that fill approximately 0,60 m high and are braced to the floor of the building by a wooden structure made of 2x3" studs. Elevation of the well at that point is 81,000. The well is not in the center of the structure but rather located asymmetrically below the east portion of the building. Water is pumped and re-circulated close to the bottom of that well through pipes of 250 mm diameter that connect to the well through link seals at elevation 69,300. The piping to the water intake extends 50 m away from the well (downstream the river) and the intake lies approximately four (4) meters below the actual river level. For over two (2) years, water was delivered to housing by pumping from that location directly into the water truck with chlorination done directly into the tank of the truck. The water distribution plant (photo 2, Appendix C) has not been in use since the rupture of a pipe between the pumping station and the plant, over two years ago.

Photos 1 and 2 – North view of Tasiujaq pumping station and Disinfection plant

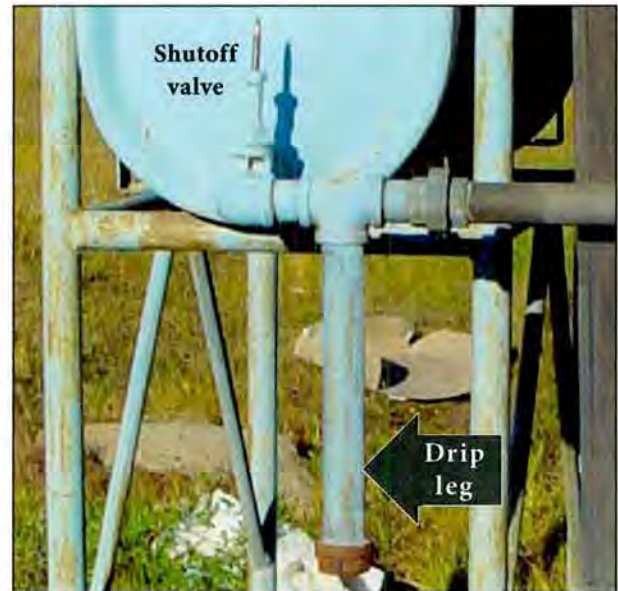
4.3 Drip leg extends below the level of the fuel line.

A fuel line and drip leg of a large diameter – two inches – is the best configuration as it is much more forgiving if accumulated water freezes inside of it. Narrow diameter lines of one inch and less are far less forgiving and tend to rupture when water freezes inside of them. If the fuel

line/drip leg diameter is less than two inches, the drip leg should be as long as possible – a minimum of 12 inches – to increase its capacity to hold water. This, however, should not be used as a substitute for regularly draining water from the heating oil tank and drip leg.

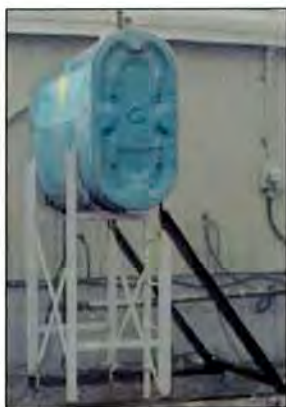
4.4c Note that owner has stabilized the base of his oil tank by lengthening the horizontal support members on the side of the tank where the fuel delivery ladder is located, and adding steel struts at a 45-degree angle to provide greater stability.

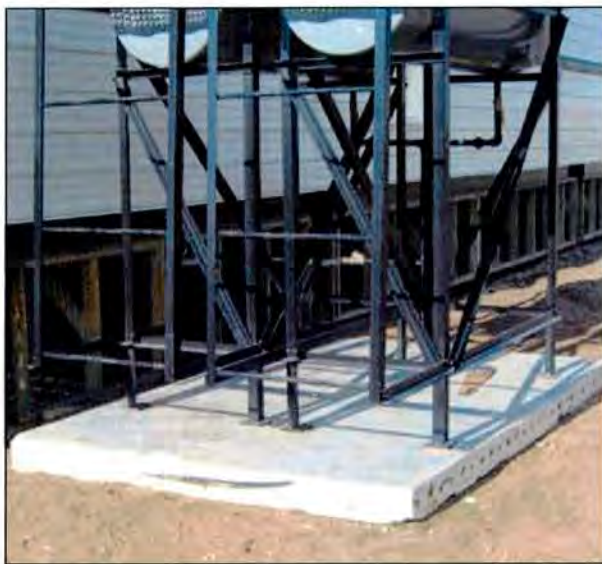
4.4d A twin tank installation firmly secured to a full concrete pad. This provides a solid foundation.

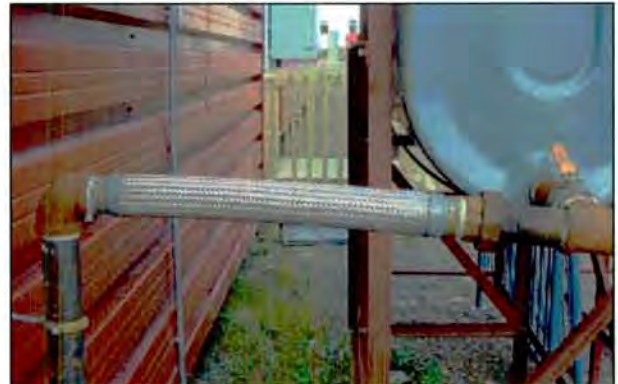
4.5c This flex connector has been properly installed: note that it is aligned in a straight line and the steel weave is tight.

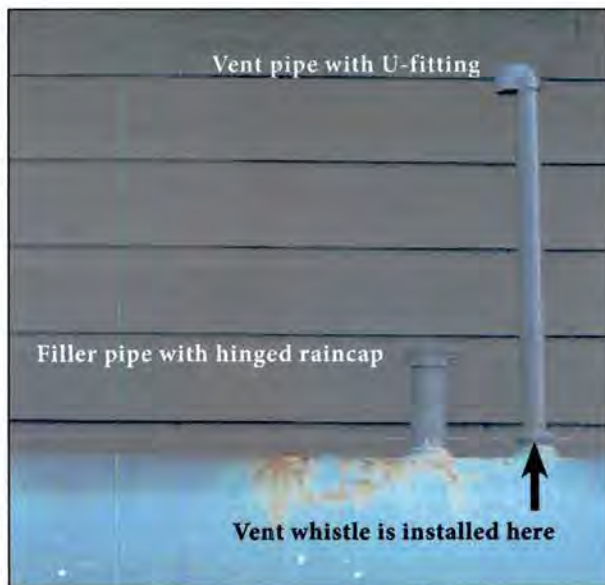
4.8b Note the length of the oil tank vent (the pipe on the right hand side of the tank) is roughly one foot higher than the filler pipe.
