CANADIAN FORCES .
1 CONSTRUCTION ENGINEERING UNIT .

ENGINEERING STUDY 83-CEU-40
NORTHERN QUEBEC MID-CANADA LINE SURVEY
28 SEP 1983

MID CANADA LINE SURVEY PHASE II

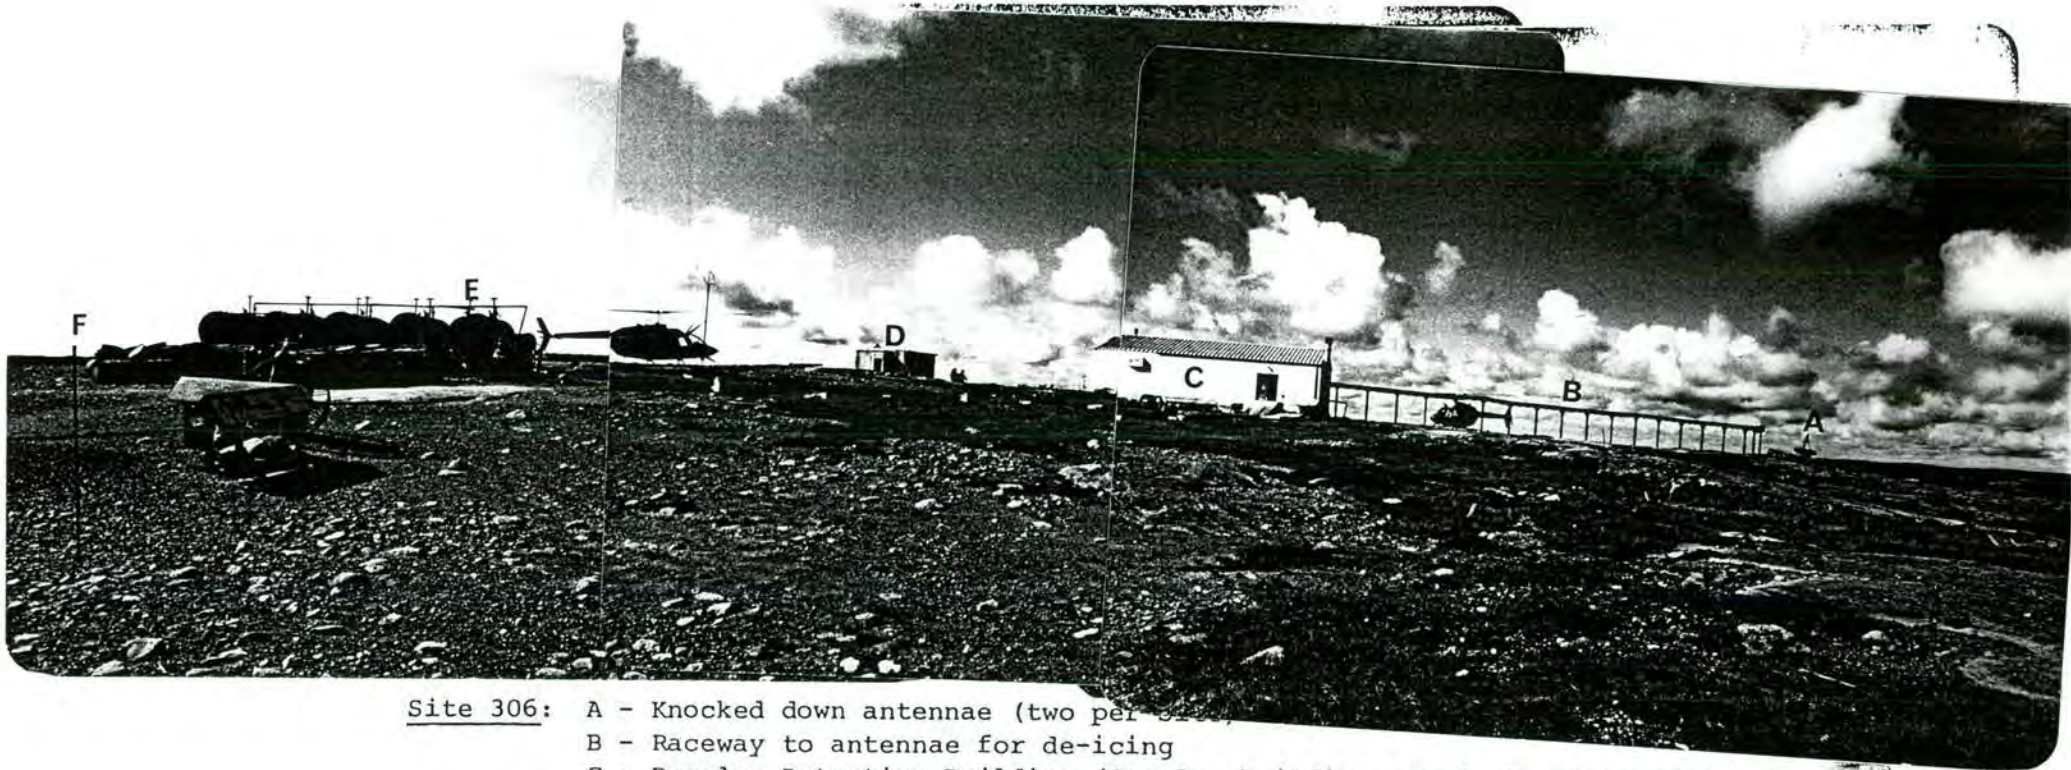
TYPICAL SITE LAYOUT OF AN AUXILIARY MID-CANADA STATION

- Site 306:
- A - Knocked down antennae (two per antenna)
 - B - Raceway to antennae for de-icing
 - C - Doppler Detection Building (Steelox building manufactured by ARMCO Drainage and Metal Products)
 - D - Four man survival hut
 - E - 22 730 L (5 000 gal) fuel storage tanks and 205 L (45 gal) drums
 - F - Rock or wood helicopter landing pad
