**MID-CANADA LINE  
CLEAN-UP PROJECT - PHASE 2**

**1999-2000**

**Report on Completed Clean-up Work**

**Kativik Regional Government  
Kuujjuaq, Québec**

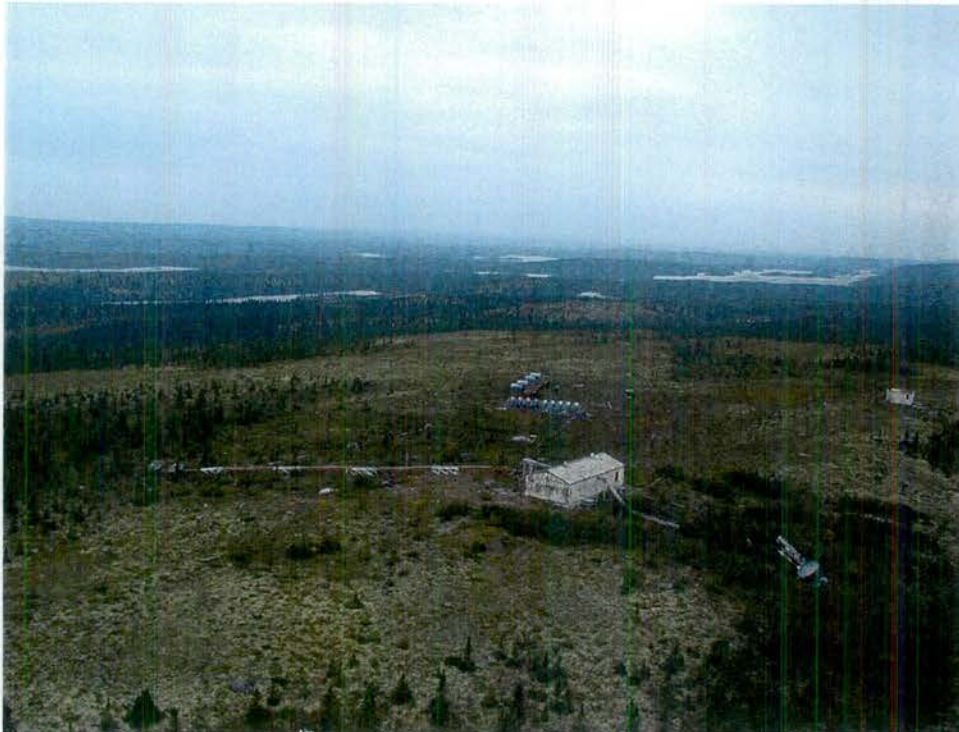
**Antennas:** Antennas are not covered under the clean-up project, as mentioned in the acceptance criteria. Antennas are generally tall and can be seen by snowmobilers in winter (Photo 1, Appendix 5).

**Photo 1.** Typical detection site located on the top of a hill with a main building, a survival shelter, fuel tanks, barrels and two tall antennas.
