Brunelle, J. and M. Barrett. 2002. *Mid-Canada Line Clean-up Project – Phase 2. 2001-2002*. Report submitted to the Ministère de l'Environnement du Québec. Kativik Regional Government. Kuujjuaq, Québec.

MID-CANADA LINE (Québec)

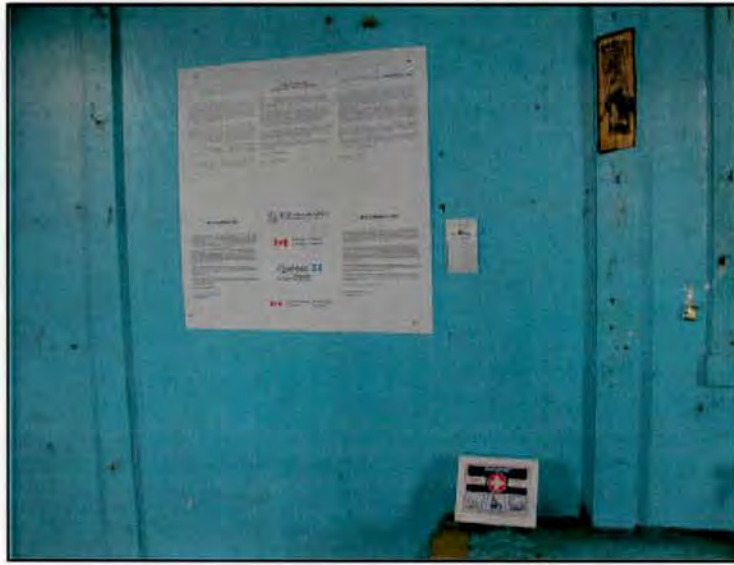
Debris in the survival shelter was removed (photo 10) and placed in the main disposal site. The floor was swept. An information sign and first aid kit were installed on the far wall (photo 11). A shed belonging to the Cree, located roughly 11 m from the survival shelter, was not tidied up.

this area which were bare of moss and lichen and where the depth of the soil permitted (photo 10). This restored area is roughly 60 m². The biological degradation process was also applied in two smaller sandy areas totalling 3 m² where the four barrels of diesel were located and a final area 3 m² near a pile of 20 barrels (Appendix 3).

Photo 10 Site 339A: barrels from the dock now stacked behind the survival shelter; survival shelter after cleaning; stacked sections of dismantled pipeline; application of the biological degradation process in contaminated areas (26 September 2002).
